# HYGROTHERMAL DURABILITY OF BOND IN FRP-STRENGTHENED MASONRY

## ABSTRACT

This paper presents the results of an experimental program aimed at investigating the hygrothermal durability of bond in FRP-strengthened bricks. Accelerated ageing tests were performed on the FRP-strengthened brick elements and the bond degradation was periodically investigated by visual inspection and by conventional single-lap shear bond tests. The changes in the properties of material constituents have also been monitored. The obtained results are presented and critically discussed.

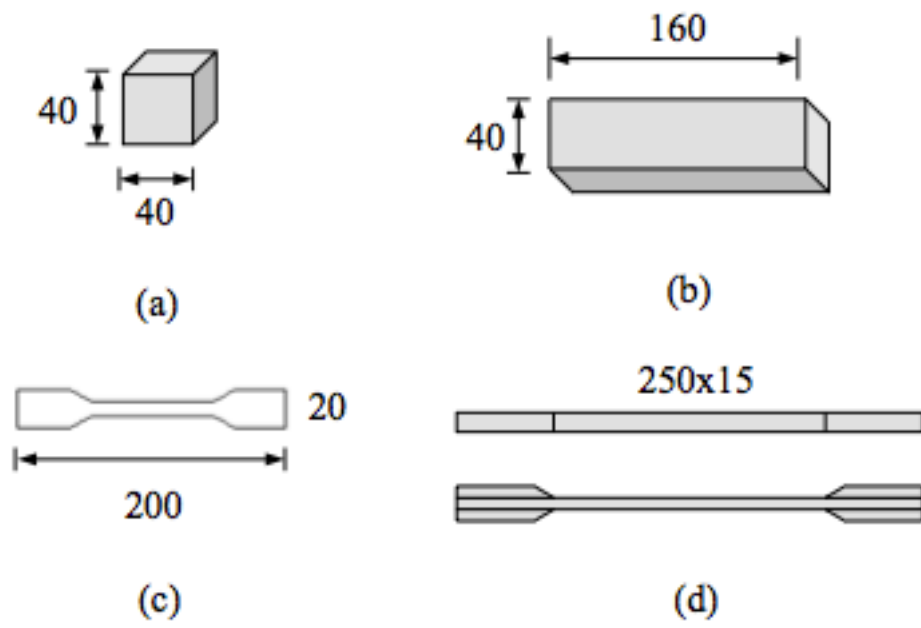
**Fig. 1** Tests on material components (dimensions in mm): (a) brick compressive specimen; (b) brick flexural tensile specimen; (c) epoxy resin and primer tensile specimen; (d) GFRP coupon tensile specimen

**Fig. 1** Tests on material components (dimensions in mm): (a) brick compressive specimen; (b) brick flexural tensile specimen; (c) epoxy resin and primer tensile specimen; (d) GFRP coupon tensile specimen

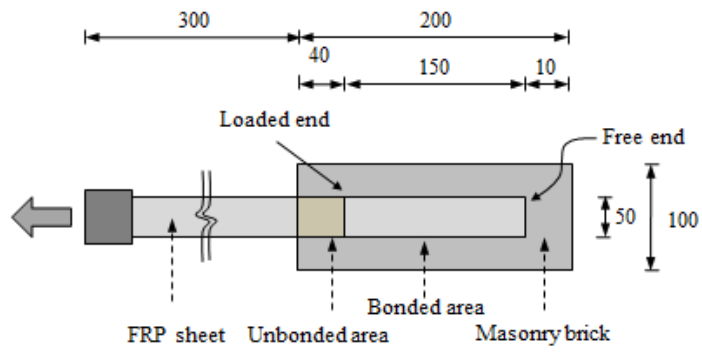
**Fig. 2** Specimens' details for single-lap shear bond tests

**Fig. 2** Specimens' details for single-lap shear bond tests

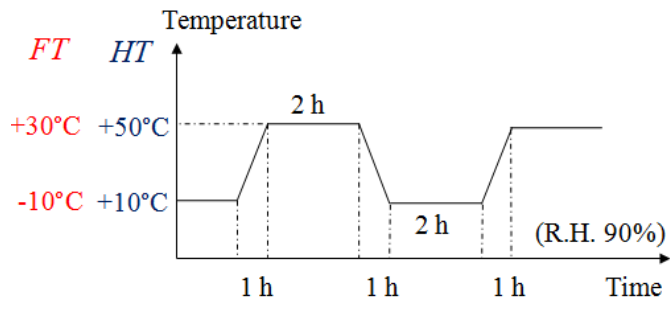
**Fig. 3** Hygrothermal cycles adopted

**Fig. 3** Hygrothermal cycles adopted

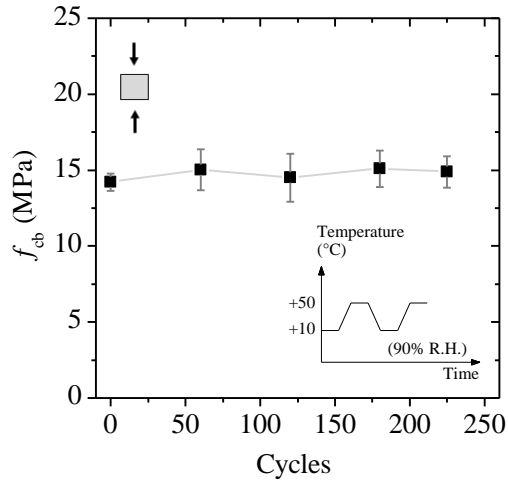
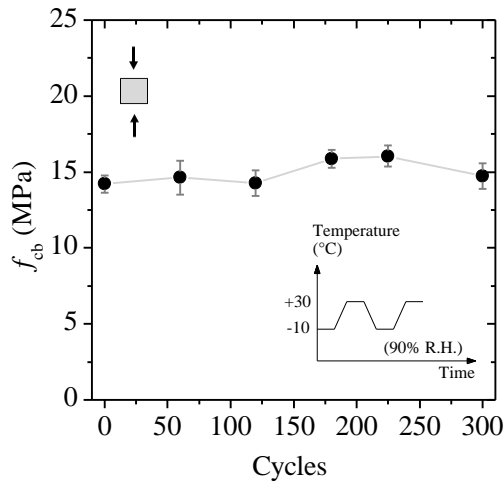
**Fig. 5** Effect of hygrothermal exposures on the compressive strength of bricks: (a) exposure HT; (b) exposure FT

**Fig. 5** Effect of hygrothermal exposures on the compressive strength of bricks: (a) exposure HT; (b) exposure FT

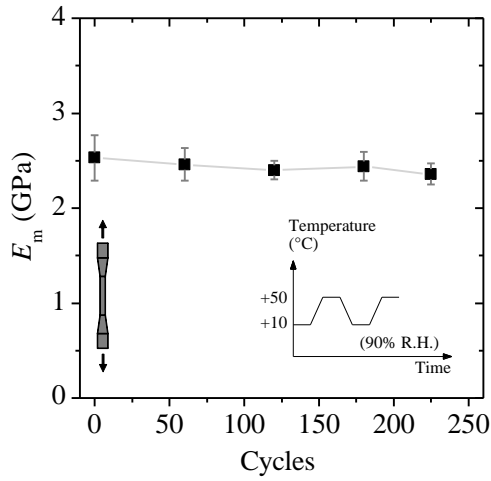
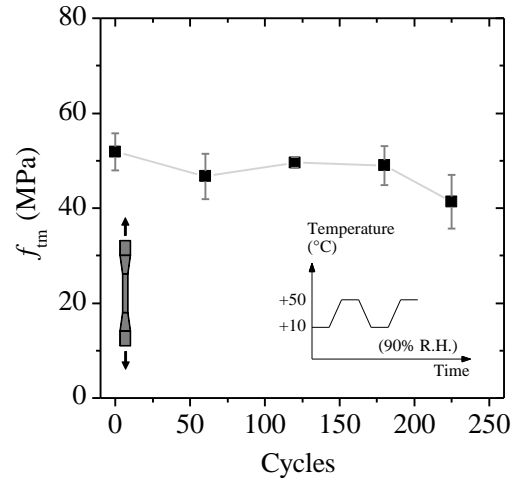
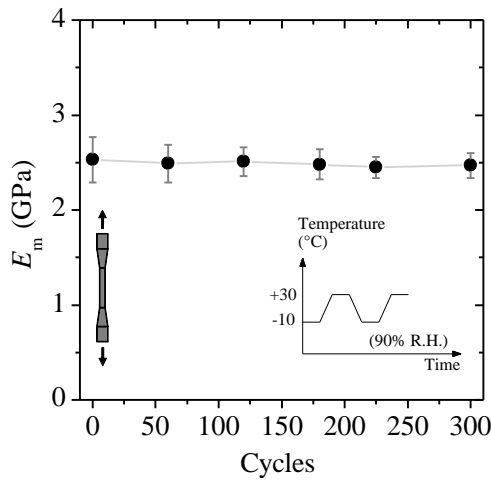
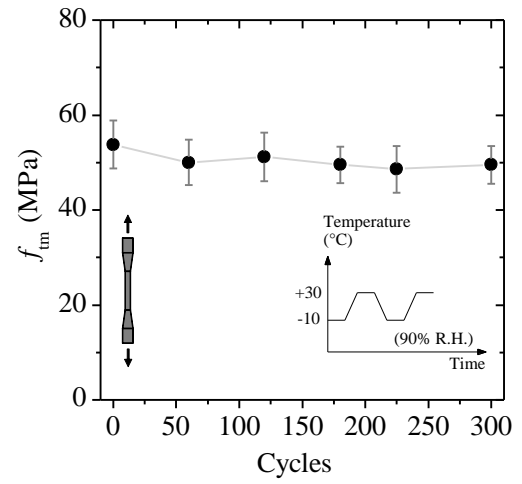
**Fig. 6** Changes in mechanical properties of epoxy resin: (a) HT exposure-elastic modulus; (b) HT exposure-tensile strength; (c) FT exposure-elastic modulus; (d) FT exposure-tensile strength

**Fig. 6** Changes in mechanical properties of epoxy resin: (a) HT exposure-elastic modulus; (b) HT exposure-tensile strength; (c) FT exposure-elastic modulus; (d) FT exposure-tensile strength

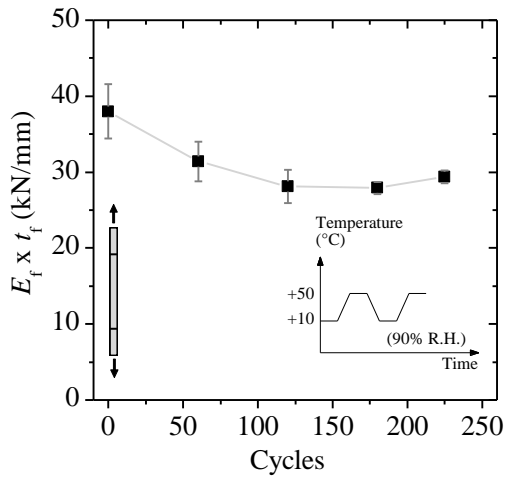
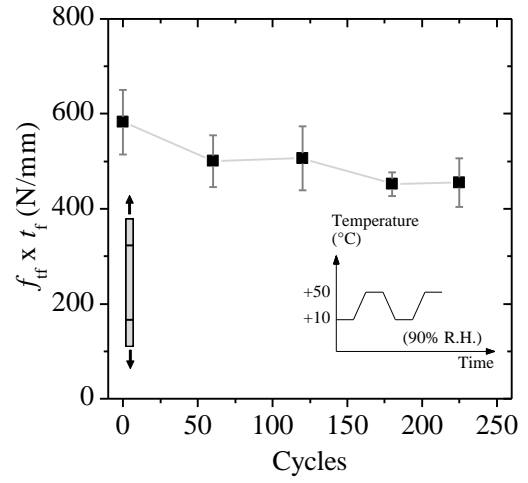
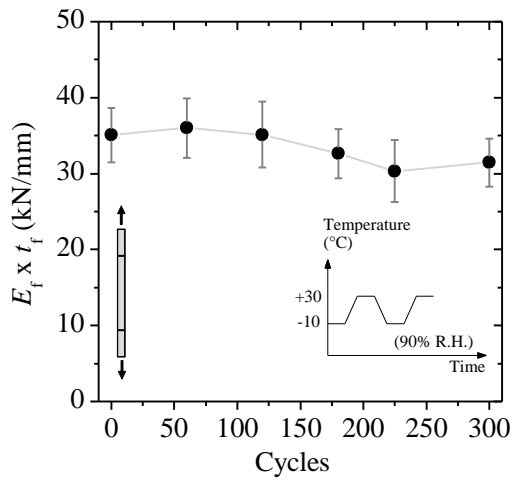
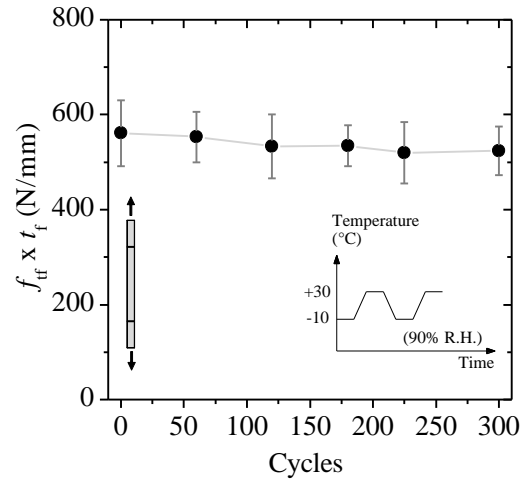
**Fig. 7** Changes in mechanical properties of GFRP: (a) HT exposure-elastic modulus; (b) HT exposure-tensile strength; (c) FT exposure-elastic modulus; (d) FT exposure-tensile strength

**Fig. 7** Changes in mechanical properties of GFRP: (a) HT exposure-elastic modulus; (b) HT exposure-tensile strength; (c) FT exposure-elastic modulus; (d) FT exposure-tensile strength

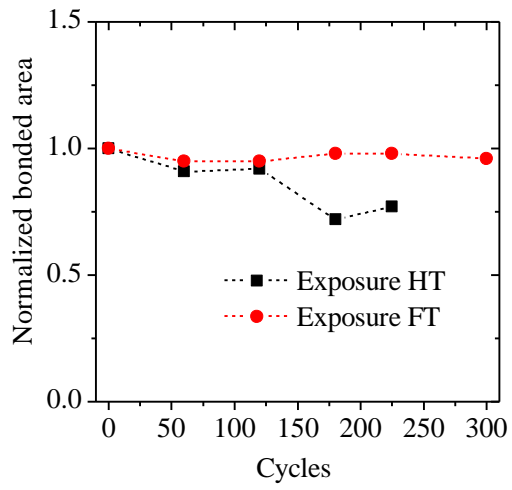
**Fig. 8** Reduction of the bonded area due to hygrothermal exposures

**Fig. 8** Reduction of the bonded area due to hygrothermal exposures: (a) exposure HT; (b) exposure FT

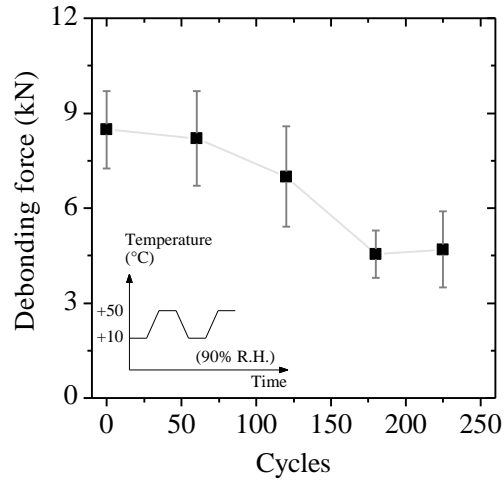
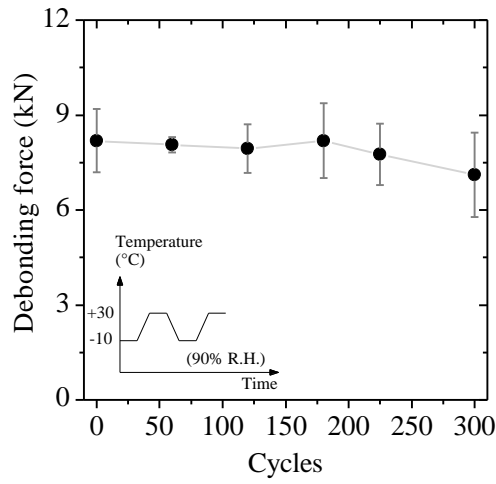
**Fig. 9** Effect of hygrothermal exposures on the debonding force: (a) exposure HT; (b) exposure FT

Fig. 9 shows the effect of two hygrothermal exposures on the debonding force. It can be observed that the debonding force has been progressively decreased with the number of exposure cycles. The debonding force decreased 17% and 45% after 120 and 225 cycles of HT exposure, respectively. Meanwhile, it decreased 4%, 6%, and 14% after 120, 225, and 300 cycles of FT exposure, respectively. A comparison between the obtained results shows that the HT exposure induces higher degradation on the specimens used in this study, see Fig. 10.

**Fig. 9** Effect of hygrothermal exposures on the debonding force: (a) exposure HT; (b) exposure FT

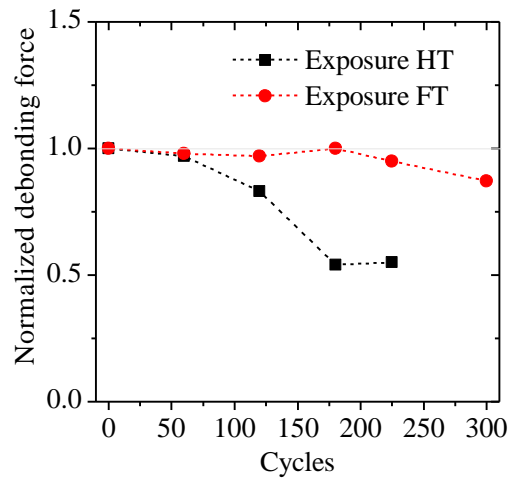
**Fig. 10** Comparison of debonding force degradation between HT and FT exposure conditions

**Fig. 10** Comparison of debonding force degradation between HT and FT exposure conditions

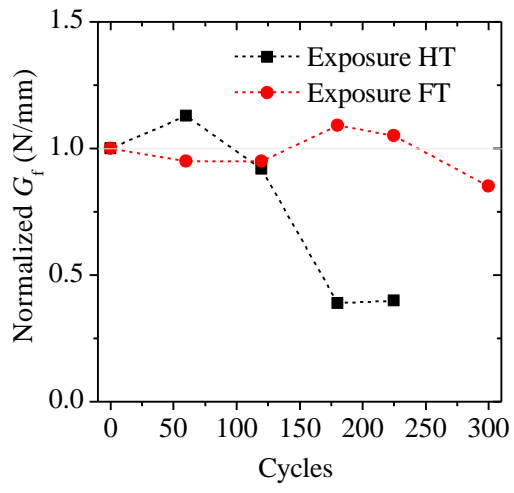
**Fig. 11** Effect of hygrothermal exposures on the bond fracture energy

The average bond fracture energy value reaches 0.38 N/mm for the reference specimens. Changes in the fracture energy of the specimens due to hygrothermal conditions are shown in Fig. 11. The fracture energy has negligible changes due to FT conditions, while a large degradation is observed in the specimens exposed to HT conditions. The interfacial fracture energy has decreased 8% and 60% after exposure to 120 and 225 cycles of HT exposure, respectively. Meanwhile, no conclusion can be made for degradation in FT exposure.

**Fig. 11** Effect of hygrothermal exposures on the bond fracture energy

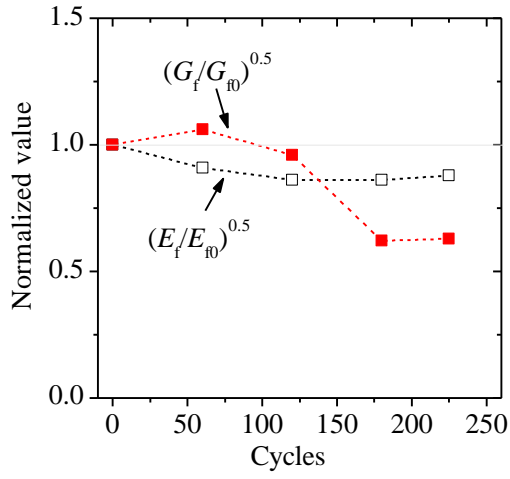
**Fig. 12** Governing degrading mechanisms in the bond behavior: (a) exposure HT; (b) exposure FT

Assuming that the FRP width and thickness are constant during the hygrothermal exposures, the debonding force is directly related to the square root of interfacial fracture energy and FRP elastic modulus, see Eq (1). Therefore, the participation of each factor in degradation of debonding force can be obtained by plotting the changes in the normalized square root of fracture energy and FRP elastic modulus as shown in Fig. 12.

It can be seen that in exposure HT, Fig. 12(a), the interfacial degradation of the bond has a major effect on the global bond degradation comparing to the FRP elastic modulus. The interfacial degradation can be attributed to the existing

**Fig. 12** Governing degrading mechanisms in the bond behavior: (a) exposure HT; (b) exposure FT

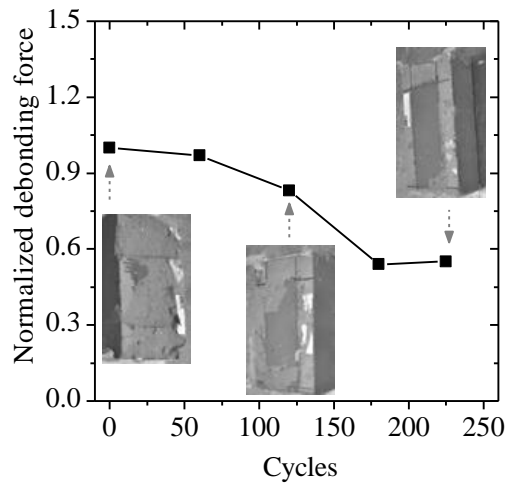
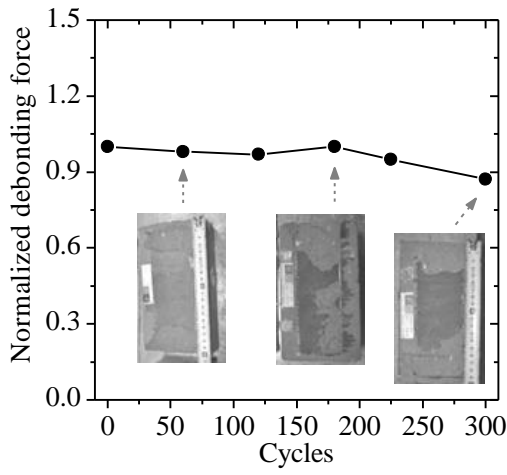
**Fig. 13** Observed failure modes in shear bond tests: (a) exposure HT; (b) exposure FT

Regarding the failure mode, three different failures were observed in the specimens: (1) cohesive failure within a thick layer of brick; (2) cohesive failure within a superficial layer of brick, next denoted by interfacial cohesive; (3) adhesive failure at the FRP/brick interface. For both hygrothermal exposures, a progressive change of failure mode from cohesive to adhesive was observed in the specimens with the increase of exposure cycles, Fig. 13. Such a change in the failure mode of the specimens, also reported in (Green et al. 2000), can be attributed to the observed bond degradation during environmental exposures. The contribution of each failure mode in the debonding behavior is presented in Fig. 14. These values are obtained by measuring the area corresponding to each failure mode on the failure surface of the specimens after debonding tests. Then, the

**Fig. 13** Observed failure modes in shear bond tests: (a) exposure HT; (b) exposure FT

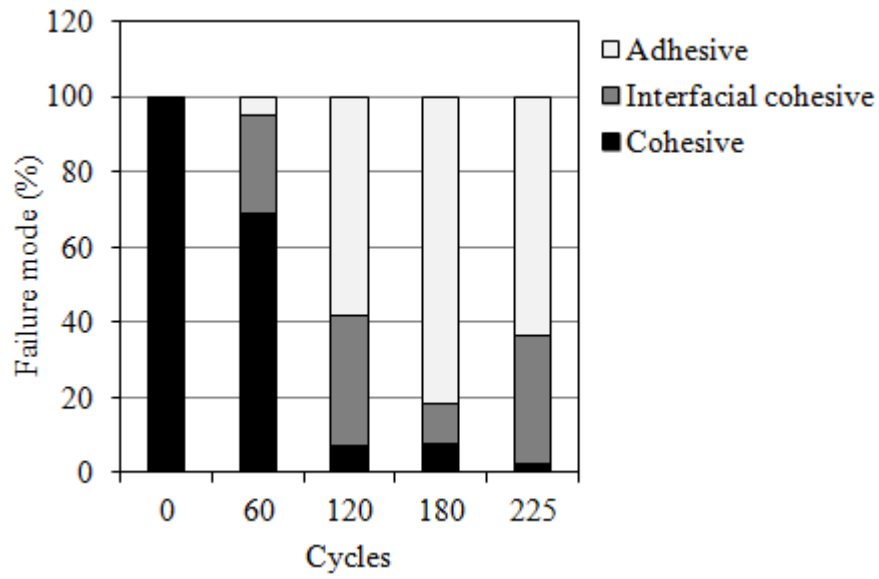
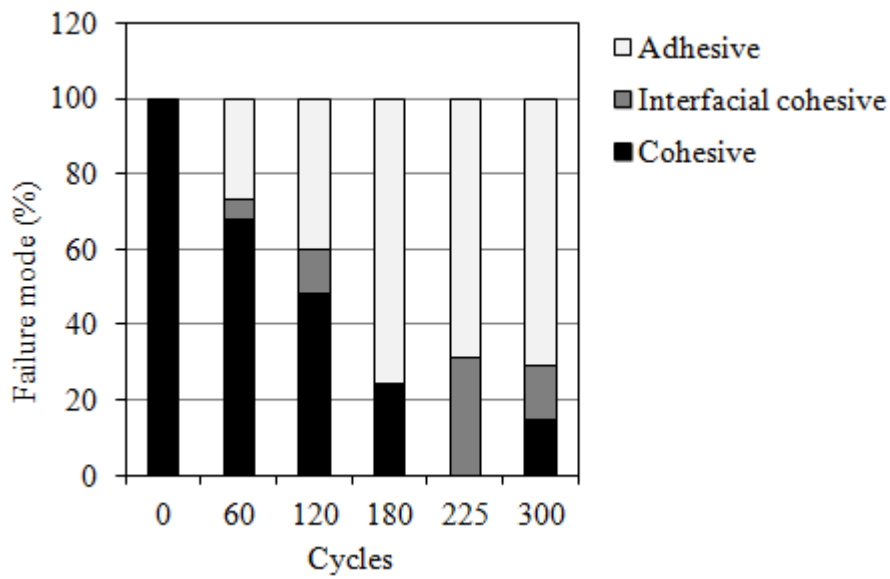
**Fig. 14** Contribution of each failure mode in the debonding behavior: (a) exposure HT; (b) exposure FT

**Fig. 14** Contribution of each failure mode in the debonding behavior: (a) exposure HT; (b) exposure FT
