# Application of acoustic emission technique for bond characterization in FRP-masonry systems

**Abstract.** The acoustic emission (AE) technique is used for investigating the interfacial fracture and damage propagation in GFRP- and SRG-strengthened bricks during debonding tests. The bond behavior is investigated through single-lap shear bond tests and the fracture progress during the tests is recorded by means of AE sensors. The fracture progress and active debonding mechanisms are characterized in both specimen types with the aim of AE outputs. Moreover, a clear distinction between the AE outputs of specimens with different failure modes, in both SRG- and GFRP-strengthened specimens, is found which allows characterizing the debonding failure mode based on acoustic emission data.

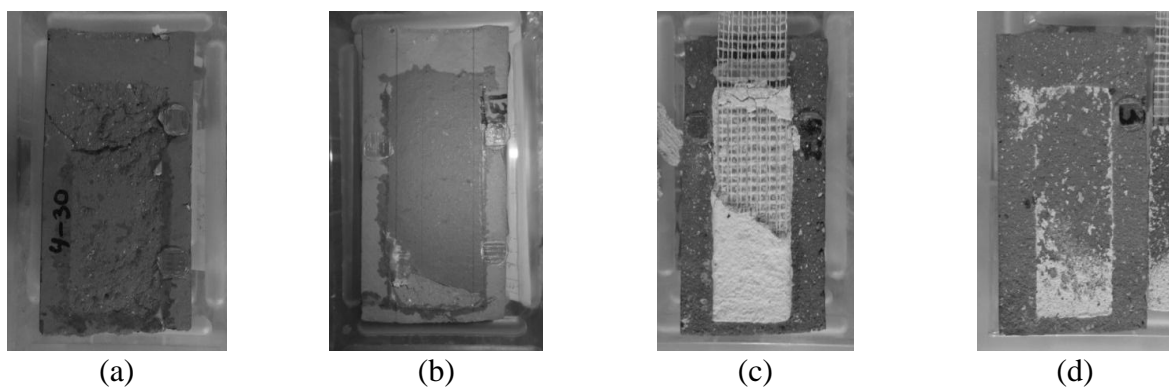
**Fig. 1** Observed failure modes in GFRP- and SRG-strengthened brick specimens: (a) cohesive failure; (b) adhesive failure; (c) steel fibers slipping and mortar cover separation; (d) mortar-brick interface debonding

In case of strengthening with steel reinforced grout (SRG), in addition to masonry cohesive failure, steel tensile rupture, and adhesive debonding at the mortar-brick interface, debonding at the fiber-mortar interface may occur. The latter, being the most observed failure modes in the experimental tests performed here, is followed by fibers slipping from the matrix. The typical failure modes in GFRP- and SRG- strengthened brick specimens are presented in Fig. 1.

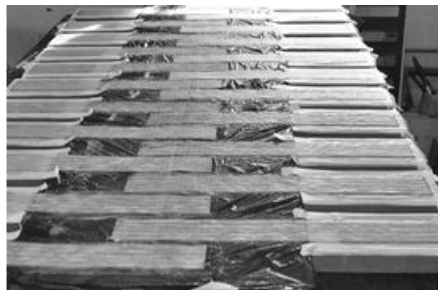
**Fig. 4** (a) GFRP-brick specimens; (b) SRG-brick specimens.

In the GFRP-strengthened brick specimens, GFRP strips were applied to the brick surface along its centerline following the wet lay-up procedure, see Fig. 4(a). The bricks were dried in the oven before application of the GFRP sheets. Then, a two-part epoxy primer was applied to the bricks' surfaces for preparation of the substrate surface. Finally, a two-part epoxy resin was used as the matrix for the composite material and adhesion to the masonry substrate.

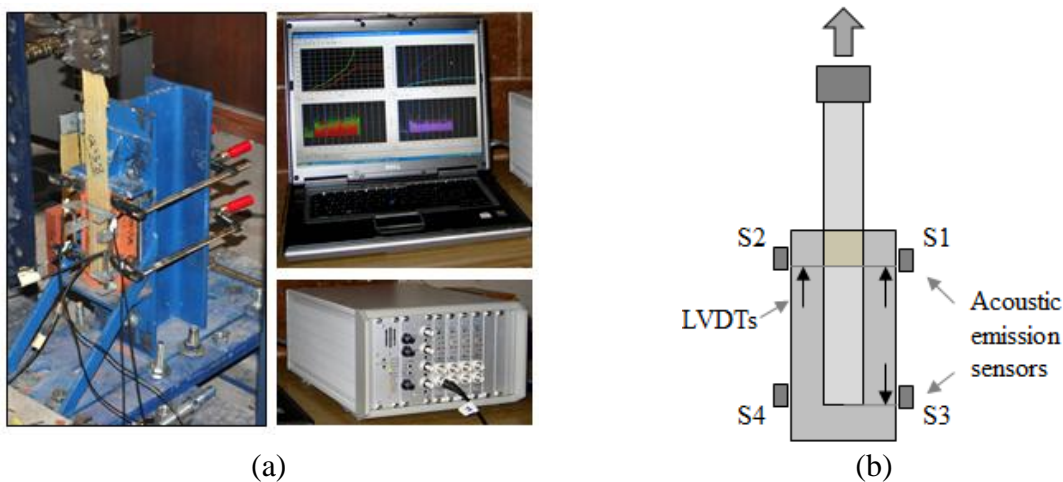
**Fig. 5** (a) Test setup; (b) test instrumentation.

placed on the steel frame and firmly clamped to it as shown in Fig. 5(a). The specimens were pulled monotonically with a rate of 5  $\mu\text{m}/\text{sec}$  under displacement control conditions with reference to the LVDT placed at the loaded end of the FRP composite. The resulting load was measured by means of a load cell. The relative slip between the composite material and the brick was measured with the two LVDTs glued at the loaded end and one glued at the free end, see Fig. 5(b).

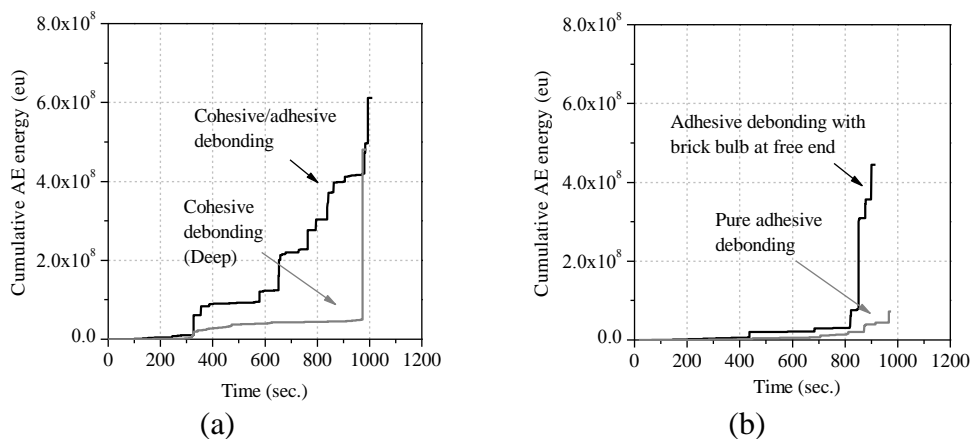
**Fig. 7** Comparison of different failure modes in GFRP-strengthened bricks: (a) cohesive debonding; (b) adhesive debonding.

A comparison is made next between the AE outputs in specimens with different failure modes. The aim was to investigate the existence of any correlation between the fracture process and the AE outputs. In GFRP-brick specimens, the comparison is made between cohesive and adhesive failure modes, see Figs. 7, 8. It can be observed that in the specimen with cohesive debonding the AE energy remains relatively low throughout the test, accompanied by a sudden and large amount of AE energy release when the debonding occurs at the end of the test, Fig. 7. The observed behavior confirms the brittle and sudden nature of the cohesive debonding. On the contrary, in the specimen with cohesive/adhesive failure a progressive release of energy is observed during the test. The high rate of energy detection shows the high number of active cracks and progressive failure during the tests. Progressive detection of AE energies is observed until the complete debonding. However, the magnitude of the detected energies is much lower than the ones detected in the specimens with cohesive failure mode. This large difference is due to the different nature and fracture properties of brick and FRP/brick interface. The specimen with adhesive failure combined with formation of a brick bulb at the free end shows a similar AE energy emission to the specimen with pure adhesive failure. However, a large amount of energy is released in this specimen before debonding due to the brick bulb fracture at the free end. Fig. 8 presents the energy/hit (E/h) ratio during the tests. The cohesive failure shows a peak at the end of the tests showing that a strong energy has been emitted at the moment of debonding. However, several peaks can be observed in the specimens with adhesive debonding showing the progressive nature of failure in this mode.

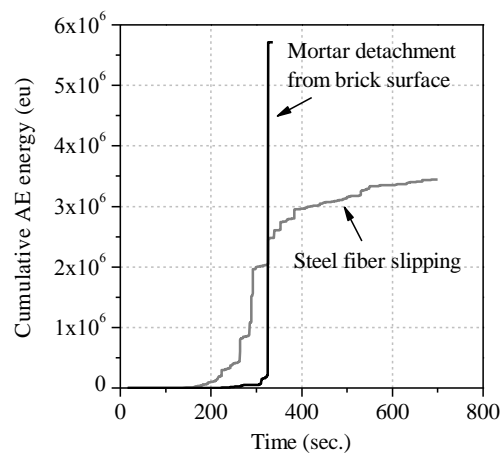
**Fig. 9** Comparison of different failure modes in SRG-strengthened bricks.

Fig. 9 presents a comparison between two failure modes in SRG-brick specimens. A brittle behavior is observed in the specimen with brick/mortar detachment failure. The detected energy in this specimen is very low during the test followed by a sudden release of energy at the moment of debonding. On the other hand, the fibers slipping failure mode produces a progressive release of energy during the test until diminishing the adhesive bond, followed by a reduction of the AE energy rate in the stage governed by frictional resistance. This E/h curve, Fig. 10, confirms this hypothesis. Again, in the specimens with mortar detachment failure a large peak is observed at the moment of debonding, while the specimen with fiber slipping failure shows several peak during the test.
