Detection and localization of debonding damage in composite-masonry strengthening systems with the acoustic emission technique

E. Verstrynge & K. Van Balen

ABSTRACT: Different types of strengthening systems, based on fiber reinforced materials, are under investigation for external strengthening of historical masonry structures. A full characterization of the bond behavior and of the short- and long-term failure mechanisms is crucial to ensure effective design, compatibility and durability of the strengthening solution. In this paper, the effectiveness of the Acoustic Emission (AE) technique for debonding characterization and localization on Fiber Reinforced Polymer (FRP)- and Steel Reinforced Grout (SRG)-strengthened clay bricks is investigated. The AE technique proves to be efficient for damage detection during accelerated ageing tests under thermal cycles and during experimental shear bond tests. AE data demonstrated the thermal incompatibility between brick and epoxy-bonded FRP composites during the accelerated ageing tests and debonding damage was successfully detected, characterized and located during the shear bond tests.

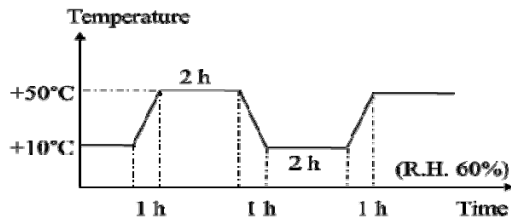
Figure 1. Hygrothermal exposure cycle

To investigate the effect of environmental exposure, the specimens were exposed to 180 temperature cycles in a climatic chamber. In each cycle, the temperature was kept constant at +10°C for 2 h. It was then increased to +50°C in 1 h, followed by 2 h constant temperature at +50°C. Then, the temperature was decreased again to +10°C in 1 h, resulting in 6 h cycles of exposure, see Figure 1.

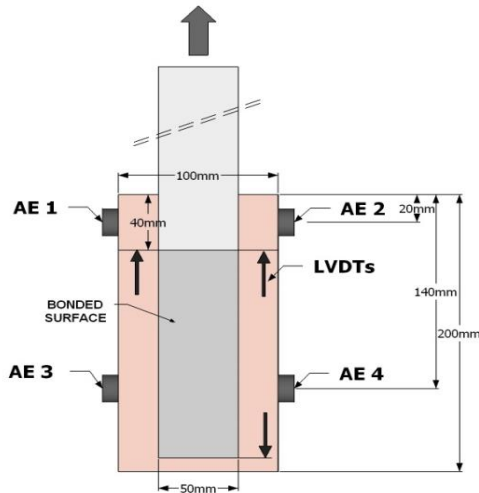
Figure 2. Single-lap shear bond test: test instrumentation and specimen dimensions.

resulting load was measured by means of a load cell. The relative slip between the composite material and the brick was measured with two LVDTs glued at the loaded end and one LVDT glued at the free end, (Figure 2). Four 150kHz resonance AE sensors were attached two by two on opposite sides of the bricks.

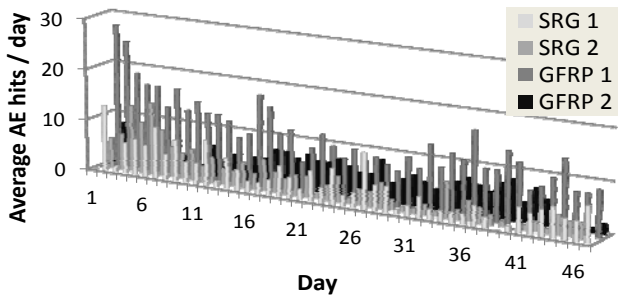
Figure 3. Average number of AE hits per day, recorded on 2 SRG-strengthened and 2 GFRP-strengthened specimens during environmental ageing test.

Damage progress was monitored by means of acoustic emission detection on two SRG- and two GFRP-strengthened bricks. The average number of AE hits per day recorded for each specimen within a period of 45 days is presented in Figure 3. Limited AE activity is recorded for each type of specimen and, as a first observation, it can be mentioned that not much difference is observed between the SRG- and GFRP-strengthened specimens.

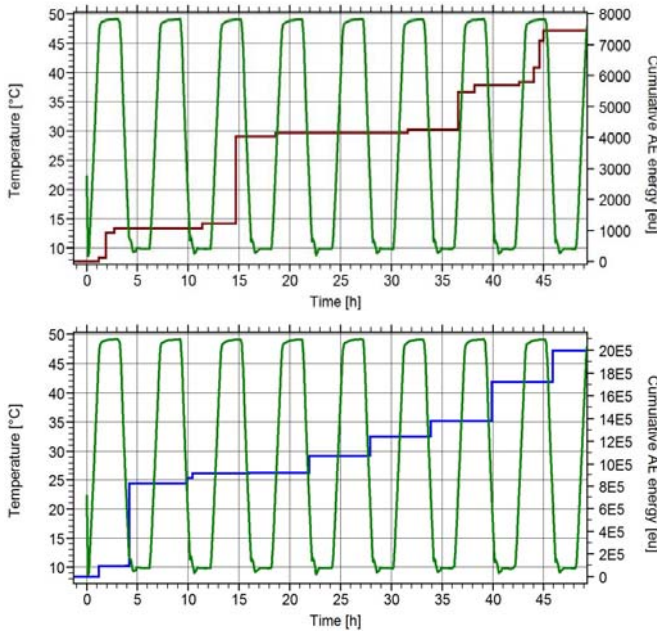
Figure 4. SRG-strengthened specimen: typical temperature fluctuation and random emission of AE energy (above); GFRP-strengthened specimen: typical temperature fluctuation and periodically emitted AE energy (below).

When the moments of AE energy emission are compared for both types of specimen, an important difference is observed. AE emissions in the SRG-strengthened specimens occur randomly, while for the GFRP-strengthened bricks, the majority of AE energy is emitted during temperature decrease (Figure 4). This is an indication of the different damage sources. The AE hits which are detected from SRG-strengthened specimens probably originate from the further hardening, shrinking or cracking of mortar. In the GFRP-strengthened bricks, the AE output during temperature decrease is a manifestation of the thermal incompatibility between the epoxy glue and the brick. Since the thermal expansion coefficient of epoxy can be up to 10 times larger compared to brick, the temperature cycling causes stress concentrations which might lead to damage propagation at the brick-GFRP interface.

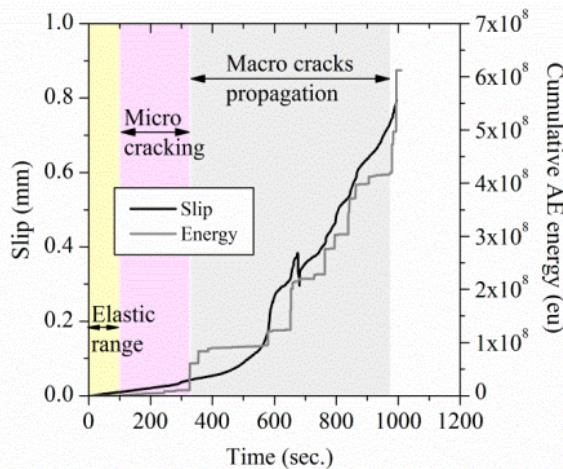
Figure 5. Typical AE results in a GFRP-strengthened brick specimen with cohesive/ adhesive failure mode: evolution of slip and cumulative AE energy

Typical AE results obtained from the debonding tests on GFRP-strengthened brick specimens are presented in Figures 5-6. The results in Figure 5 are presented for a specimen with mixed cohesive/adhesive failure mode, in terms of cumulative AE energy and slip development during the test. Generally, the debonding phenomenon can be divided into three main regions: elastic range, micro-cracking range, macro-cracking and progressive fracture. In the elastic range, the system deforms without any crack generation or AE activity. The small displacement measured at this stage is due to the elastic deformation of the FRP composite. As the applied force increases, micro-cracks appear in the interfacial region and they can be distinguished by initiation of AE activity with low emitted energies. As the debonding progresses, macro-cracks are formed and propagate along the interface with higher fracture energy being released. The cumulative AE energy increases with a stepwise pattern in which each sudden jump can be attributed to macro-fracture events. A sudden release of AE energy is also observed at the moment of full debonding at the end of the test. The cumulative AE energy could thus be applied to define the subsequent regions of fracture progress.

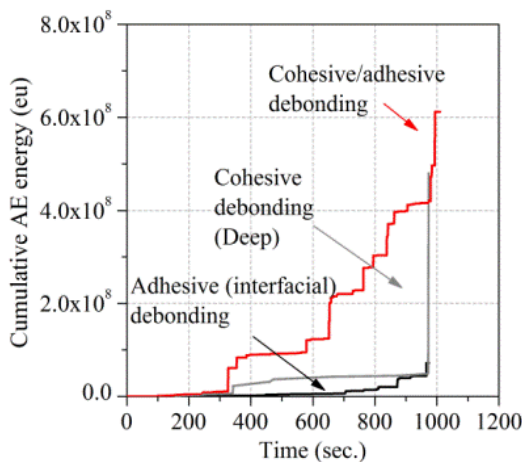
Figure 6. Comparison of AE output for different failure modes in GFRP-strengthened bricks

The effect of failure mode on the AE outputs is investigated in Figure 6. A clear distinction is found between AE outputs of specimens with different failure modes. In the specimen with cohesive debonding, the AE energy release remains relatively low throughout the test, accompanied by a sudden and large amount of AE energy release when debonding occurs at the end of the test. The observed behavior confirms the brittle and sudden nature of the cohesive debonding. In the specimen with cohesive/adhesive failure, a progressive release of energy is observed during the test. In the specimen with adhesive debonding mode, progressive detection of AE energies is observed until complete debonding. However, the magnitude of the detected energies is much lower than the ones detected in the specimens with cohesive failure mode, due to the different nature and fracture properties of brick and FRP/brick interface.

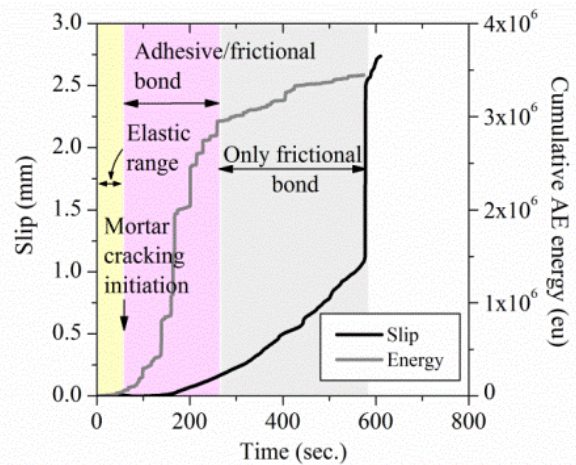
Figure 7. Typical AE results in an SRG-strengthened brick specimens: evolution of slip and cumulative AE energy

Figure 7 presents a typical result obtained from an SRG-strengthened brick specimen, which failed with slipping of the steel fibers and mortar cover separation. Mainly, three regions representing different mechanisms can be observed during the debonding process. AE activities before the first cracking of the mortar are negligible. During the mortar cracking, the rate of AE activities increases and high AE energy is detected as the force increases. The resisting mechanisms in this region are adhesive bond and friction between the steel fiber and mortar. Detachment of the bond is accompanied by

releasing relatively high fracture energies, observed as sudden jumps in the AE cumulative energy curve. As the debonding progresses, the bond diminishes and friction governs the failure mechanism resulting in a reduction of the detected AE energy rate. The debonding occurs with a sudden force reduction and slip increase. In contrary to the GFRP-strengthened specimens, no direct relation can be observed between the measured slip and AE cumulative energy.

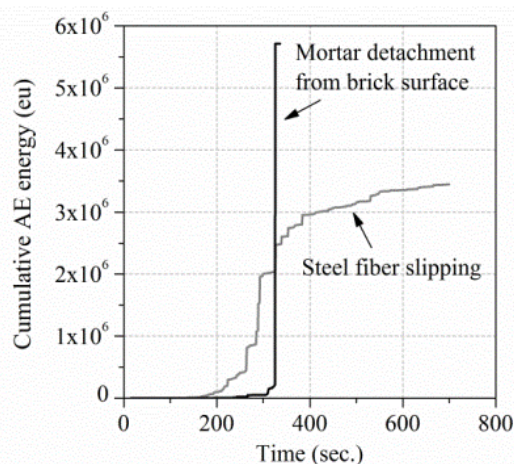
Figure 8. Comparison of AE output for different failure modes in SRG-strengthened bricks

In Figure 8, a comparison is made between two SRG-strengthened specimens with different failure modes, namely brick/mortar detachment and fibers slipping. A brittle behavior is observed in the specimen with brick/mortar detachment failure. The detected AE energy level in this specimen is very low during the test followed by a sudden release of energy at the moment of debonding. On the other hand, the fibers slipping failure mode produces a progressive release of energy during the test while the adhesive bond diminishes, followed by a reduction of the AE energy rate in the stage governed by frictional resistance. A more detailed analysis and characterization of debonding mechanisms based on AE results was presented in (Ghiassi et al., 2014).
