# 1 Comparison of the performance of hydraulic lime- and clay-based grouts in 2 the repair of rammed earth

## 6 **Abstract:**

20 **Keywords:** Rammed earth; grout injection; clay-based grout; lime-based grout; repair; shear behaviour; diagonal  
21 compression; digital image correlation; sonic testing.

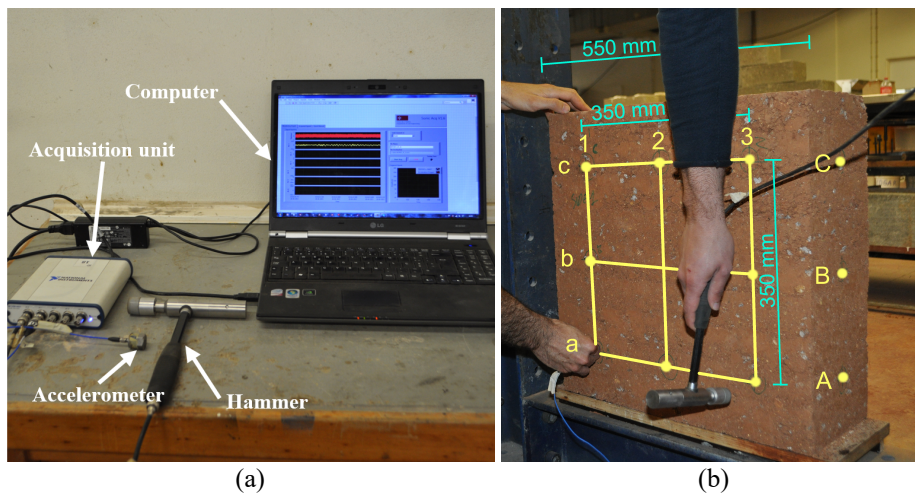
201 Fig. 3 – Sonic tests: (a) overview of the testing equipment; (b) tested alignments.

180 The test equipment used for performing the sonic tests is illustrated in Fig. 3a and consists of an instrumented  
181 hammer for inducing an initial sonic pulse (20 Hz to 20 kHz), a piezoelectric accelerometer to measure the  
182 arrival of the pulse, an acquisition unit from National Instruments with acquisition rate of 100 kHz and a  
183 computer with a software developed at University of Minho for acquisition and analysis of the results. Direct and  
184 indirect sonic tests were performed for all wallets, as illustrated in Fig. 3b. Direct tests were performed for three  
185 horizontal alignments (A, B and C) with a length of about 550 mm, where the pulse was generated in one of the  
186 edges and the arrival was measured at the opposite edge. Indirect tests were performed on one selected face of  
187 the wallets using a grid composed of three horizontal alignments (a, b and c) and three vertical alignments (1, 2

188 and 3). The length of each alignment was of about 350 mm. The velocity of the P-waves ( $V_p$ ) depends on the  
189 distance between the point of impact of the hammer and the point of measurement of the arrival of the pulse ( $s$ ),  
190 and is computed according to eq. (1). It should be noted that six valid tests were considered to compute the  
191 average arrival time of the P-waves ( $\Delta t$ ) in each alignment.

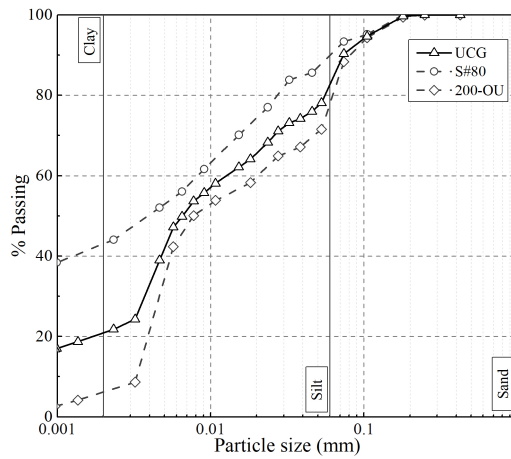
244  
 245 Fig. 5 – Particle size distribution curves of the materials used in grout UCG.  
 246

220 Three wallets were repaired using grout UCG, and other three wallets were repaired using grout FB790. UCG  
221 consists of an unstabilised clay-based grout previously studied in Silva et al. [14] (mud grout B) and is composed  
222 of the same soil used to build the rammed earth wallets, which was previously wet sieved to remove the particles  
223 larger than 0.180 mm (S#80). This grout incorporated limestone powder (200-OU) as a filler material to reduce  
224 the clay content of the sieved soil to a value of about 21% (see Fig. 5 for particle size distribution), while sodium  
225 hexametaphosphate (HMP) was used to obtain adequate fluidity and low water/solids ratio (W/S). FB790 is a  
226 commercial grout provided by Fassa Bortolo and is composed of hydraulic lime (NHL 3.5) and graded fillers,  
227 including pozzolanic materials. The manufacturer specifies the use of this grout in the consolidation of historical

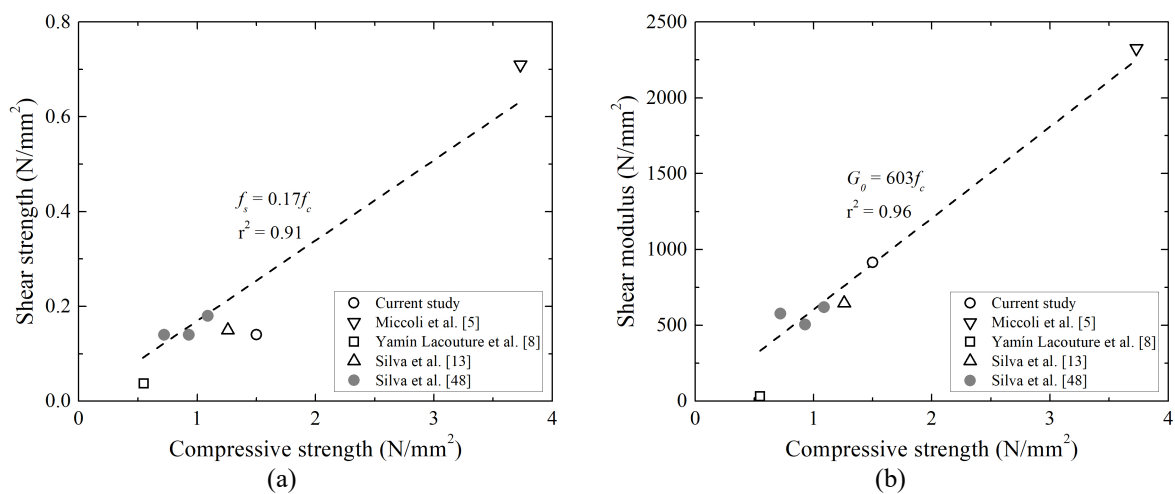
329 Fig. 8 – Relationship between compressive strength and parameters obtained from diagonal compression tests:  
 330 (a) shear strength; (b) shear modulus. (unstabilised rammed earth: empty points / stabilised rammed earth: filled  
 331 points)  
 332

305 However, a linear relationship can be found with respect to the reported compressive strength values, as  
 306 illustrated in Fig. 8a. The average shear stiffness computed from the first series of tests is of  $914 \text{ N/mm}^2$ , a value  
 307 higher than that reported in Silva et al. [14] ( $646 \text{ N/mm}^2$ ), although it should be noted that this parameter is  
 308 typically affected by high variability. The range of shear modulus values reported in the literature is also found  
 309 to be wide, though Fig. 8b seems to show a consistent relationship of this parameter with the compressive  
 310 strength. It is noteworthy to mention that the relationships presented could benefit from further testing and  
 311 additional results, since the available data is limited.
