Chapter 4

Evaluation of laser-glazed plasma-sprayed TBCs under high temperature corrosive conditions

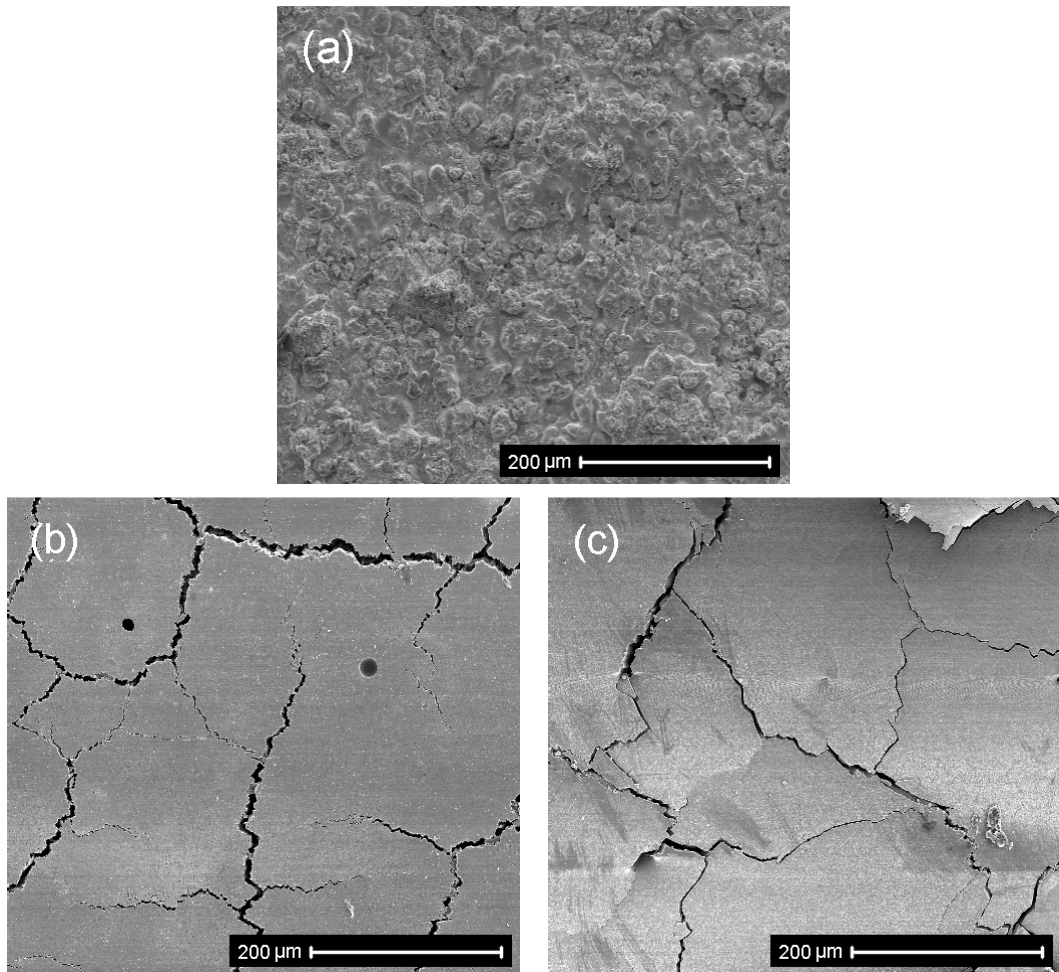
Fig. 4.1 depicts the initial surface morphology of the TBCs used in the hot corrosion test. Both laser-glazed coatings presented a considerable reduction of the surface roughness if compared with the as-sprayed ones. In addition, the surface porosity was eliminated but a network of cracks perpendicular to the surface has formed in both cases. The crack density is similar in both, however the width of the cracks is substantially smaller in those treated with Nd:YAG laser. Also, voids were found at the surface of the CO₂ laser-glazed coatings while none has been noticed in those treated with the Nd:YAG laser. The microstructure of the glazed layers changed from lamellar to columnar due to the direction of the heat flow on cooling down to room temperature.

Fig. 4.1. Secondary electron (SE) micrographs illustrating the surface morphology of the coatings prior to the hot corrosion test; (a) plasma-sprayed condition, (b) laser-glazed with CO₂ laser and (c) laser-glazed with Nd:YAG laser.

A comparison of the destabilization fractions is presented in Fig. 4.5. It can be seen that V₂O₅ had a detrimental effect on the coatings leading to the transformation from tetragonal to monoclinic phase up to 97% in volume. The laser-glazed coatings reduced the destabilization at the surface although the effect was rather small (6-10%). They presented less monoclinic phase than the plasma-sprayed ones, being in agreement with the results obtained by Tsai and Hsu [13]. The Nd:YAG laser-glazed coatings presented lower destabilization than those glazed with the CO₂ laser as a result of a lower surface area due to absence of surface voids and smaller width of cracks (see Fig. 4.1b and c).

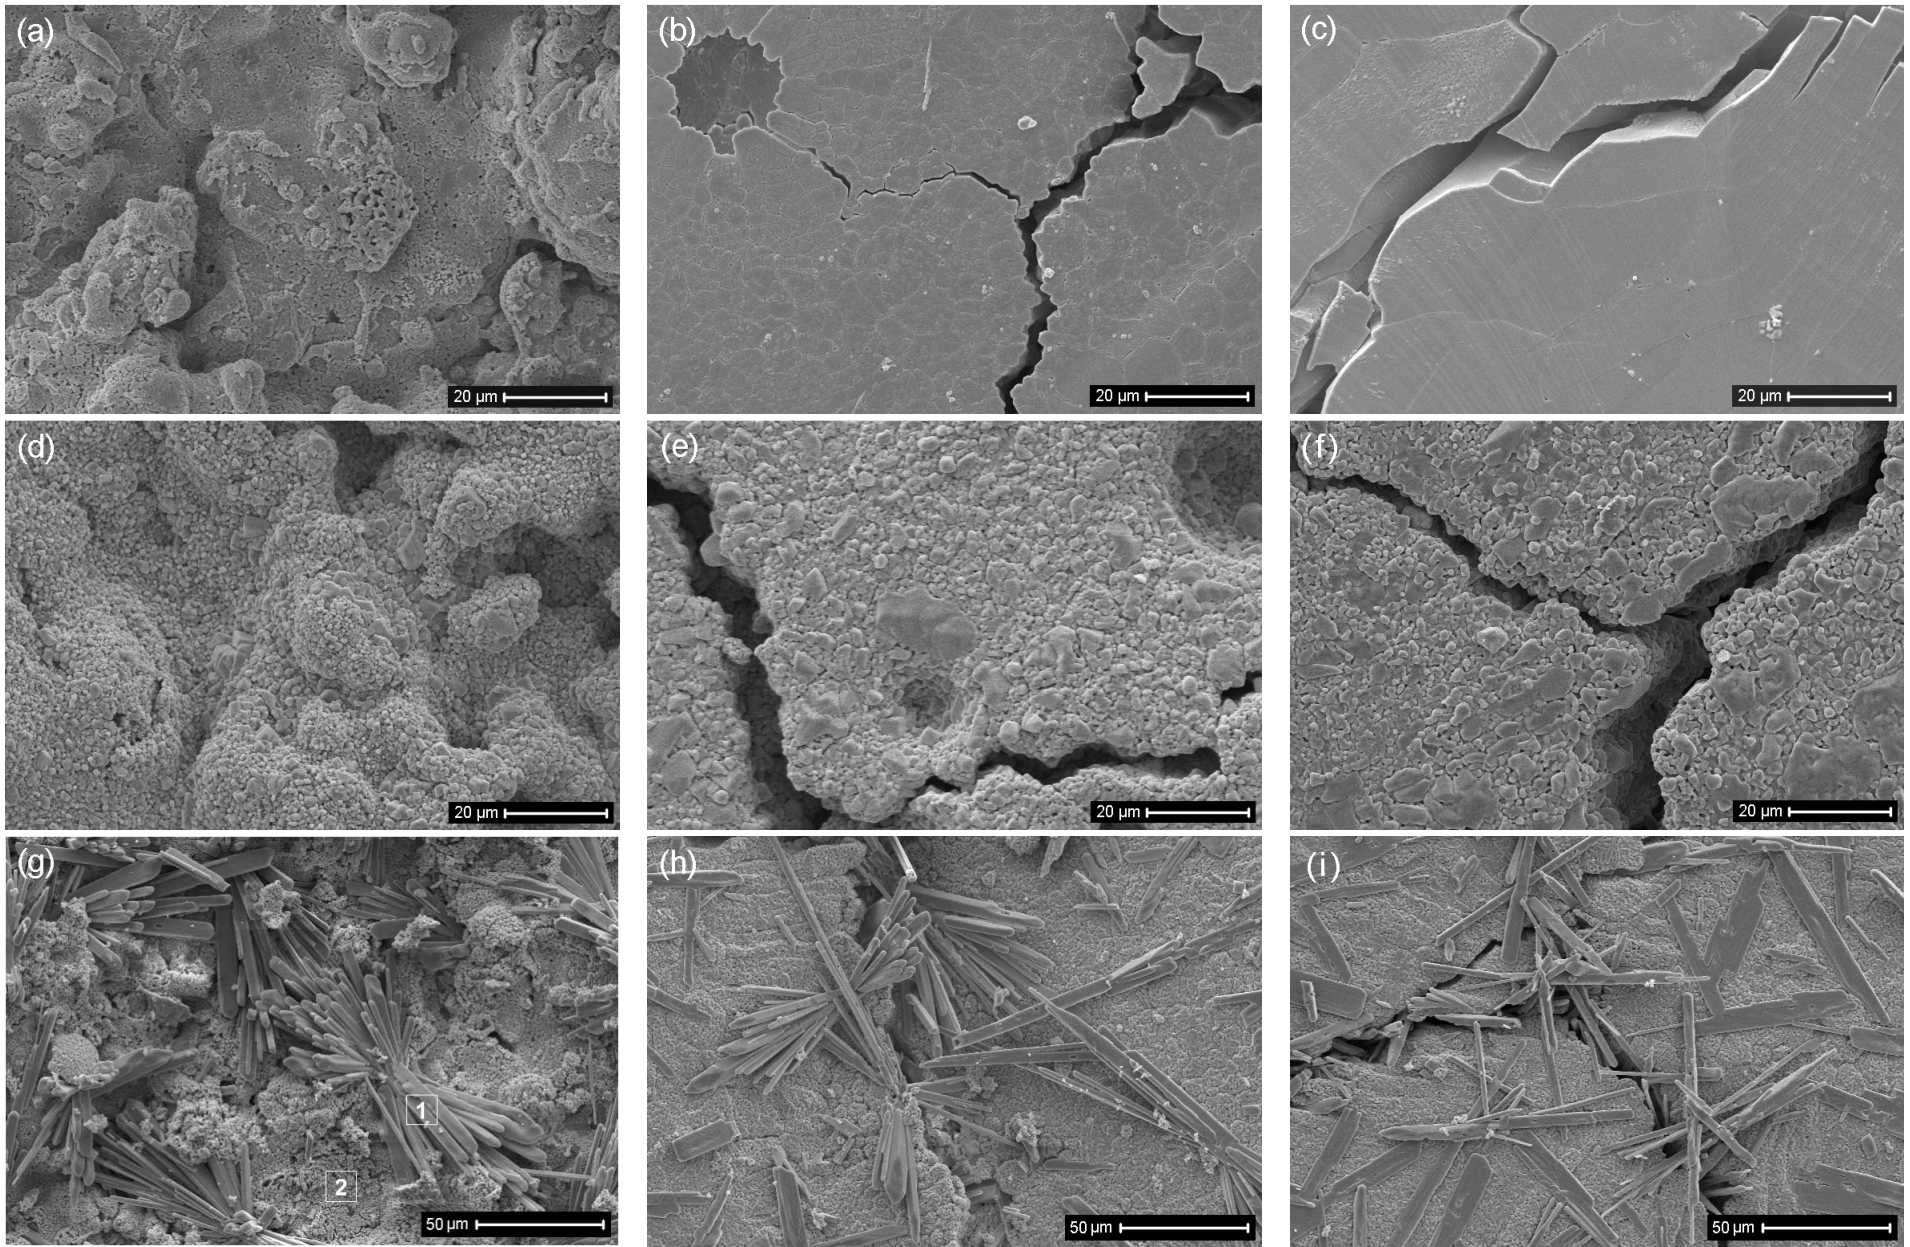
Fig. 4.2. SE micrographs illustrating the surface view of coatings after the hot corrosion test: (a) Sprayed- Na_2SO_4 ; (b) CO_2 - Na_2SO_4 ; (c) YAG- Na_2SO_4 ; (d) Sprayed- V_2O_5 ; (e) CO_2 - V_2O_5 ; (f) YAG- V_2O_5 ; (g) Sprayed-MIX; (h) CO_2 -MIX; (i) YAG-MIX.

SEM observations of the various surfaces after the corrosion testing are depicted in Fig. 4.2 and reveal evident morphological modifications and particular features in some of the coatings.

Specimens tested with Na_2SO_4 (Fig. 4.2a,b,c) did not show visible signs of degradation of the initial surface morphology although a slight increase of porosity has been noticed for the as-sprayed condition specimen (Fig. 4.2a). Moreover, no Na- or S-containing products have been found at the surface by EDS probably due its low content below the detection limit of the XRD diffractometer.

Specimens tested with V_2O_5 (Fig. 4.2d,e,f) or $\text{V}_2\text{O}_5+\text{Na}_2\text{SO}_4$ (Fig. 4.2g,h,i) presented their surfaces highly porous and in particular those in the as-sprayed condition (Fig. 4.2d,g). The as-sprayed coating tested with $\text{V}_2\text{O}_5+\text{Na}_2\text{SO}_4$ was extremely damaged and showed significant amounts of detached material (Fig. 4.2d). In specimens corroded by $\text{V}_2\text{O}_5+\text{Na}_2\text{SO}_4$, lace-like agglomerates of crystals were found. The crystals presented a high aspect ratio with needles up to 100 μm long. On the other hand, specimens corroded solely by V_2O_5 only showed irregular crystals embedded on the surface (Fig. 4.2d,e,f). It was found by EDS analysis (Fig. 4.3) that the crystals in both cases were composed of yttrium, vanadium and oxygen and confirmed to be YVO_4 by XRD analysis.

Na_2SO_4 itself did not have significant consequences on destabilization of zirconia (2nd pattern of Fig. 4.4a,b,c). Only the one in the as-sprayed condition presented some traces of monoclinic phase (less than 2%, Fig. 4.5). The specimens corroded either by $V_2O_5+Na_2SO_4$ or V_2O_5 presented a high monoclinic/tetragonal peak intensity ratio indicating a destabilization of zirconia ranging from 87% to 97%. Moreover, the intensity of the main peak of YVO_4 is noticeably higher in specimens corroded by $V_2O_5+Na_2SO_4$ and is related with the formation of the large needle-like YVO_4 crystals (Fig. 4.2g,h,i).

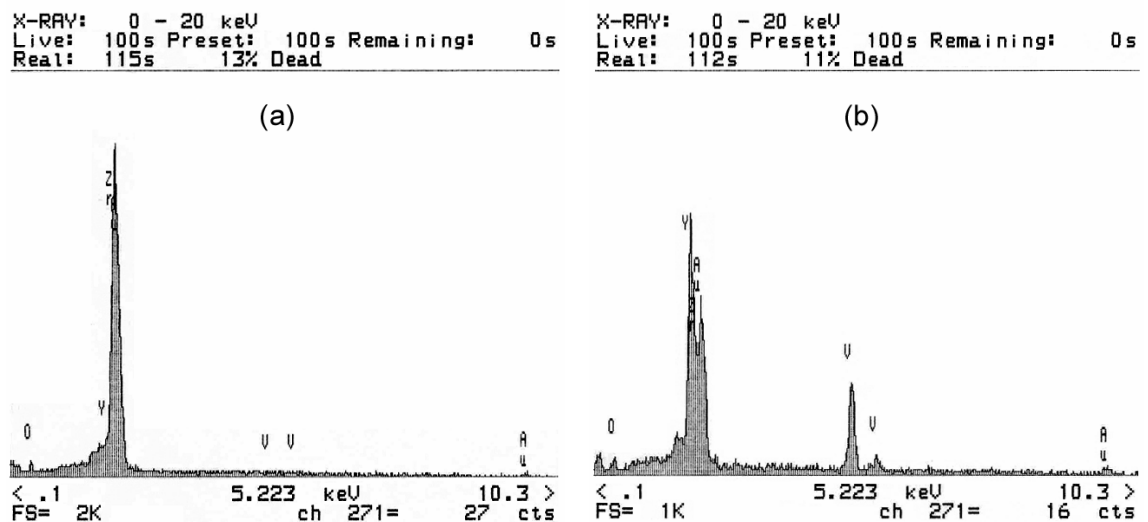
Fig. 4.3. EDS spectra acquired from the surface of coating Sprayed-MIX; (a) zirconia matrix, indicated as 2 in Fig. 4.2g, (b) crystal on the surface, indicated as 1 in Fig. 4.2g.

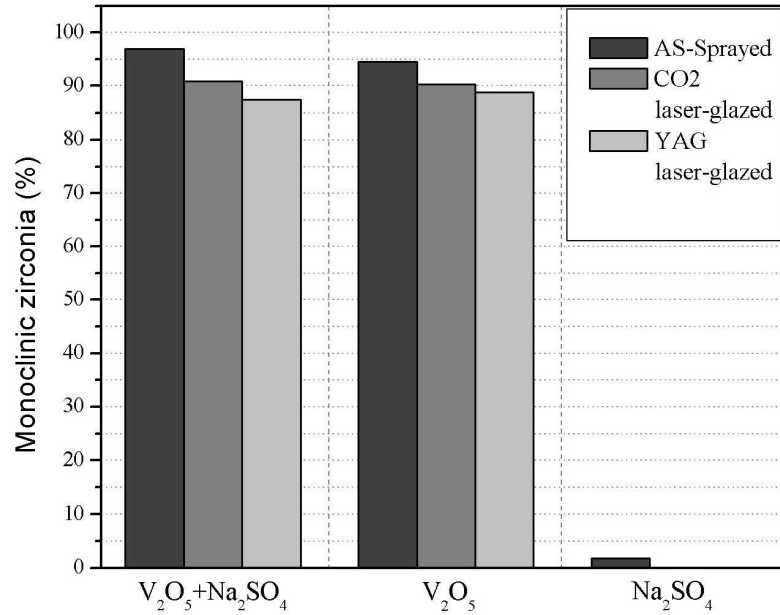
Fig. 4.5. Destabilization of zirconia coatings after the corrosion testing at 1000°C during 100 hours. Evaluation of the three sets of specimens: glazed with CO₂ laser, glazed with Nd:YAG laser and as-sprayed condition; tested with Na₂SO₄, V₂O₅ and V₂O₅+Na₂SO₄.

It seems that the molten NaVO_3 has increased atom mobility enhancing the depletion of yttria and hence promoted the growth of YVO_4 crystals. In terms of destabilization and consequent phase transformation the results are quite similar (Fig. 4.5).

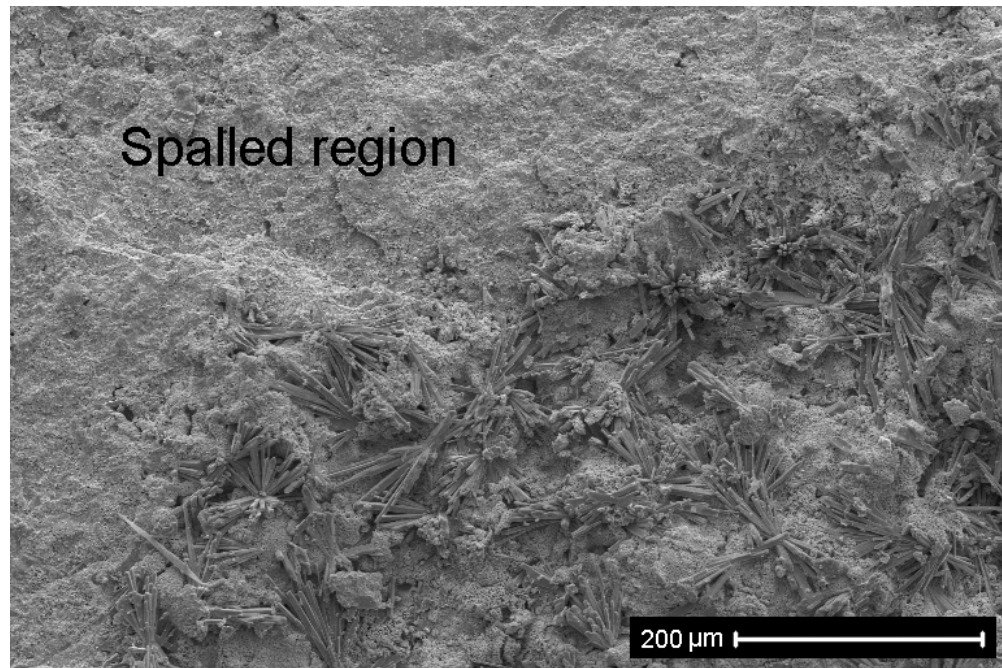
Fig. 4.6. View of the surface of Sprayed-MIX coating in a region where a large portion of material has spalled.

In Fig. 4.6 is shown the surface appearance of the coating Sprayed-MIX where a portion of the coating has spalled. The destabilization and consequent phase transformation to monoclinic accompanied with volume increase has severely weakened the coating. Furthermore, the formation of the needle-like YVO_4 crystals has introduced additional stresses to the damaged areas and hence contributed to the loss of material by spallation. On the other hand, the Sprayed- V_2O_5 coating failed not by losses of material from the outermost surface but by detachment from the bond coat due to phase transformation induced-stresses near the top coat/bond coat interface.

stabilizers of zirconia and; the final is completed by macroscale damage as a consequence of thermal and mechanical stresses that promote gradual losses of material from the surface (see Fig. 4.6). Furthermore, failure at or near the top coat/bond coat interface has also been observed in the specimen Sprayed- V_2O_5 which had fully spalled from the substrate. The molten V_2O_5 had deeply penetrated along the whole thickness of the coating, reacted with Y_2O_3 and the consequent phase transformation induced-stresses arisen at or near the top coat/ bond coat interface were released by detachment of the top coat. In the case of the laser-glazed specimens, since the molten salts may preferably attack the YSZ under the remelted dense layer (Fig. 4.8), the last failure step may be accomplished firstly by delamination of the external dense layer and then if continuously in service, behave as regular plasma-sprayed coating experiencing gradual losses of material from the surface and/or spallation near the top coat/bond coat interface.

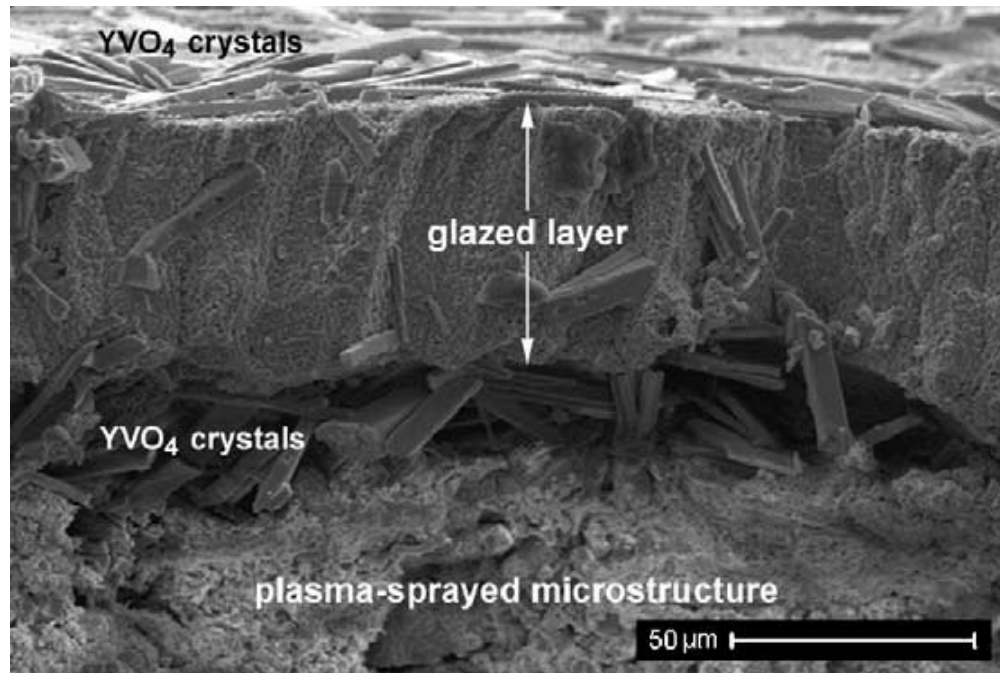
A fracture surface of coating CO_2 -MIX after the corrosion testing is shown in Fig. 4.8. It is clearly visible a preferential formation of YVO_4 crystals just below the dense glazed layer where

the contact area is much higher than that at the surface. The formation of those needle-like YVO_4 crystals may contribute to the failure of the coating not only by promoting the disruptive phase transformation from tetragonal to monoclinic but also by introducing additional stresses and thus reduce the tolerance of the TBC to thermal shock.

Fig. 4.8. Cross-sectional SE view of a fracture plane of coating CO₂-MIX after the corrosion testing. The laser glazed coating presented regions where the top glazed layer was detached from the plasma-sprayed microstructure.
