MONITORING OF HISTORICAL MASONRY STRUCTURES WITH OPERATIONAL MODAL ANALYSIS: TWO CASE STUDIES

Abstract

Two monuments in Portugal are being monitoring by the University of Minho: the Clock Tower of Mogadouro and the Church of Jerónimos Monastery, in Lisbon. Vibration sensors and temperature and relative air humidity sensors are installed in the two monuments. Operational modal analysis is being used to estimate the modal parameters, followed by statistical analysis to evaluate the environmental effects on the dynamic response. The aim is to explore damage assessment in masonry structures at an early stage by vibration signatures as a part of a health monitoring process to preserve the historical constructions. The paper presents all the preceding dynamic analysis steps before the monitoring task, which includes the installation of the monitoring system, the system identification and subsequent FE model updating analysis, the automatic modal identification and the investigation of the influence of the environment on the identified modal parameters.

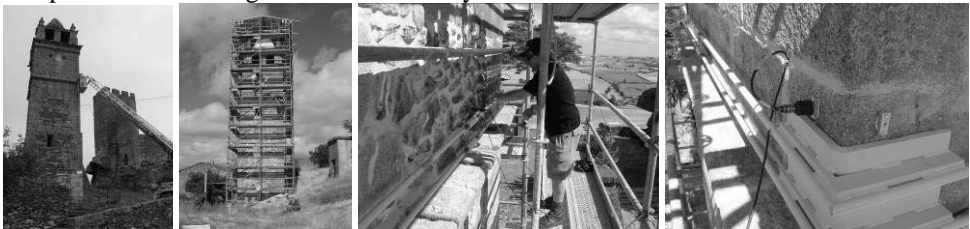
Figure 2: Measurements before and after the rehabilitation showing also some sensor locations

Two dynamic modal identification tests were performed before and after the structural rehabilitation. Operational modal analysis was used to estimate the modal parameters. Figure 2 presents some images of the ambient dynamic tests.

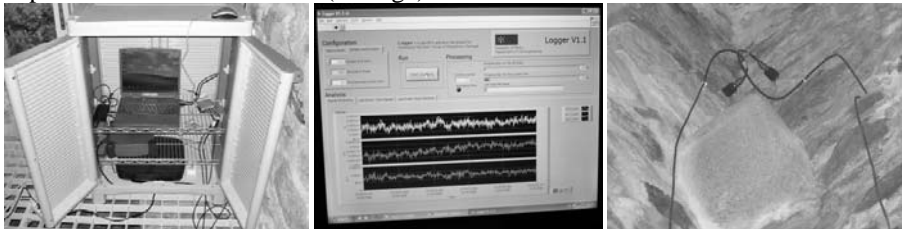
Figure 6: Dynamic monitoring system: datalogger, acquisition software and accelerometers

From the beginning of April 2006, so after the rehabilitation, a dynamic monitoring system was installed in the tower, see Figure 6. The aim is to evaluate the environmental effects of temperature and relative air humidity on the dynamic behaviour of the tower, and to detect any possible non stabilized phenomena in the structure (damage).

Three piezoelectric accelerometers connected to an USB data acquisition card with 24 bits resolution are recording each hour 10 min of ambient vibrations. In parallel a combined sensor is recording the ambient temperature and relative air humidity. The monitoring task is performed in several campaigns (test series) during the year. During each campaign 600 records of 10 min at every hour are stored in a laptop. No triggering was applied. Until this moment 6 series were completed in the period from April 2006 till January 2007.

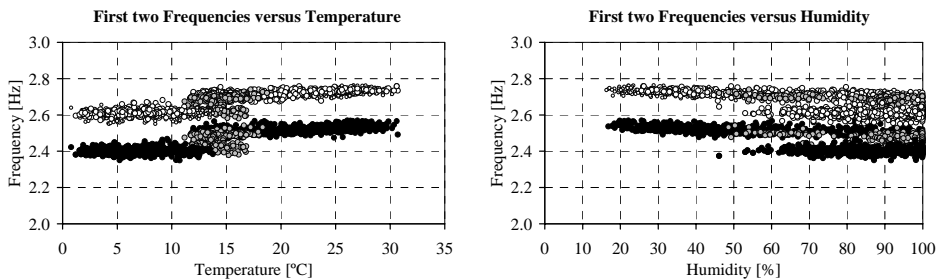
Figure 7: Environmental effects: temperature and relative air humidity

The preliminary results for the first two modes are presented in Figure 7, in terms of frequency variation according to temperature and relative air humidity. One conclusion emerged from the results is the structure sensibility to the relative air humidity (or the water absorption by the masonry material due to the raining season). As no damage was observed in the structure, the humidity influence can be observed by a shift of 4% in the linear relation between frequency and temperature by a transitory series (gray dots in the left part of Figure 7). This series was recorded between November and October, 2006 which was the first raining period at the site.

Since the structure seems to be sensitive to the humidity, it is necessary to have a complete cycle of one year to model the environmental effects. Especially, the new heating season, where the drying phenomena in the material are expected to reestablish the initial frequency values, should be included.

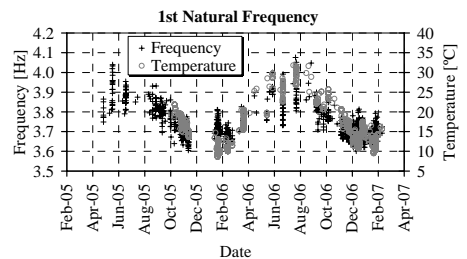
Figure 13: Environmental effects

With the same procedure for parameters estimation as presented in Section 4.3, more than 1000 records were analyzed. The results for the first frequency are summarized in Figure 13 and Figure 14. In the last one, it is possible to observe an apparent quadratic relation between frequency and temperature. For this dependency the 98% confidence intervals were established, which can be used, for future results, as borders defining the domain of significant frequency shifts (so indicating possible damage).
