# Shining Examples of Cost-Effective Energy and Carbon Emissions Optimization in Building Renovation (Annex 56)

## Energy in Buildings and Communities Programme

March 2017

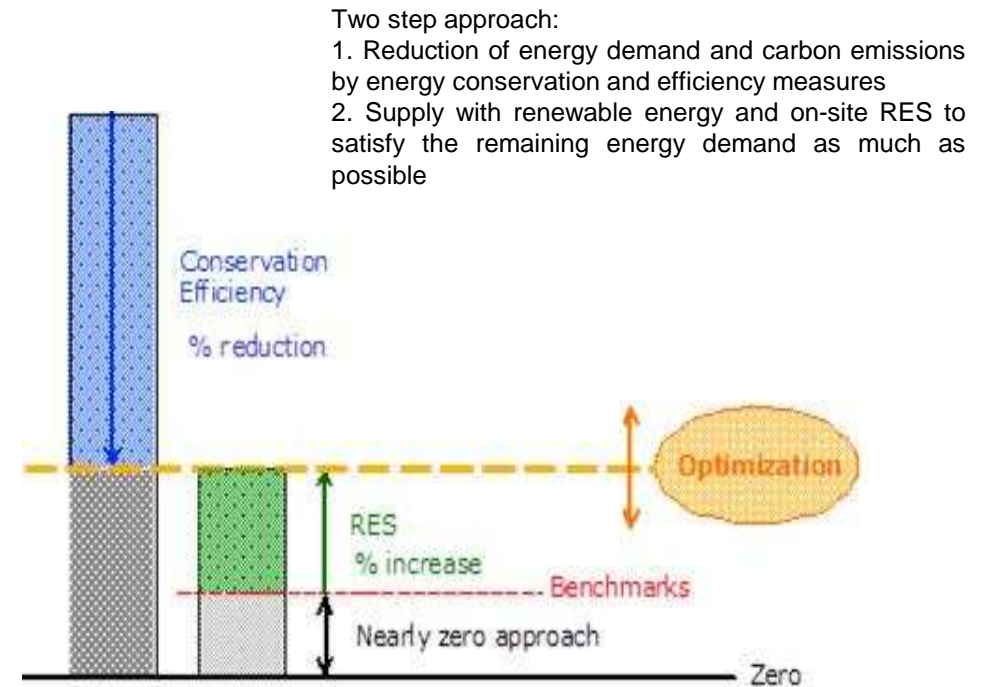
Optimized building renovation concept (Geier S., Ott W.)

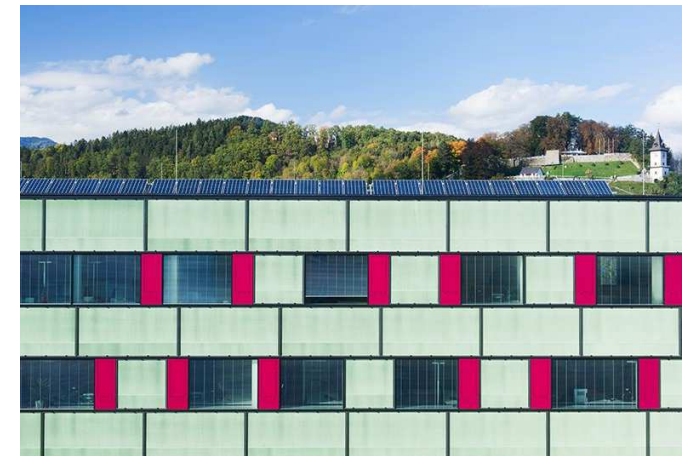
*PV-modules on the flat roof (© Markus Kaiser, Graz)*

**Energy production from PV (calculated):** 22.5 MWh/year

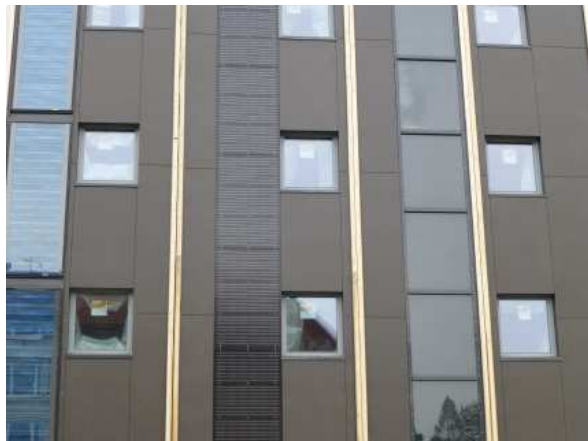
*Prefabricated façade elements with integrated active energy production (photovoltaic and solar thermal panels)*

The old pitched roof is removed and a new flat roof is established. The roof is highly insulated with approximately 35-40 cm. The windows are already integrated in the prefabricated façade modules and are of high thermal quality (triple glazing).

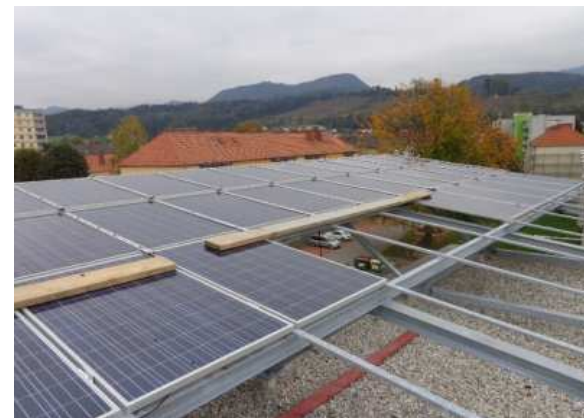
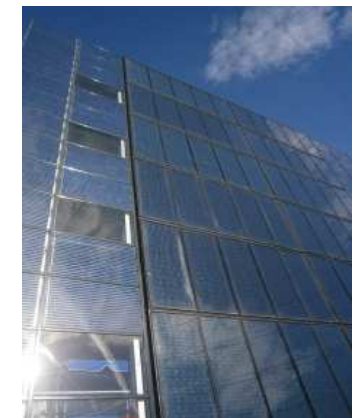
*Mounting of the photovoltaic panels on the roof (left picture), pv and solar thermal panels on the south façade (right picture)*

**Photovoltaic:** Photovoltaic panels with a size of 550 m<sup>2</sup> resp. 80 kWp are installed on the roof on a steel construction in form of a wing. Additionally 80 m<sup>2</sup> resp. 12 kWp are installed on the south facade.

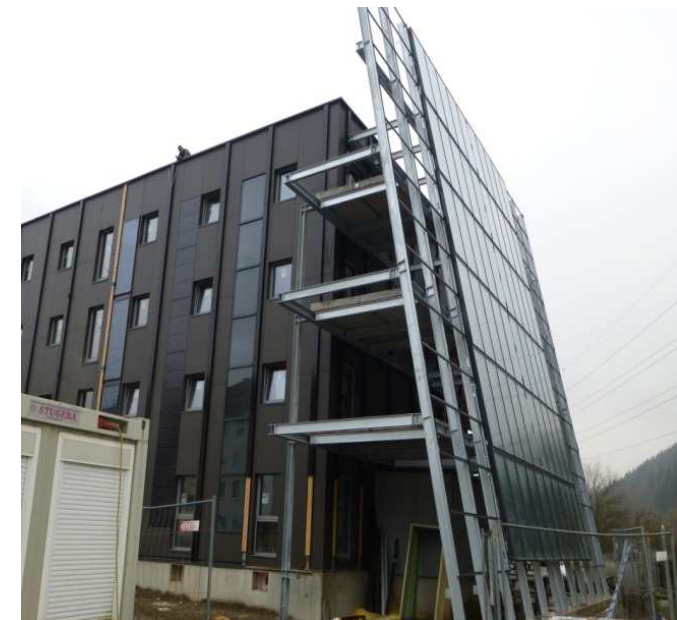
*Solar thermal and PV panels on the south facade*

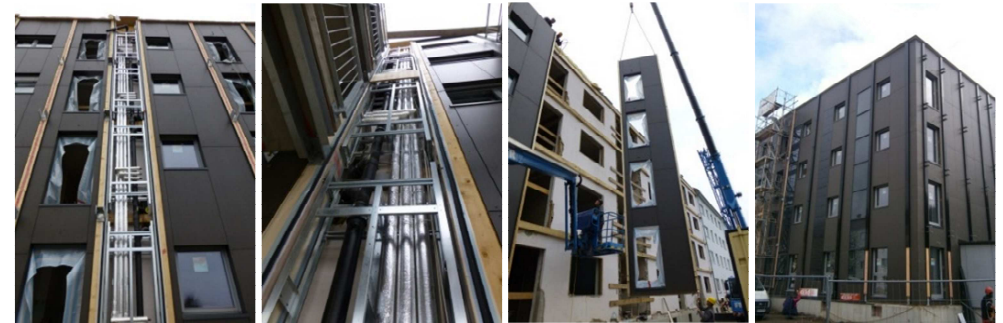
*Different steps of the building renovation process: installation of the building services, assembling of the prefabricated façade modules, almost finished building envelope (f.l.t.r.)*

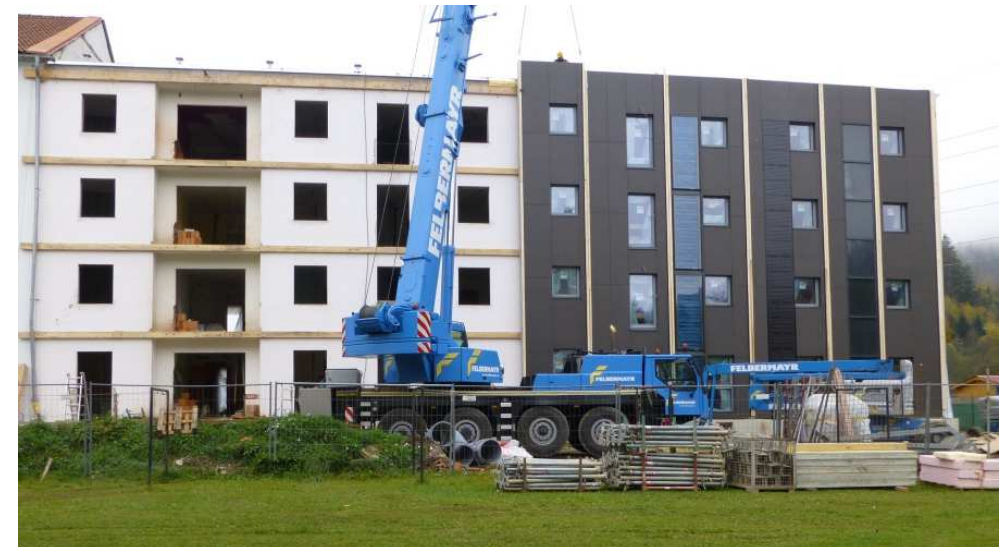
*Assembling of the prefabricated façade modules on the west facade*

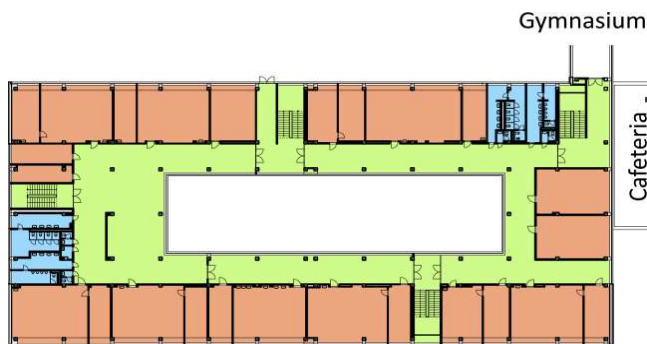
Ground plan of the A block's 2<sup>nd</sup> floor – classrooms.

The construction of the building corresponds with the period of origin – superstructure is made of prefabricated reinforced concrete frame MS-OB with basic length module 6.0 m. Walls are made mostly of 300 mm thick ceramic panels. Part of the walls is built using aerated concrete blocks.

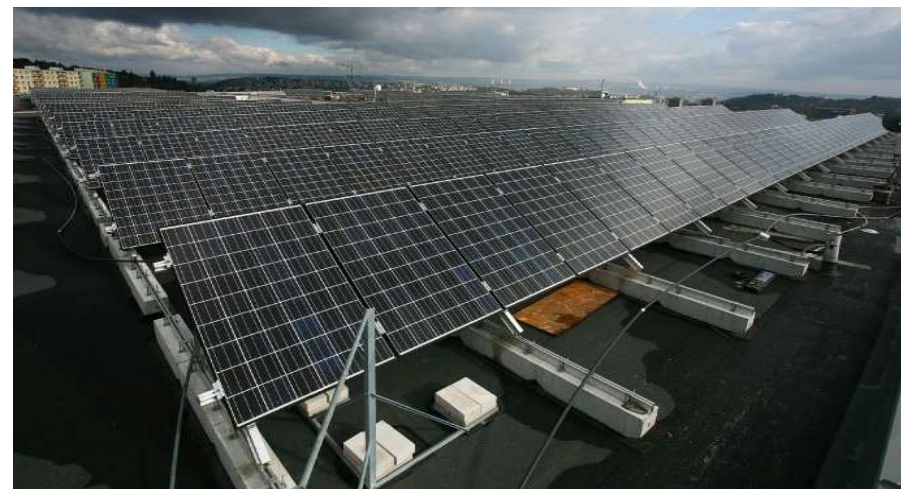
Photovoltaic panels installed on the roof of the A block. [2]

Between September 2009 (installation) and February 2014 (this report) the power plant produced 334.39 kWh of electricity.

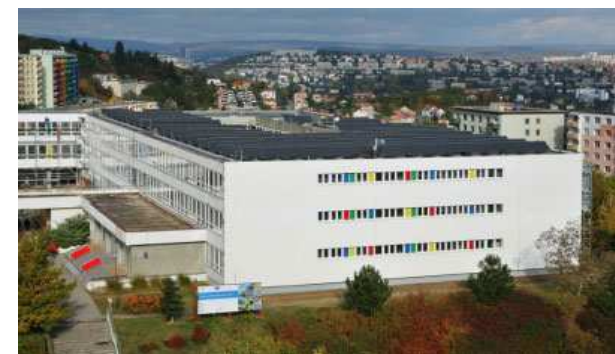
Aerial view of the school's A block with photovoltaic power plant on the roof. [2]

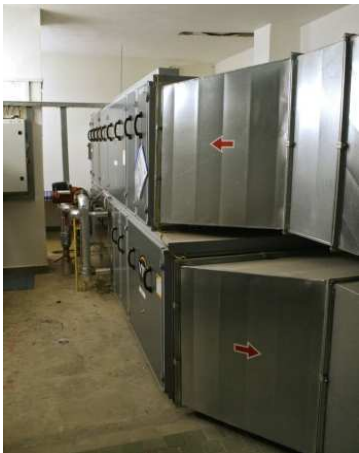
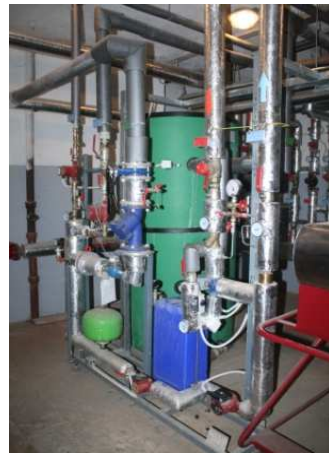
New ventilation unit (left) and heating system (right).

**Ventilation:** During the renovation the original mechanical ventilation system in block B was removed and replaced by new one (with heat recovery). System's maximum output is  $15000 \text{ m}^3/\text{h}$  of fresh air. Ventilation of storerooms in the basement of block B uses separate ventilation ( $500 \text{ m}^3/\text{h}$ ). The boiler room in block A is ventilated by an overpressure system ( $500 \text{ m}^3/\text{h}$ ). All toilets and bathrooms are ventilated using manually operated ventilators with timers. Storage rooms in the school (except block B) can be ventilated naturally by windows or by new manually operated supplementary ventilators (also manually operated with timers). All ducts are made of galvanized steel and have rubber silencers to reduce the noise ( $< 50 \text{ dB}$ ).

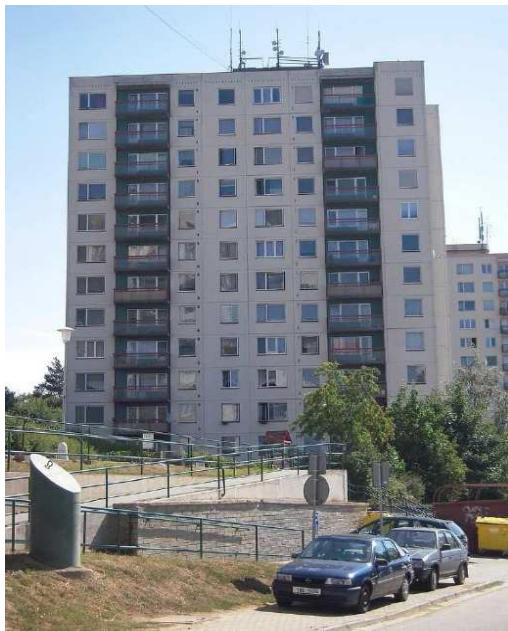
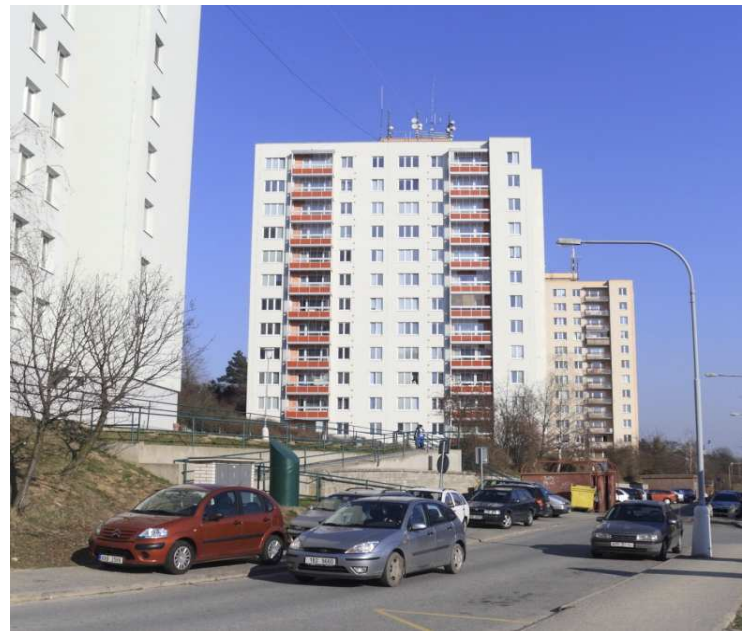
Street (western) view of the Koniklecová 4 block-of-flats before (left) and after (right) renovation. [1]

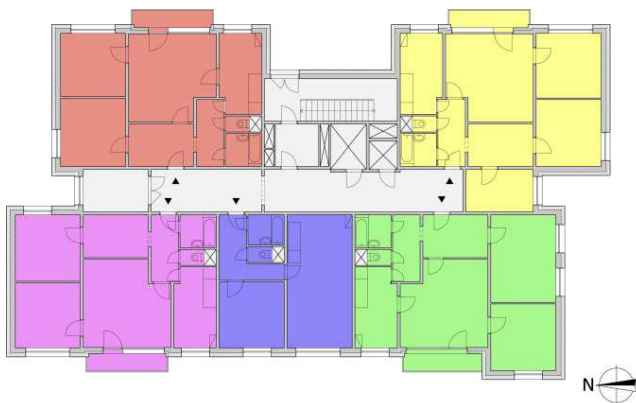
Ground plan of the A block's 2<sup>nd</sup> floor – classrooms.

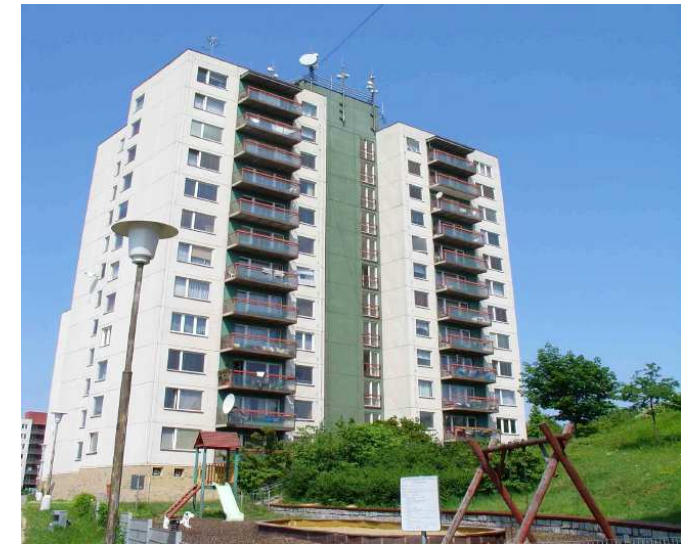
Eastern view of Koniklecová 4 block-of-flats before the renovation. [2]

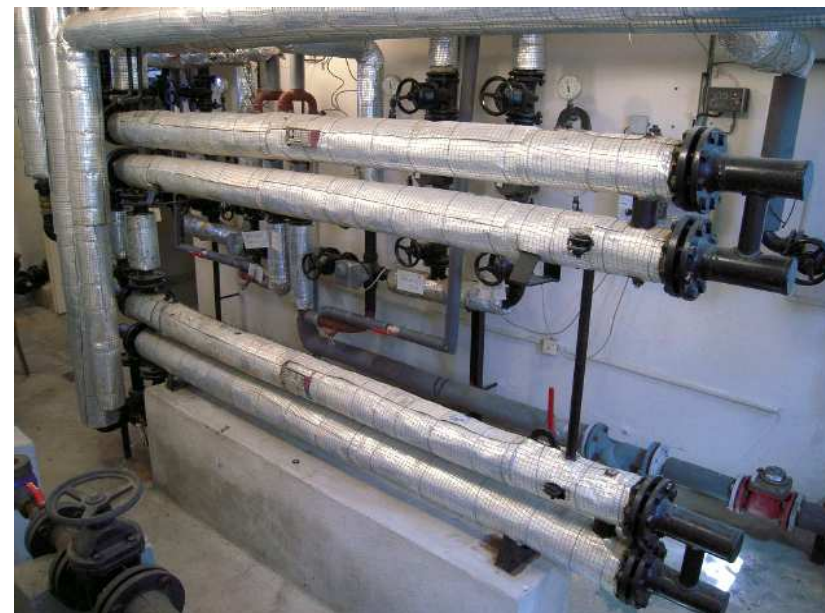
Original heat exchangers in the boiler room (before renovation). [2]

**Heating:** Energy for heating and DHW is supplied by two horizontal counter-flow heat exchangers in a boiler room on the ground floor of the building. The heating system has two main sections (East and West) representing east- and west-oriented flats. Both sections have equithermal regulation. There are gilled radiators installed in the whole building. All the radiators have thermostatic heads (since 2002). During the renovation the measuring and regulation equipment was replaced. Electronic sensors of exterior temperature were installed. Old circulation pumps were replaced by new ones with electronic regulation. Old damaged valves and heads were replaced.

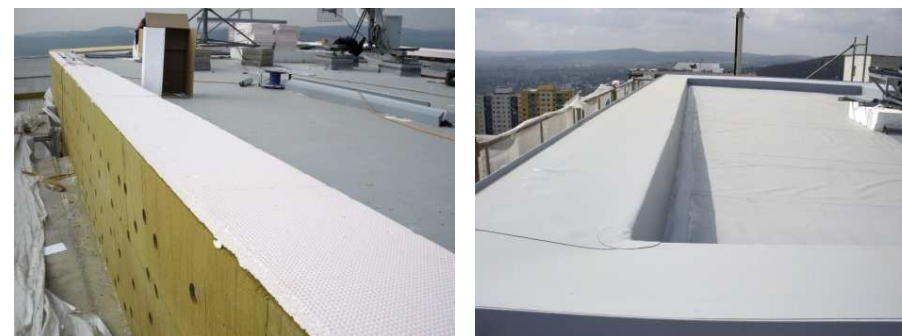
The attic during the renovation - installation of additional thermal insulation over the attic to reduce the thermal bridge (left) and a view of the new waterproofing/covering layer made of mPVC sheets (right). Precise design and construction of structural details are crucial for proper function of any energy efficient building. [1]

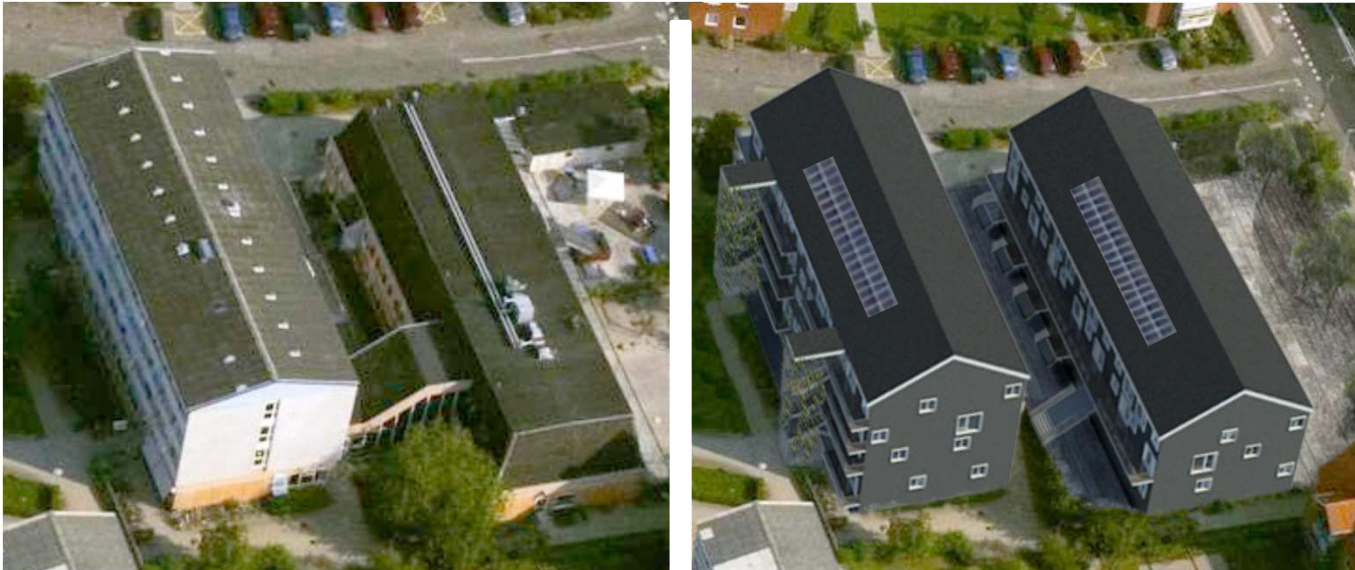
*The two blocks of Sems Have before the renovation (to the left) and after the renovation (to the right).*

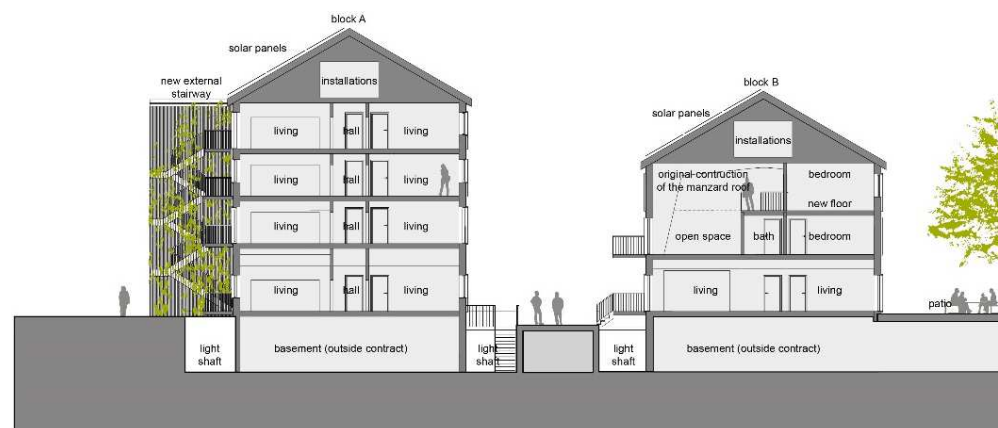
Cross section of block A (to the left) and block B (to the right) after the renovation.

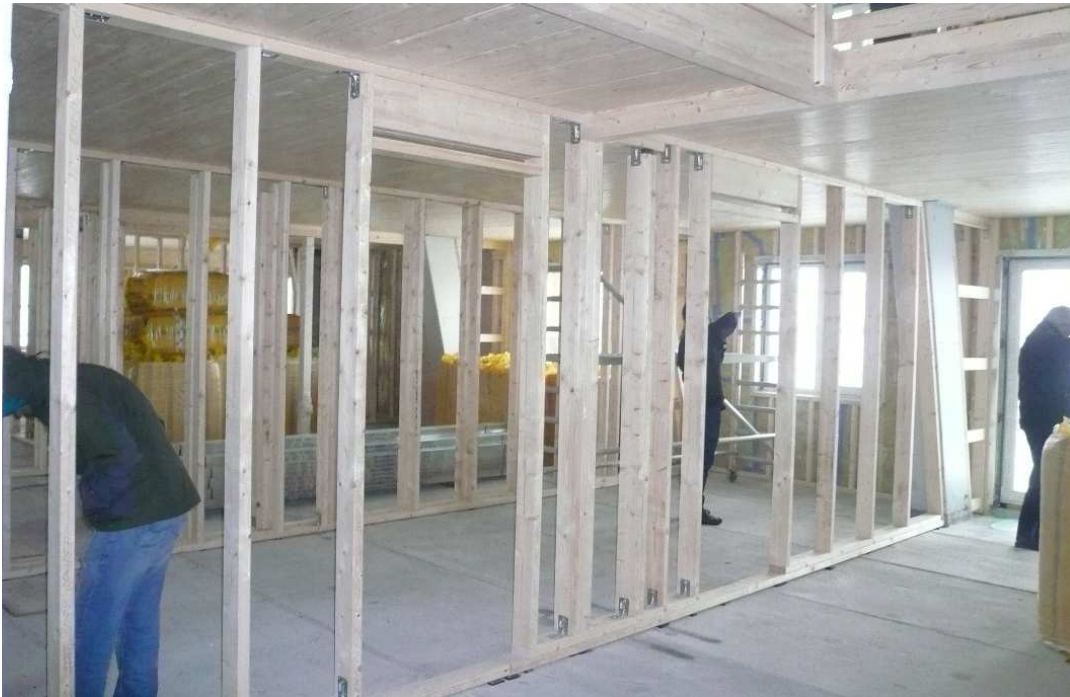
*New internal walls and inserted deck at the first floor of block B.*

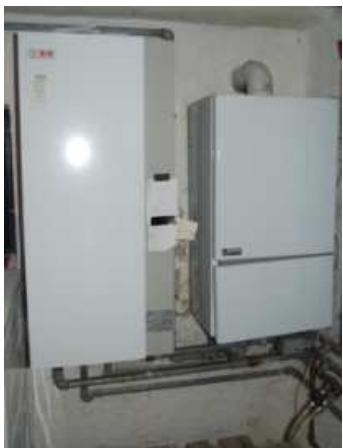
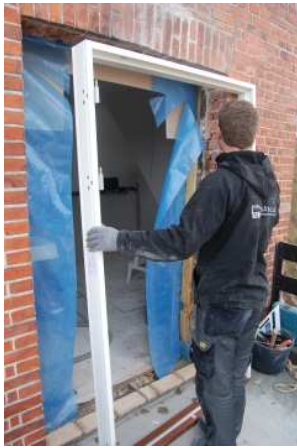
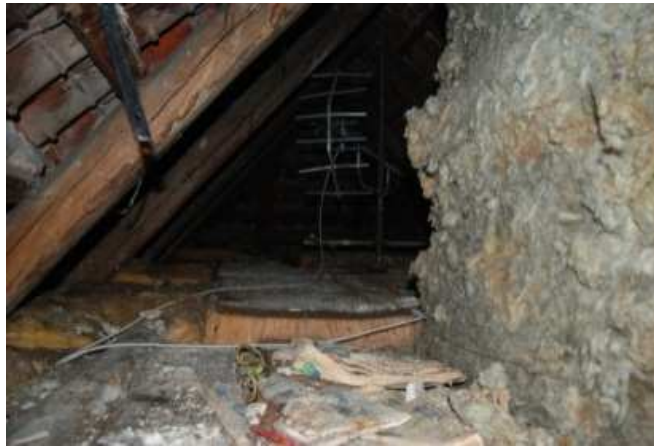
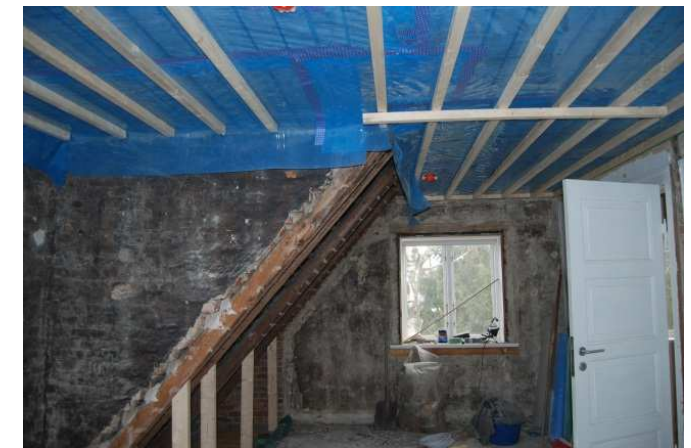
*The new vapour barrier on the loft*

*From left to right: 1. The old gas boiler and hot water tank. 2. Installation of the new B-labeled balcony door 3. Existing insulation in the loft*

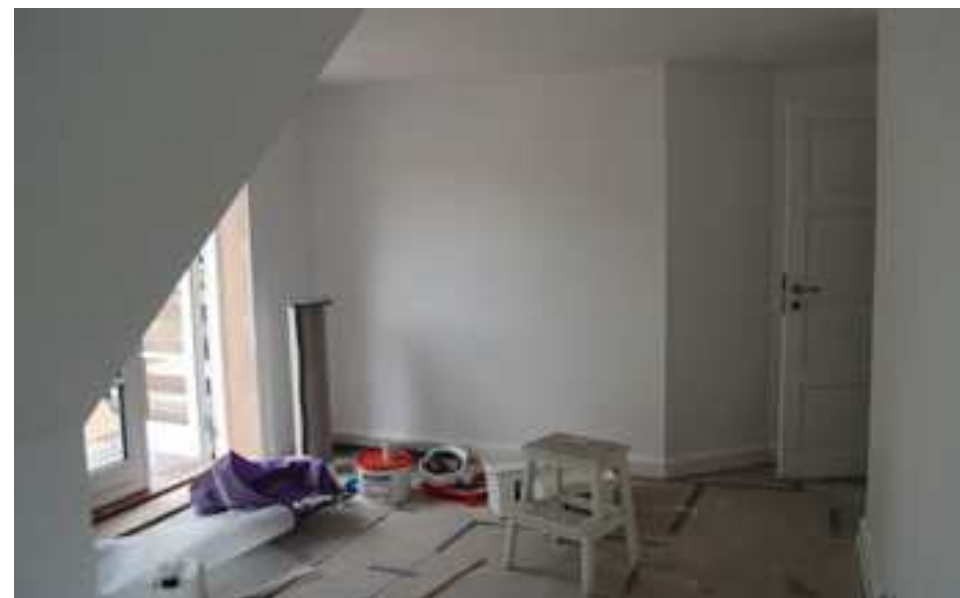
Pediment in the bedroom with new balcony door - almost ready to move in.

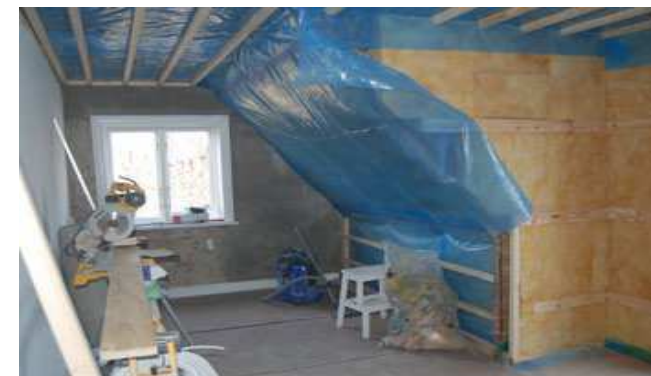
*Insulation of mansard walls and lost space walls in attic incl. vapour barrier and internal insulation of the pediment*

- Ceiling - from 100 to 400 mm
- Sloping wall – from 0/25/100 mm to 200 mm
- Roof spaces in attic - from 0/25/50 mm to 300 mm
- Solid brick walls – from 0 mm to 100 mm (inside)
- Light walls and flat roof – from 25 mm to 150 mm
- Double glazed windows/doors - replaced by low energy windows/doors
- Balcony door – replaced by low energy balcony door

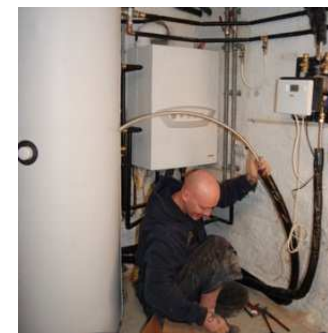
*Installation of the new heating system.*

- Gas boiler – replaced by modern condensing boiler
- Radiator valves – replaced by thermostatic valves w. electronic control
- Installed weather compensation and night setback
- Insulation of hot water, heating system and other pipes from existing 0/20 mm old insulation to 40 mm new insulation

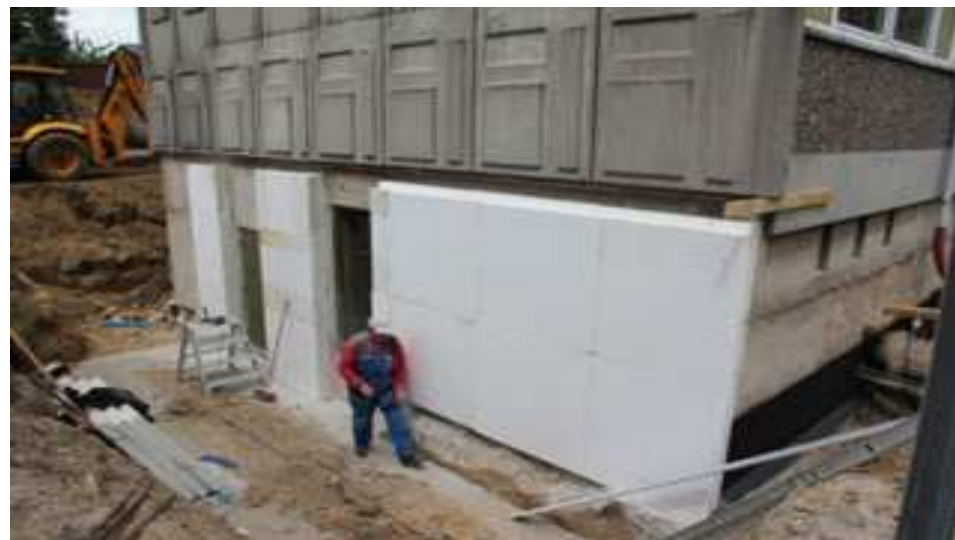
Facades – during works in base floor

- The exterior walls have been renovated: Supplementary thermal insulation is added to the outside of the exterior walls. The external insulation is continued to the base of the house to reduce thermal bridges. Cost: 12.5 million DKK = 1.67 million € (incl. VAT)
- The roofs are renovated and insulated. Cost: 4.2 million DKK = 0.56 million € (incl. VAT)
- The windows and doors are replaced with 3 layers low-energy windows. Cost: 0.85 million DKK = 114094 € (incl. VAT, excl. installation).

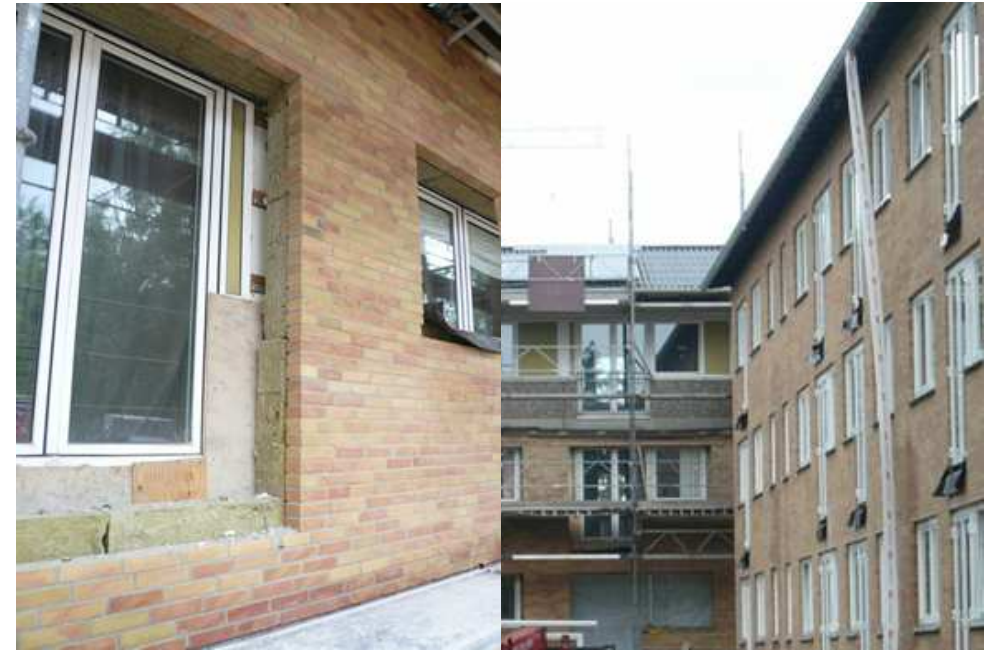
*190 mm insulation plus exterior solid standard bricks. Energy windows – aluminium – wood, 3-layer energy glass. In the panel walls: 285 mm insulation plus exterior solid standard bricks.*

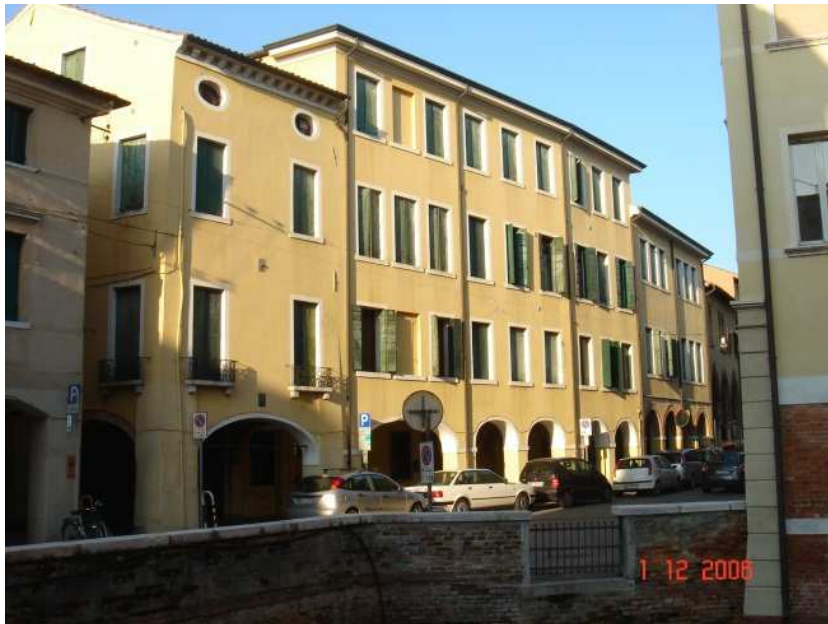
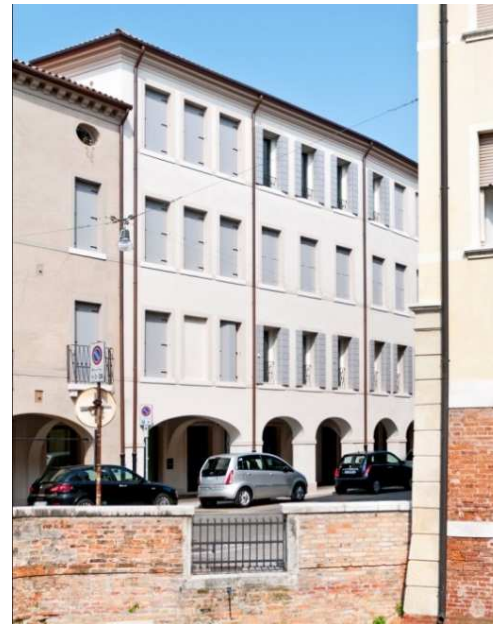
General view of the building before (left) and after (right) the intervention

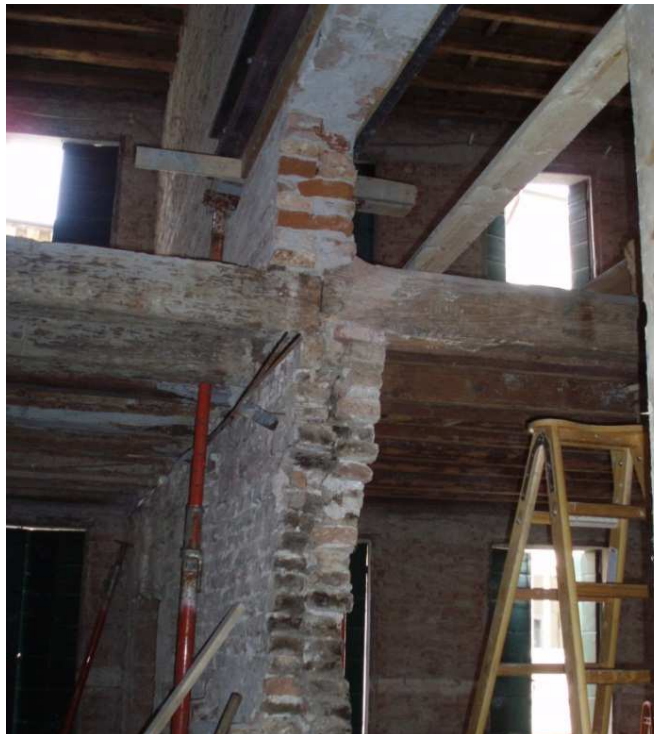
*Crooked walls, before renovation*

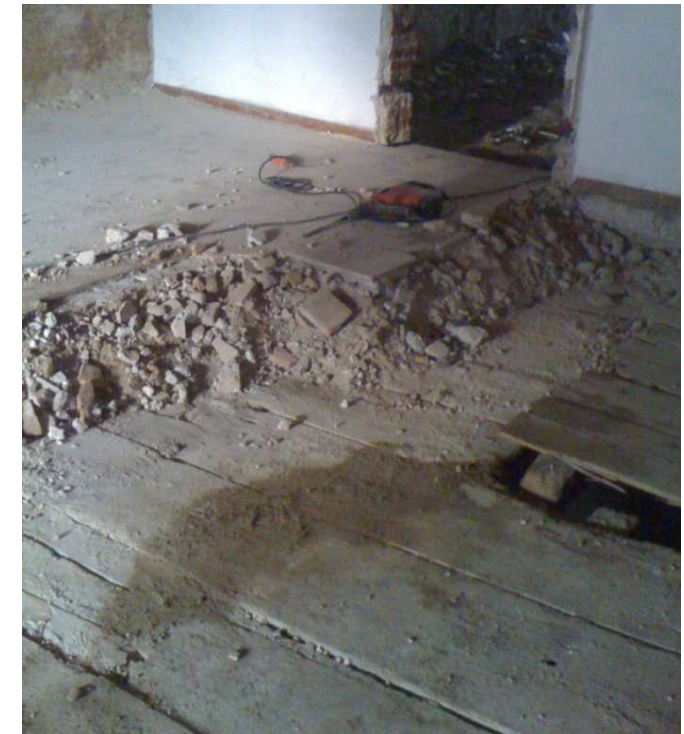
*Demolished partition walls left and used as a substrate*

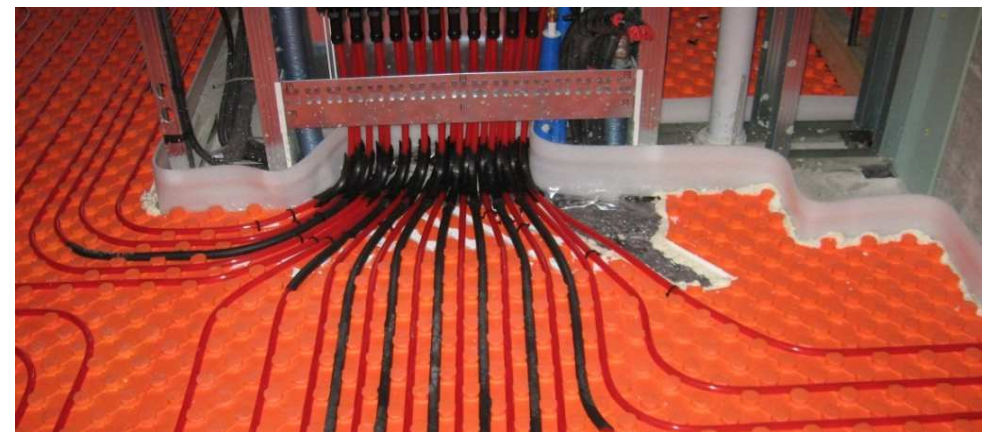
*Radiant system*

The HVAC generation system is a water to water centralized heat pump/chiller. The underlying well is the hot/cold water source and internal comfort is achieved exploiting a radiant system installed in the floor together with a dehumidification system for the summer period.

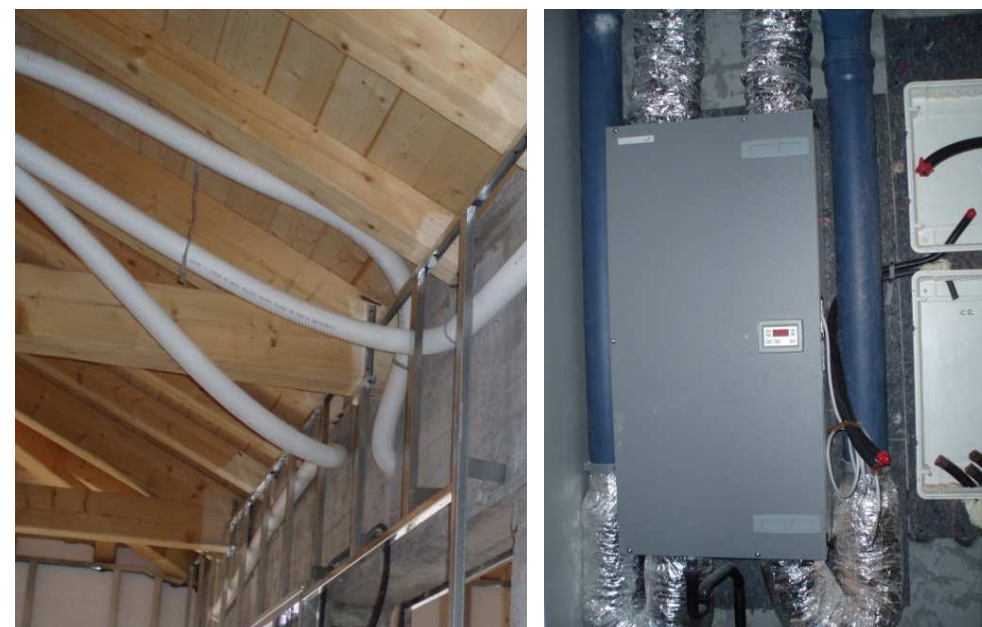
Mechanical ventilation system

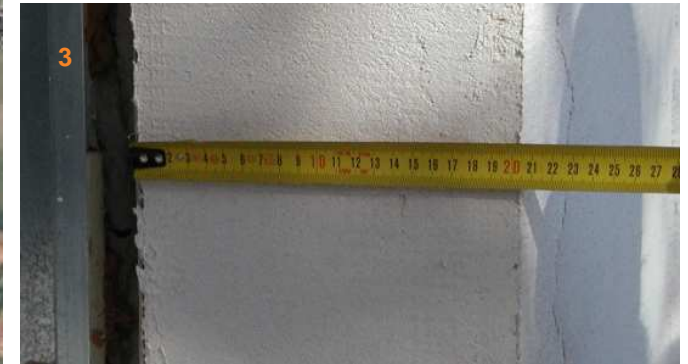
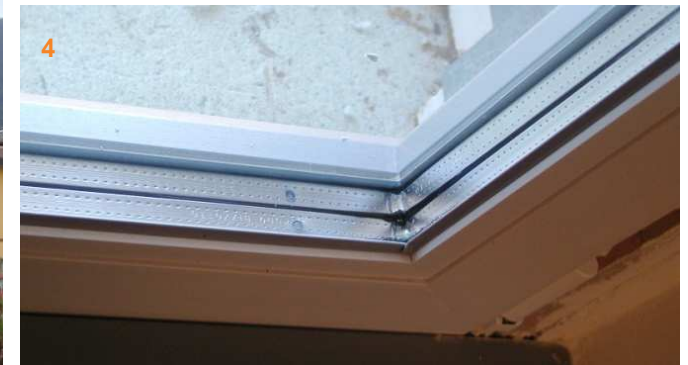
1. Satellite image of the building context;  
 2. View of the building before renovation;  
 3. External walls insulation for renovation;  
 4. New three-glazed windows after renovation.

- external insulation of walls;
- insulation of new roof and terrace;
- insulation of first heated floor;
- insulation of dumpsters;
- thermal bridge correction;
- installation of three-glazed low emissivity windows, with argon, having a PVC frame.

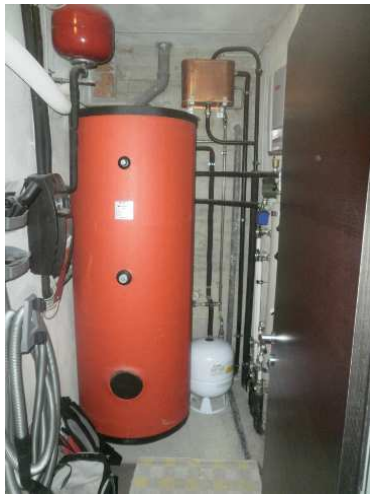
Storage tank.

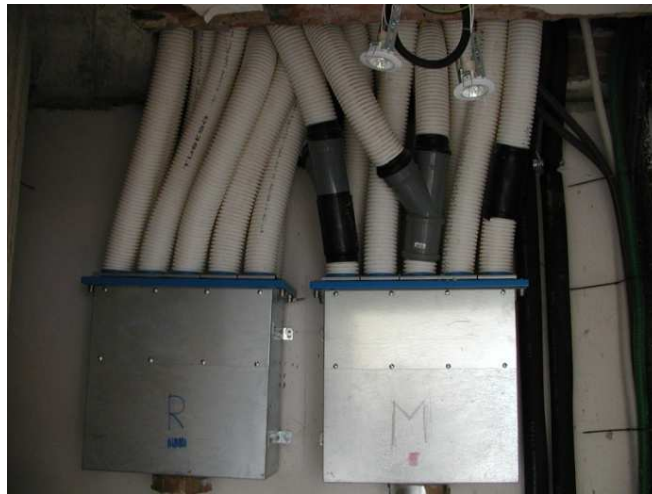
Distribution section of mechanical ventilation system.

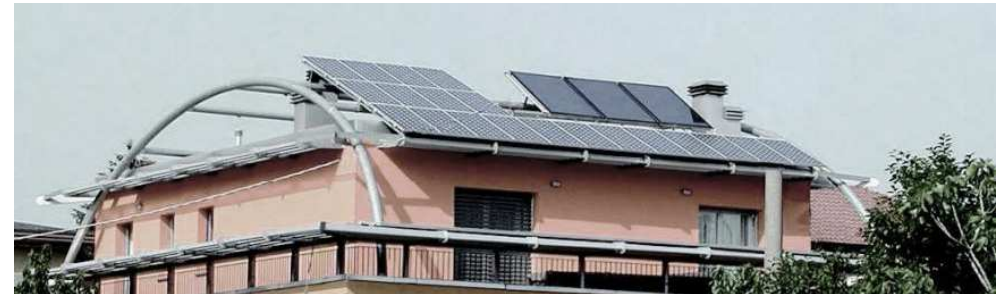
Solar and photovoltaic panels.

- solar thermal system with flat plate collectors,
- photovoltaic system.

System	Characteristics
Wood stove	21 kW
Condensing boiler	18 kW
Mechanical ventilation system	320 W – 85% nominal efficiency
Solar system	7.5 m <sup>2</sup> – 600 l tank
Photovoltaic system	4.2 kWp

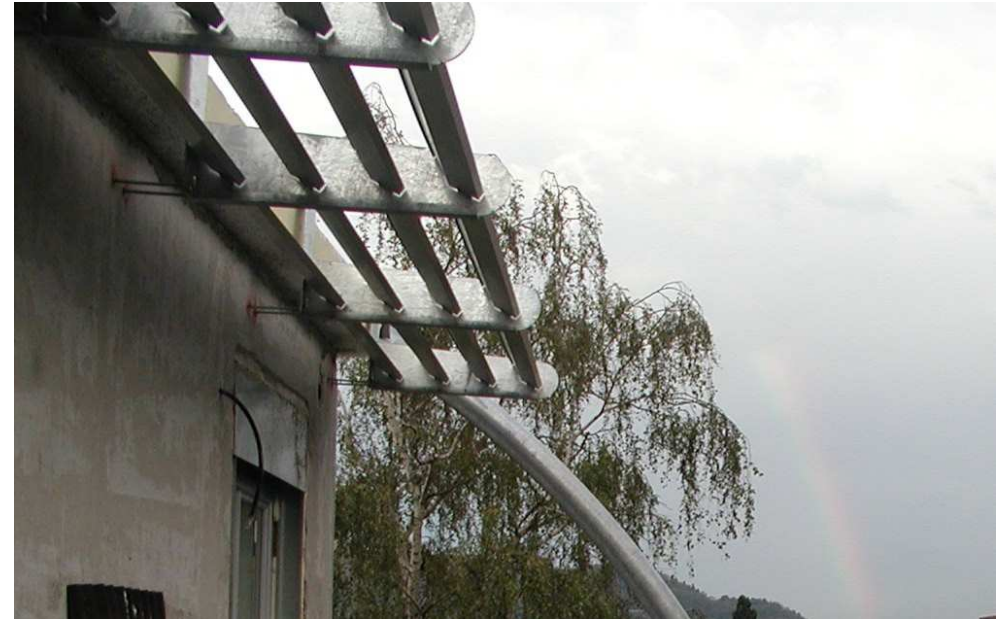
*New shading devices.*

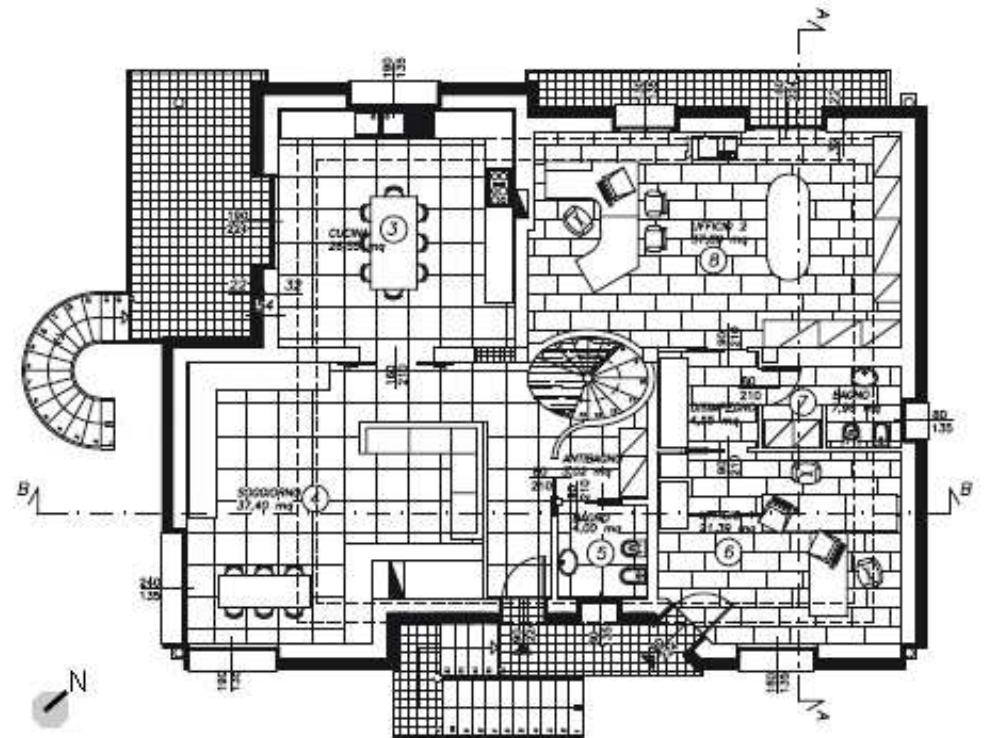
Plan of the first floor of the building.

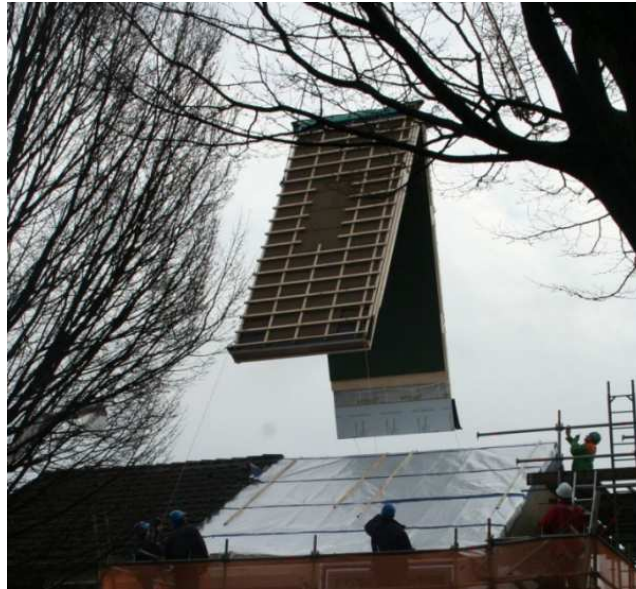
*The houses during renovation – roof installation*

Also aspects of building technology, long-term maintenance, improvement of the living environment, and sustainability were taken into consideration when making the plans. In addition, the tenants were supposed to continue their livings in the house during the renovation. Consequently, a renovation technology was developed based on full replacement of the roof and façade elements by brand new, prefabricated elements, the roof elements having the solar photovoltaic and thermal systems integrated.

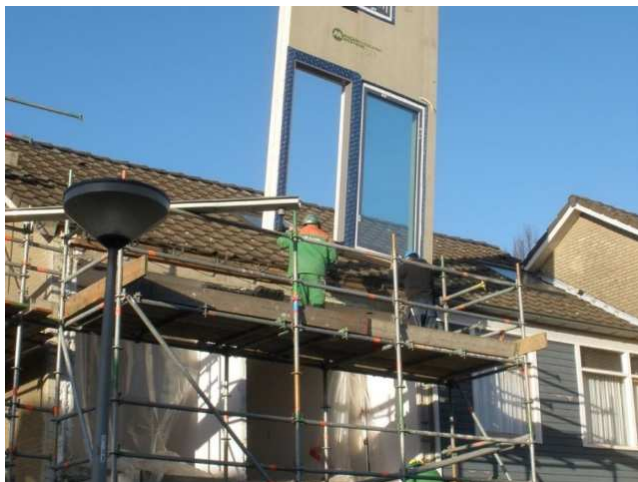
*The houses during renovation – facade installation*

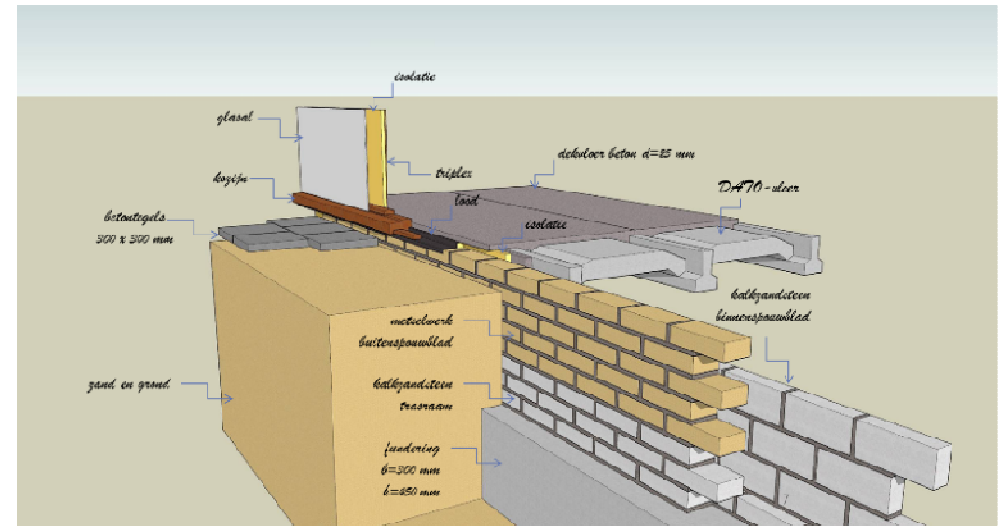
Wall-floor construction, before renovation

The building shell has been improved to passive house standard. The images at the right show the original construction of the walls, ground floor and foundation (before renovation) and the construction as it is after renovation.

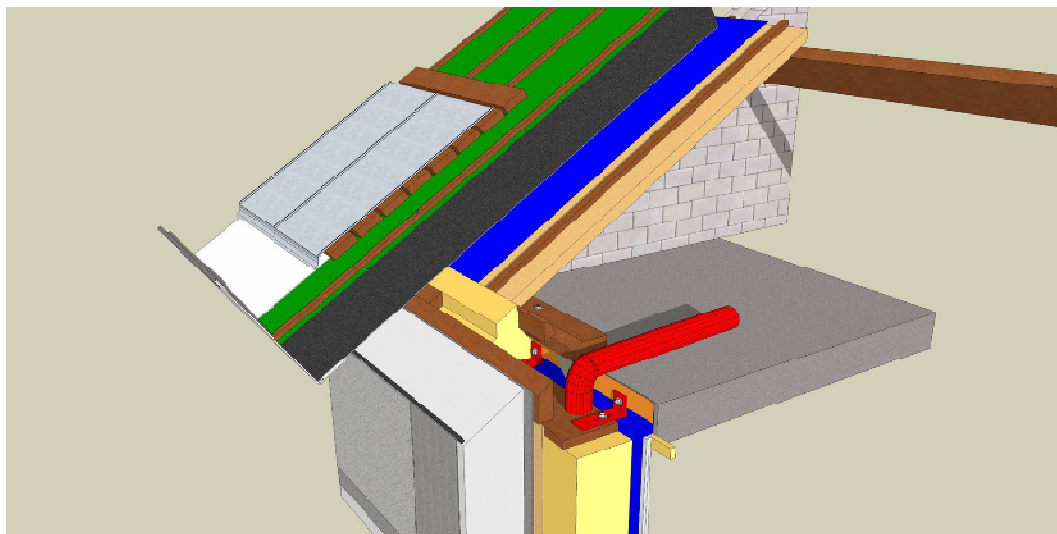
Roof-upper floor construction after renovation to passive house standard

The houses have been provided with new roof elements, including prefab integrated solar collectors and photovoltaic modules.

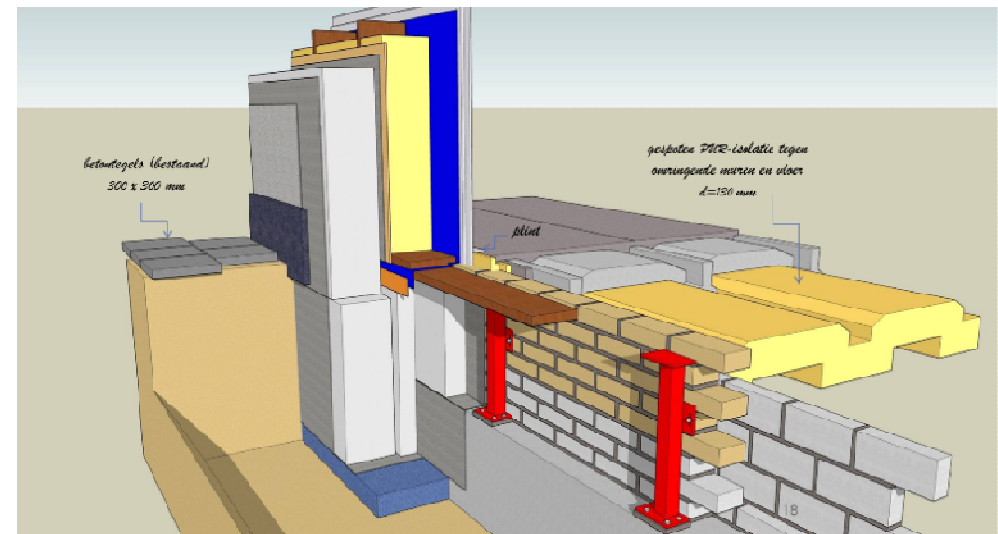
Wall-floor construction after renovation to passive house standard

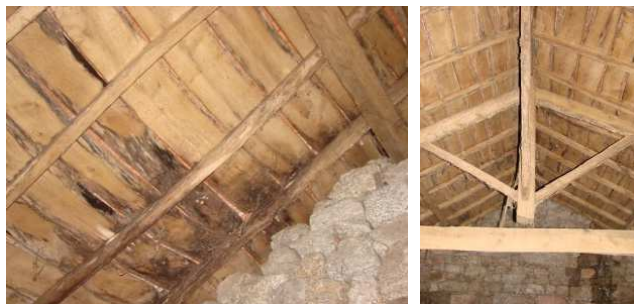
Roof condition and characteristics

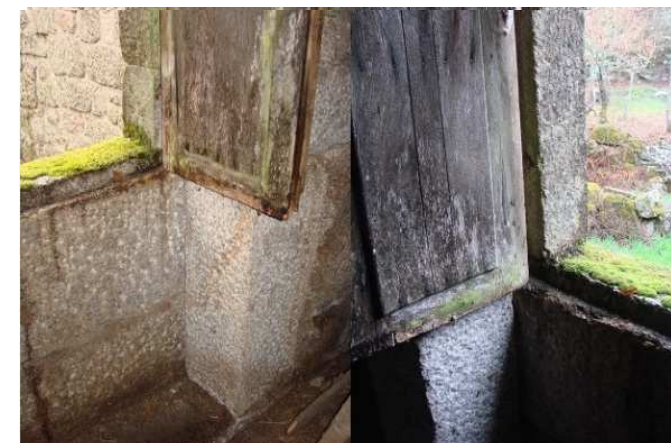
*Existing window sills*

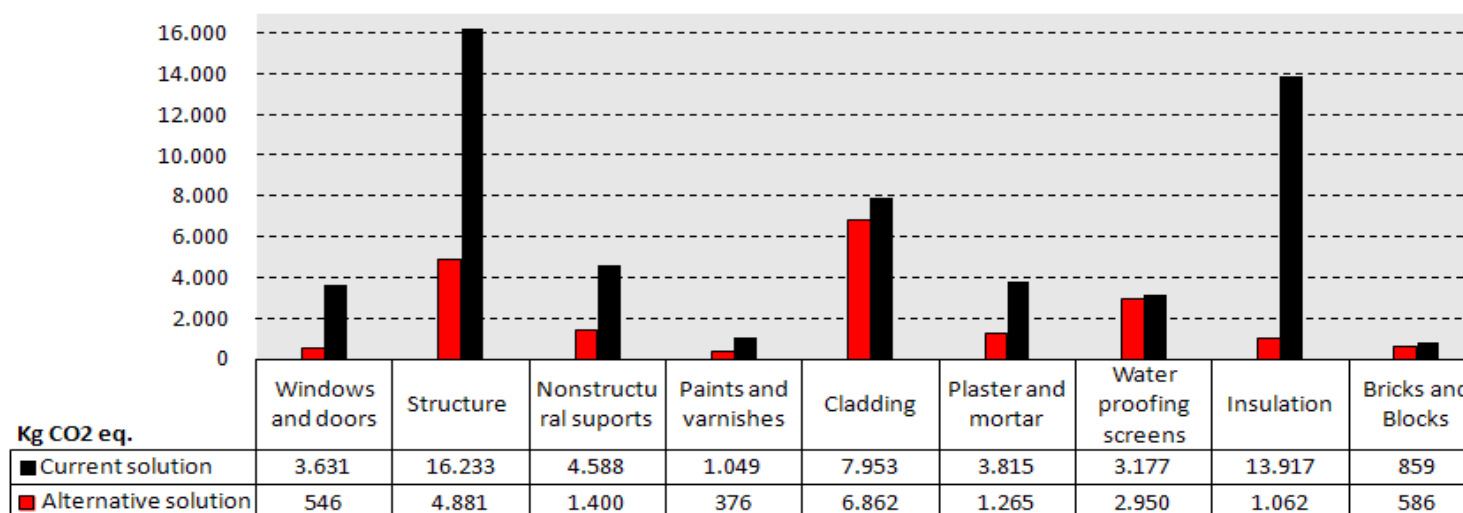
Embodied CO2 eq. amount for current and alternative material selection
