# Shining Examples of Cost-Effective Energy and Carbon Emissions Optimization in Building Renovation (Annex 56)

## Energy in Buildings and Communities Programme

March 2017

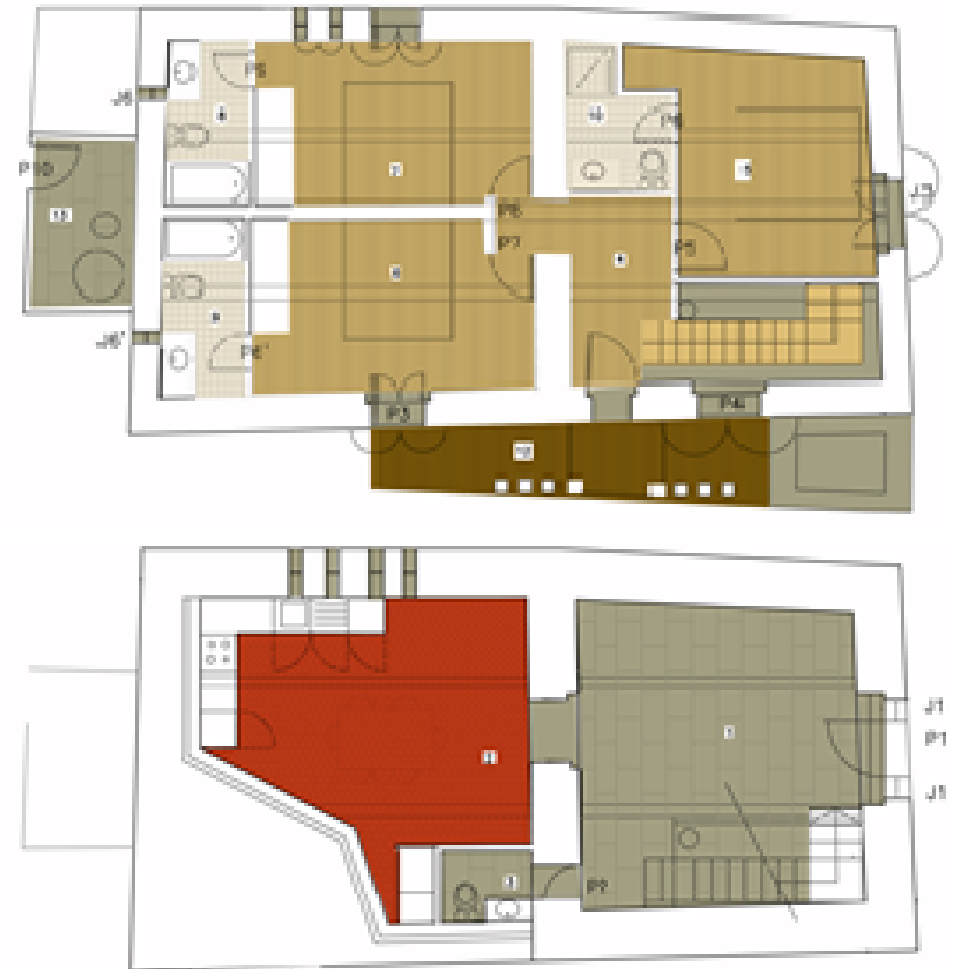
*Lower and upper architecture plans of the retrofitted house*

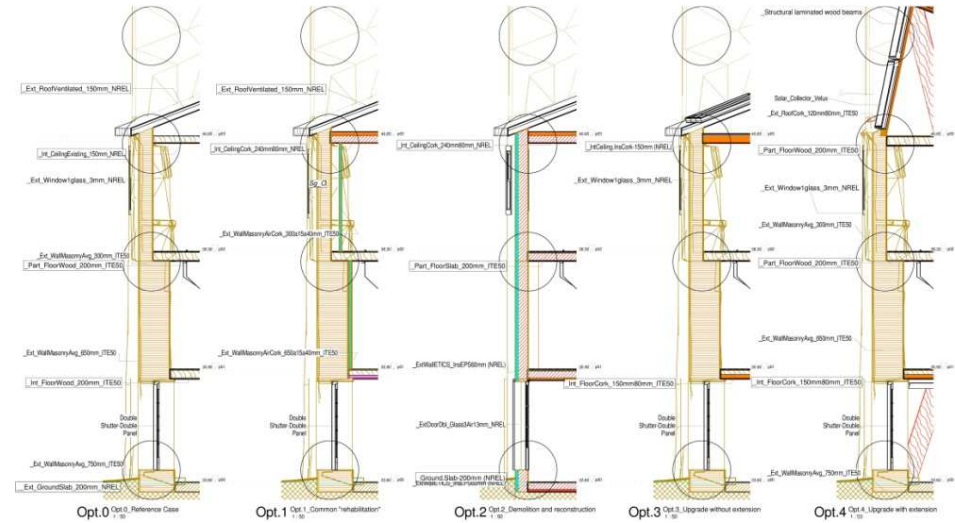
Section of building representing the reference case and other studied options

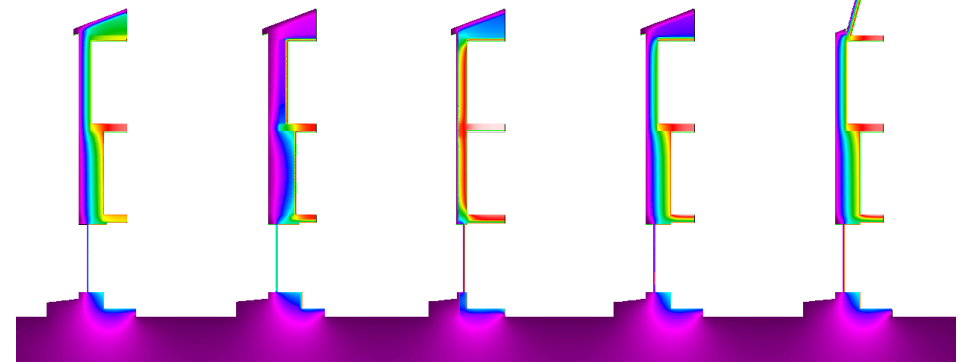
Thermal behavior analysis of the intervention options above using THERM (LBNL, 2015). Notice that Opt.1 denotes severe thermal stress in the floor area and lower temperatures inside the walls that may result in frost damage in colder nights.

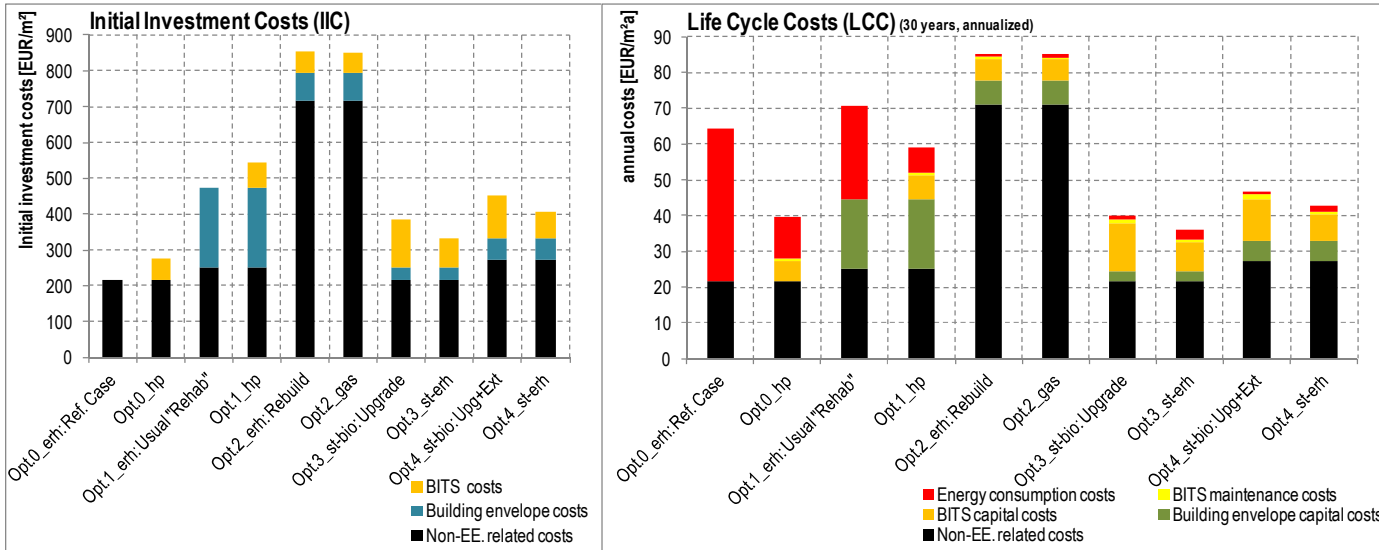
Initial Investment Costs and corresponding Life Cycle Costs for the reference case and other studied options. The “non-EE related costs” bar illustrates the investment needs that would occur anyway, even if Energy Efficiency was not considered. “Building envelope costs” quantifies all the costs on the exterior boundary, while BITS stands for Building integrated Systems to quantify ventilation and acclimatization equipments. More info in the Detailed Case Studies (IEA EBC Annex56 (Brito, 2015a).

The graphs show the **Initial Investment Costs (IIC)** per square meter of renovation area, the value the owner pays upfront, and the **Life Cycle Costs (LCC)**, a value comprising the IIC, the equipments maintenance / replacement (each 15 years) and the energy costs during 30 years, divided by 30 to simulate as if it was paid annually: **LCC is a strong indicator of real costs of ownership and use.**

Comparing both graphs demonstrates that higher IIC in efficient equipment is, most of the times, favourable on the long term LCC. The reduction of primary energy consumption seems obvious by comparison, but other conclusions emerge when tackling the LCIA analysis, on Figure 6.

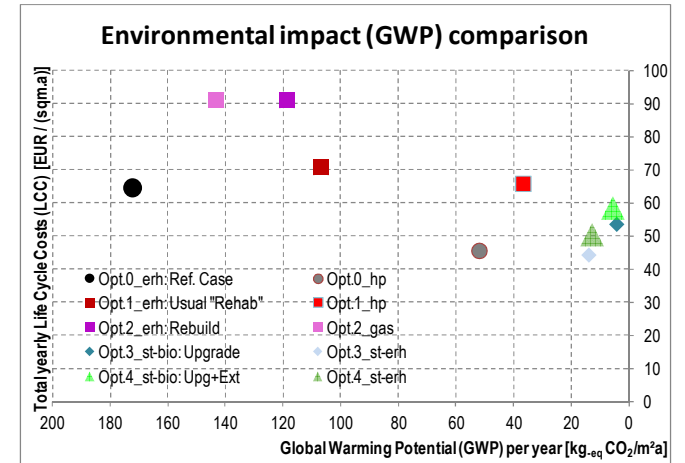
Environmental impacts comparison. The reference case (Opt.0\_erh, black circle) illustrates the current situation. The less expensive solution (Opt.0\_hp, grey circle) has significant impact, but does not reach nZEB levels.

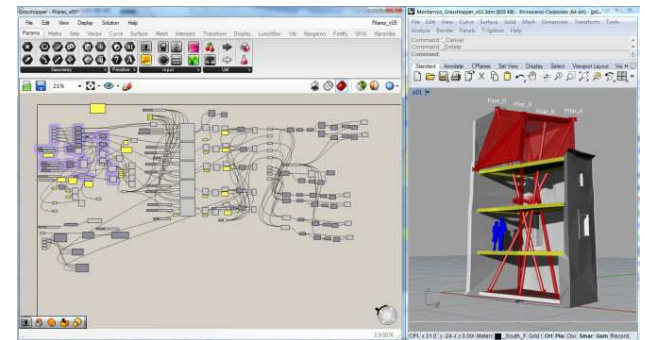
Structural reinforcement study using Rhinoceros / Grasshopper interface (special thanks to Esteban Agüero)

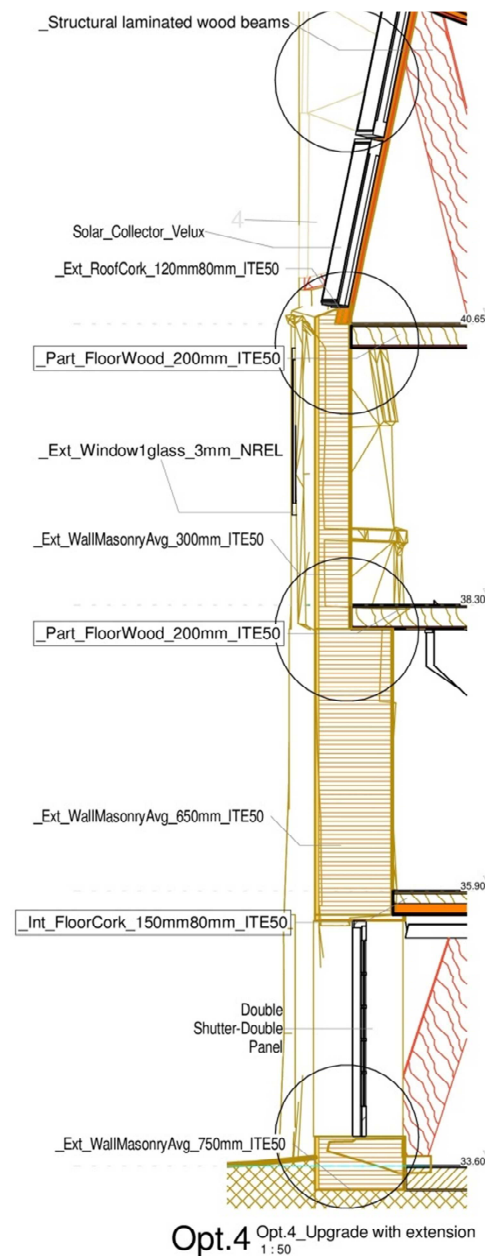
Section of Opt.4 proposal: 450€/sqm provide for a new seismic structure and 10 sqm extension, the local maximum expansion limit.

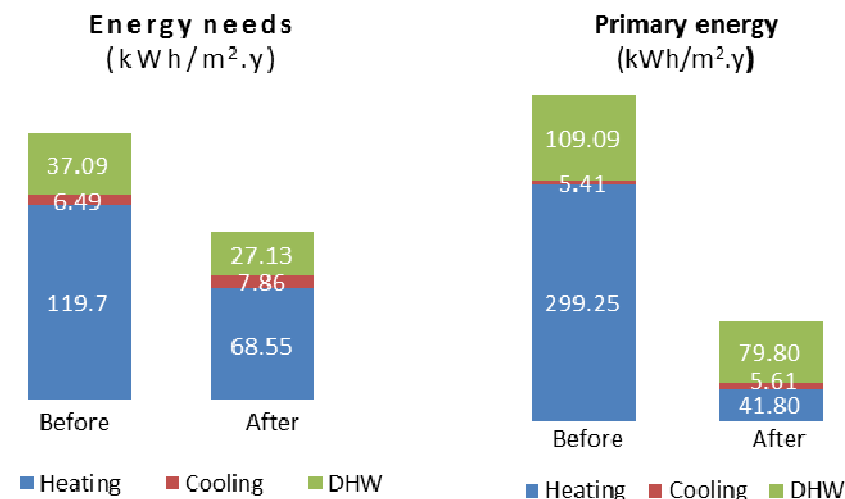
Figure above on the left shows the energy needs for heating, cooling and DHW before and after the renovation works calculated in accordance with the Portuguese thermal codes, which consider the comfort indoor temperatures of 20°C in winter and 25°C in summer.

Figure above on the right shows the non renewable primary energy use for heating, cooling and DHW, before and after the building renovation.

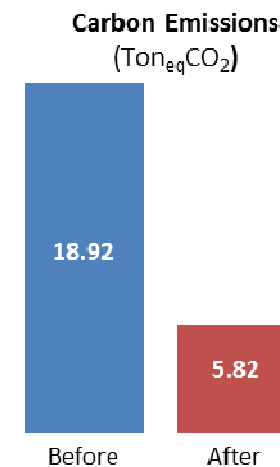
Figure on the right shows the carbon emissions before and after the building renovation related to the non renewable primary energy use.

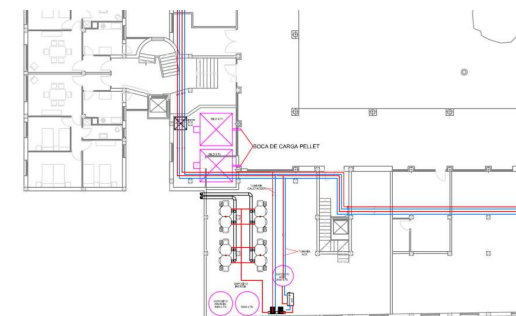
Centralized heating system based on biomass is planned to install in the future

Central heating system based on biomass is proposed and planed to install in the future.

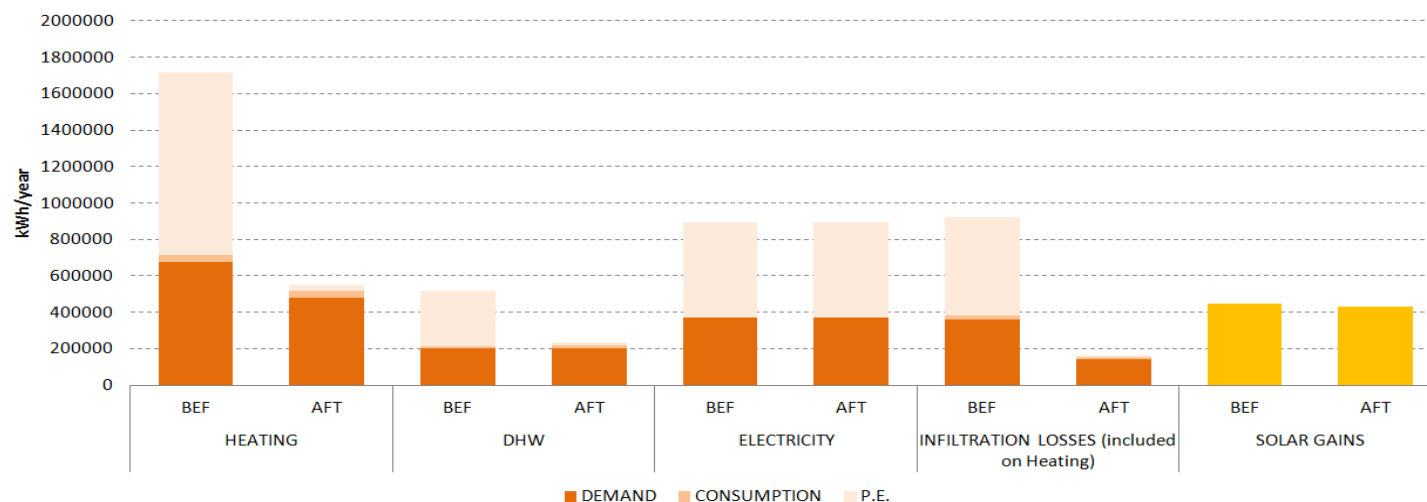
Building energy performance (Conversion Factors: Electricity 2,.4; Natural Gas: 1,.07; Source: IDAE // Infiltration before renovation: 0,6 ACH; Infiltration after renovation: 0.24 ACH)

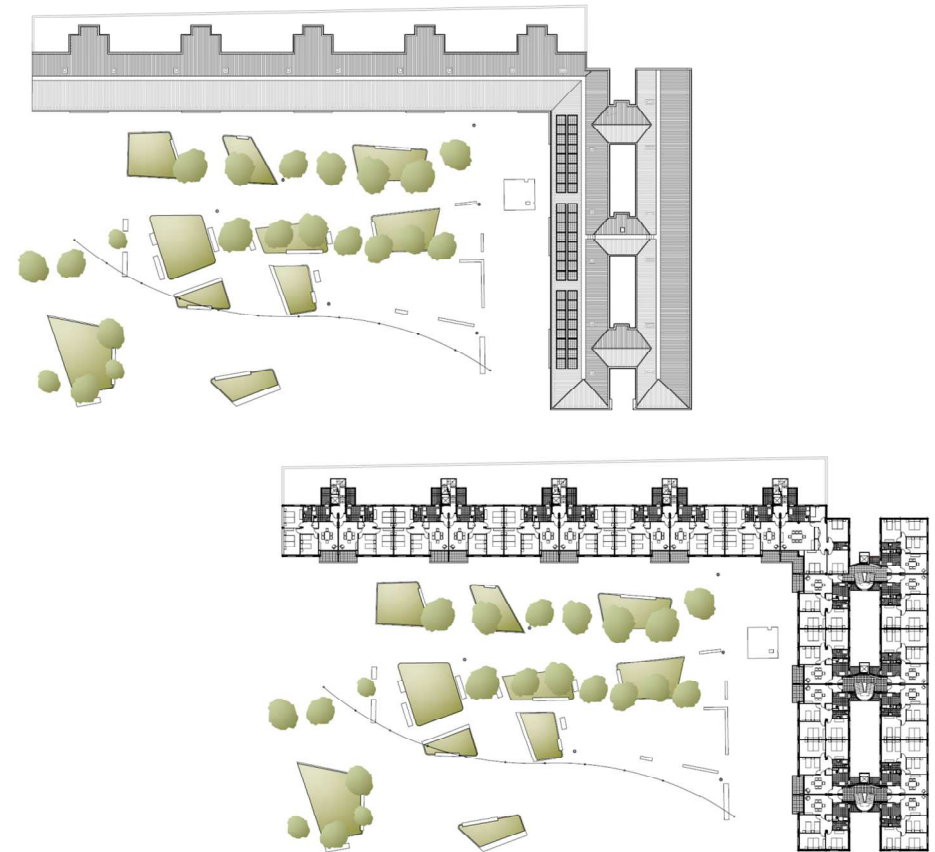
*Roof and general architecture plans of the retrofitted building.*

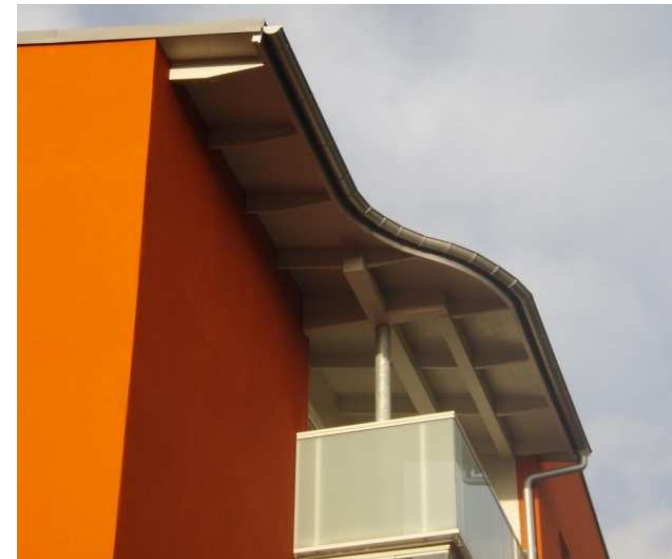
*Extended eaves and balcony after renovation*

- Water and sewage systems replaced, hot water circulation installed
- New electrical installation
- New bathrooms and kitchens
- Change to parquet floor in living rooms and bedrooms
- New surface finish in the apartments
- Safety doors for the apartments
- New extended balconies, which also reduce the thermal bridges
- Façade repaired

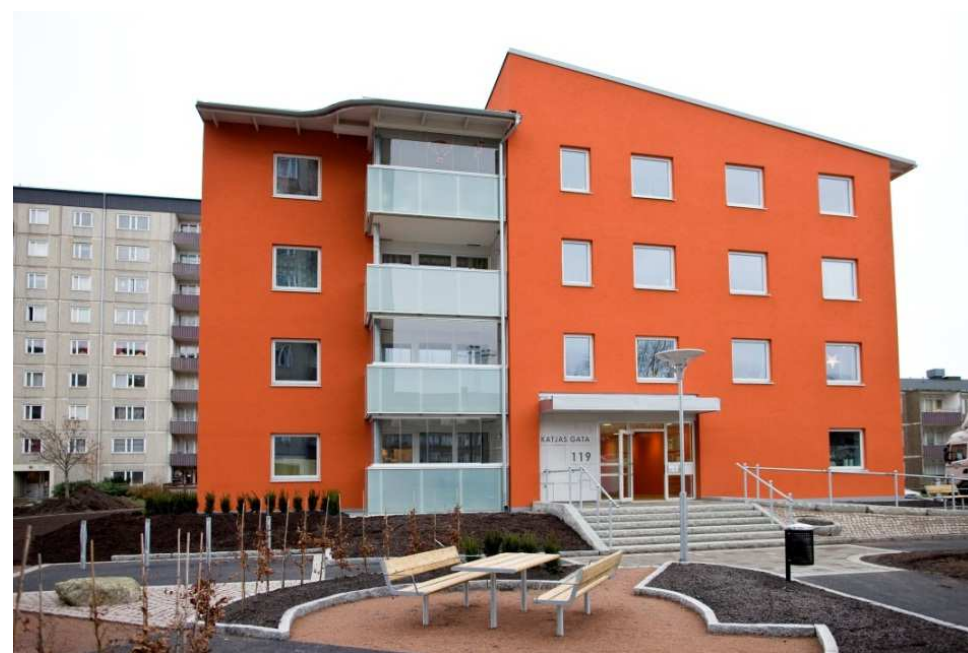
*After renovation with new facade and balconies etc.*

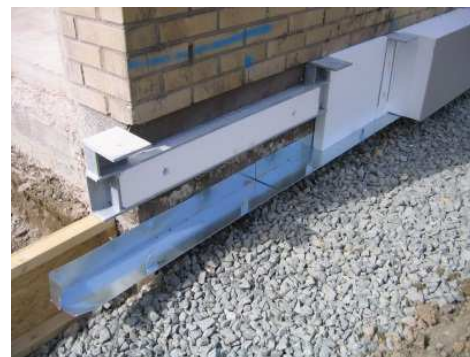
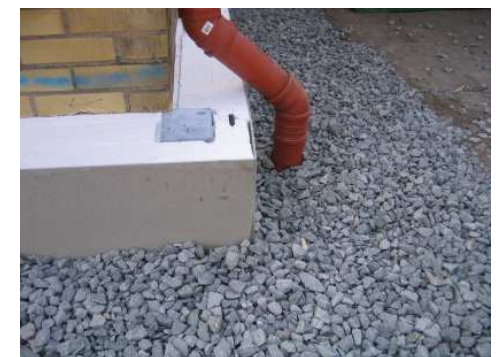
*Added insulation to the foundation*

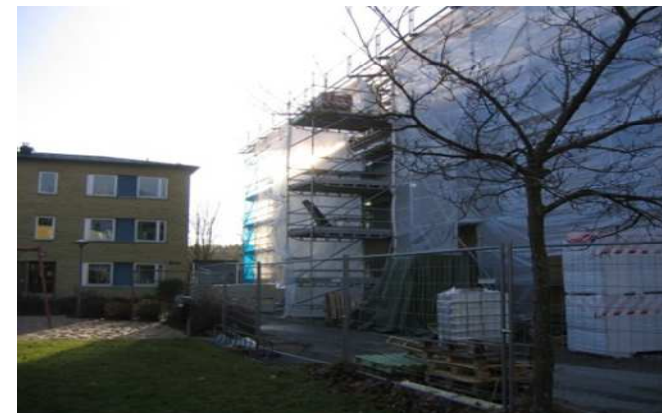
*During reconstruction the building was covered by a tent.*

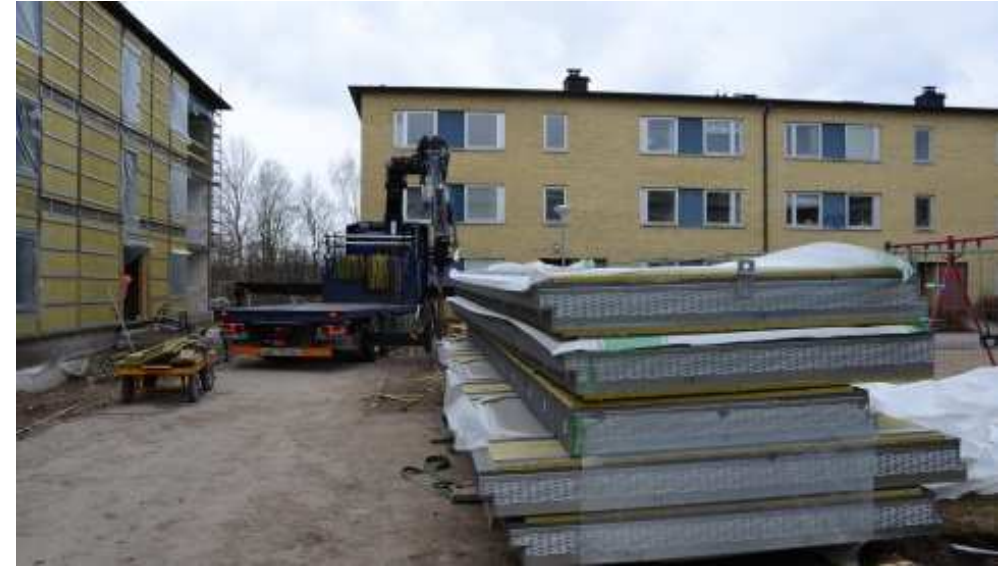
*Prefabricated facade elements for the next phase of renovation.*

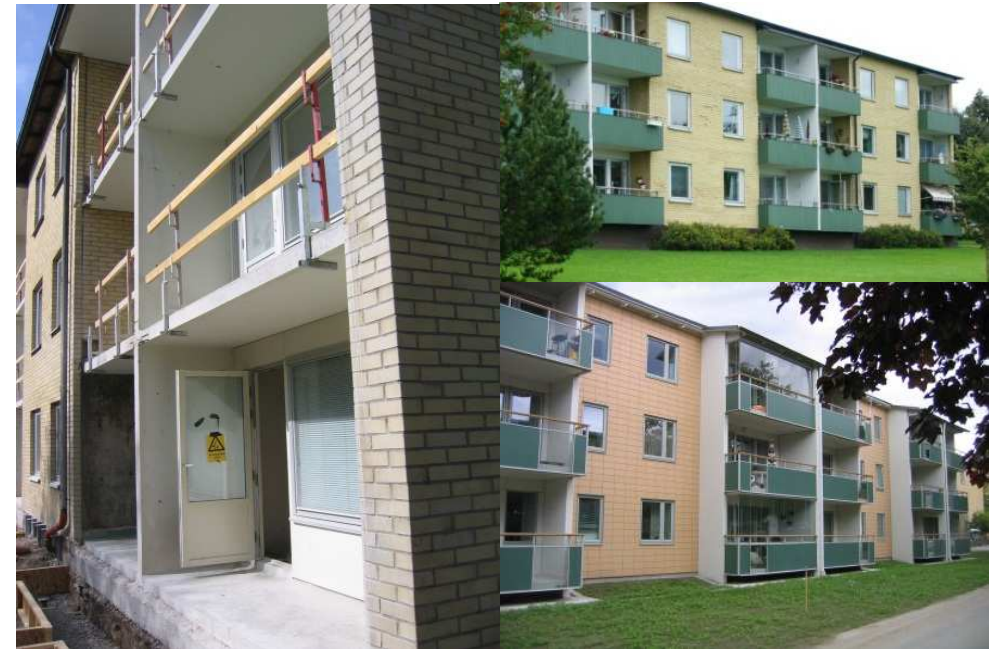
*Long side façade with balconies before (left and above) and after (below) renovation.*

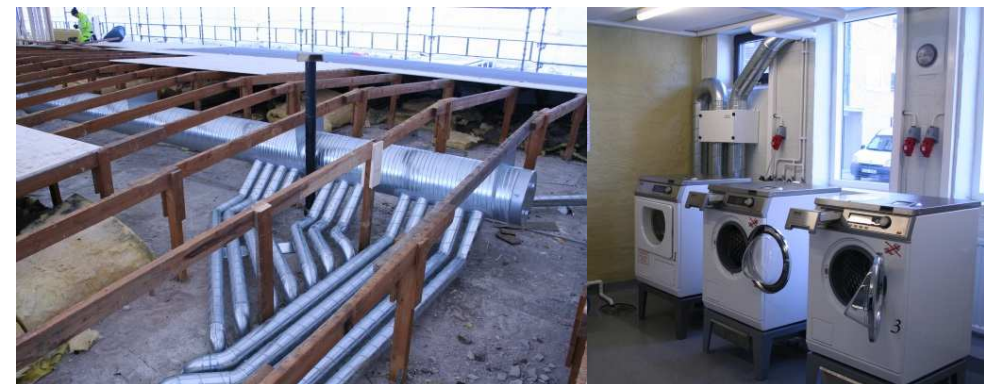
*Installation of ventilation ducts in the new attic and new washing machines in the common laundry room.*

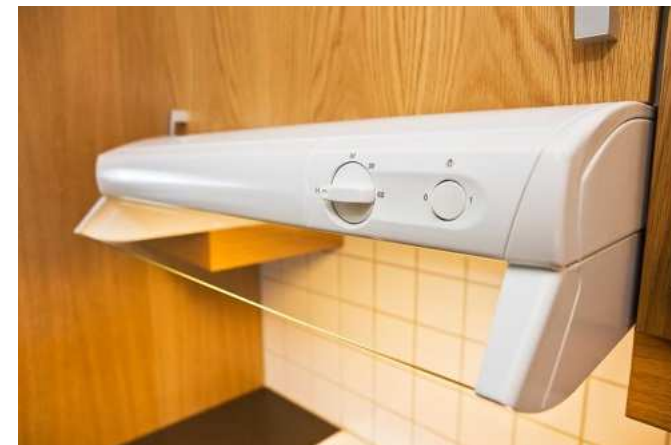
*New cooker hood.*

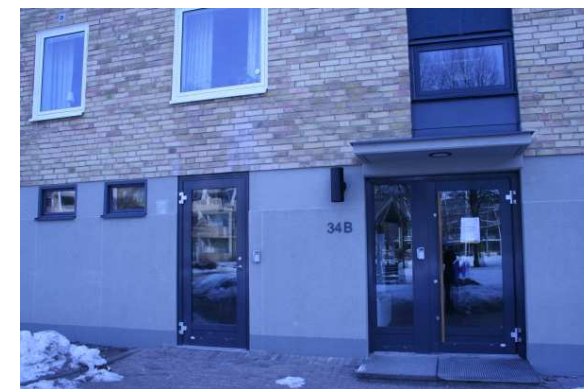
*New windows and entrance*

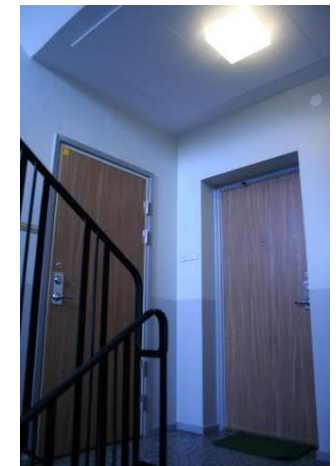
Renovated staircase with new safety doors and new energy efficient lighting.

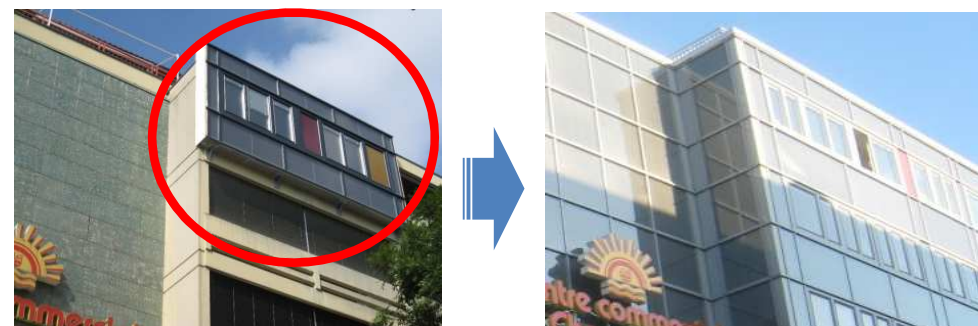
*Pre-fabricated solar facade system from gap-solution*

Element (only Block A)	After renovation
<b>Façade</b>	Concrete 200 mm / Mineral wool 180 mm / GAP module
<b>Windows</b>	2-layer low-energy windows + 1 external glass with PVC frame
<b>Roof (attic)</b>	Mineral wool 160 mm / Mineral wool 300 mm
<b>Roof (terrace)</b>	Concrete 200 mm / Mineral wool 300 mm / Bitumen sheet 5 mm
<b>Floor (above heating zone)</b>	Plaster 50 mm / Mineral wool 20mm / Concrete

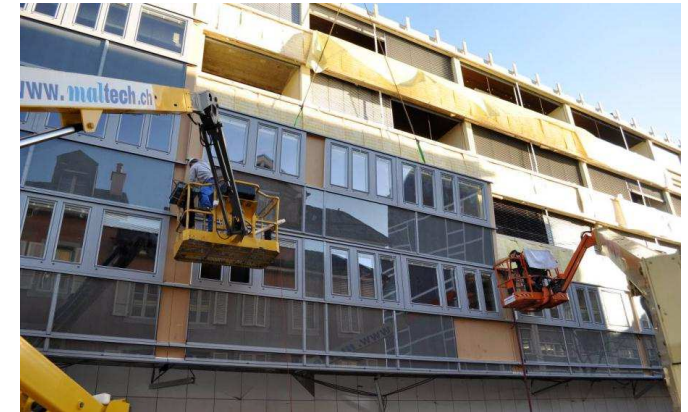
*New prefabricated modules during the renovation*

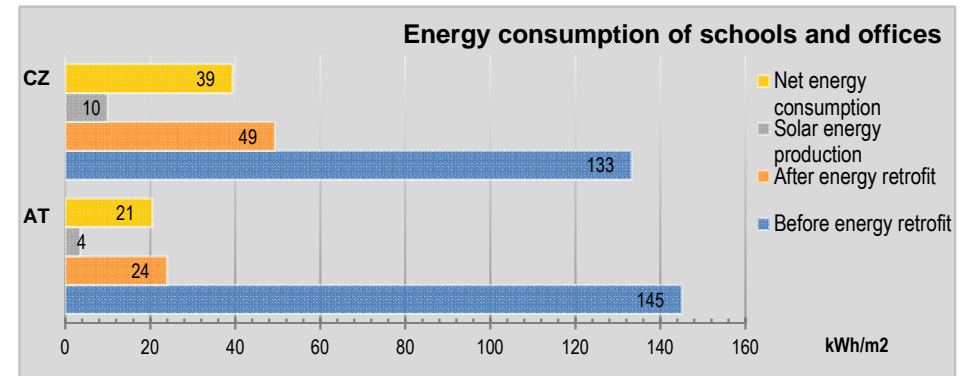
Overview of the Energy consumption before and after energy retrofit for the two Public building cases

Only two public buildings are studied, The elementary school located in Kaminky, Czech republic and The federal Ministry of Justice of Bruck/Mur in Austria. Both presents a fairly high energy reduction by the incorporation of RUE by a 63% and 83% for the School and the Official building respectively, as it can be seen from Figure 1.

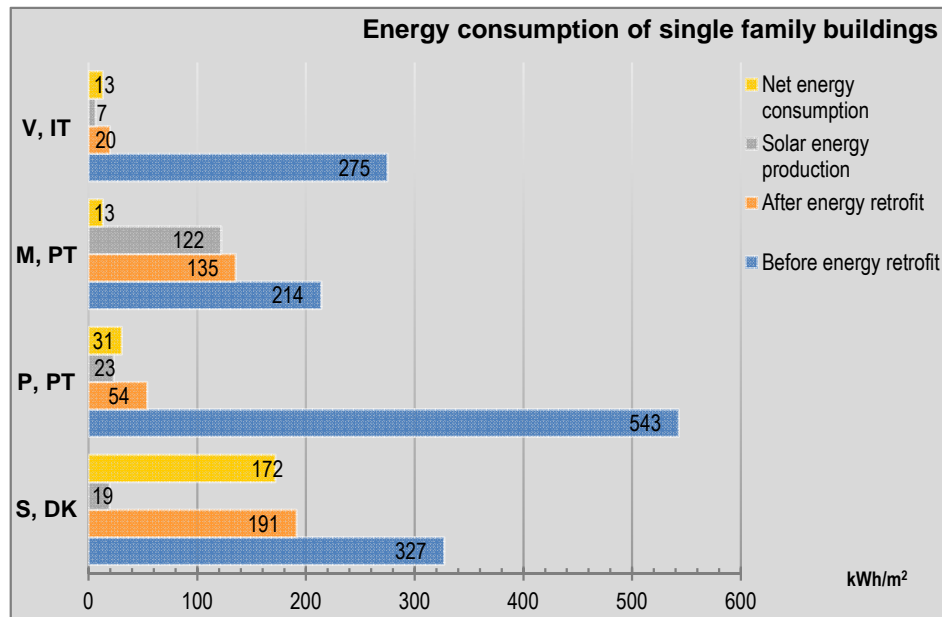
Overview of the Energy consumption before and after energy retrofit for the four single-family buildings.

Via Trento from Italy and Lugar de Pontes from Portugal present a considerable heating consumption reduction of 93% and 90%, respectively, after the RUE renovation. In addition, solar thermal collectors have been incorporated to the building reducing the heating consumption by additional 33% and 43%.

The single family house from Denmark, shows a heating energy reduction of only 42% after renovation and in addition 10% more is reduced by the incorporation of a solar thermal collectors.

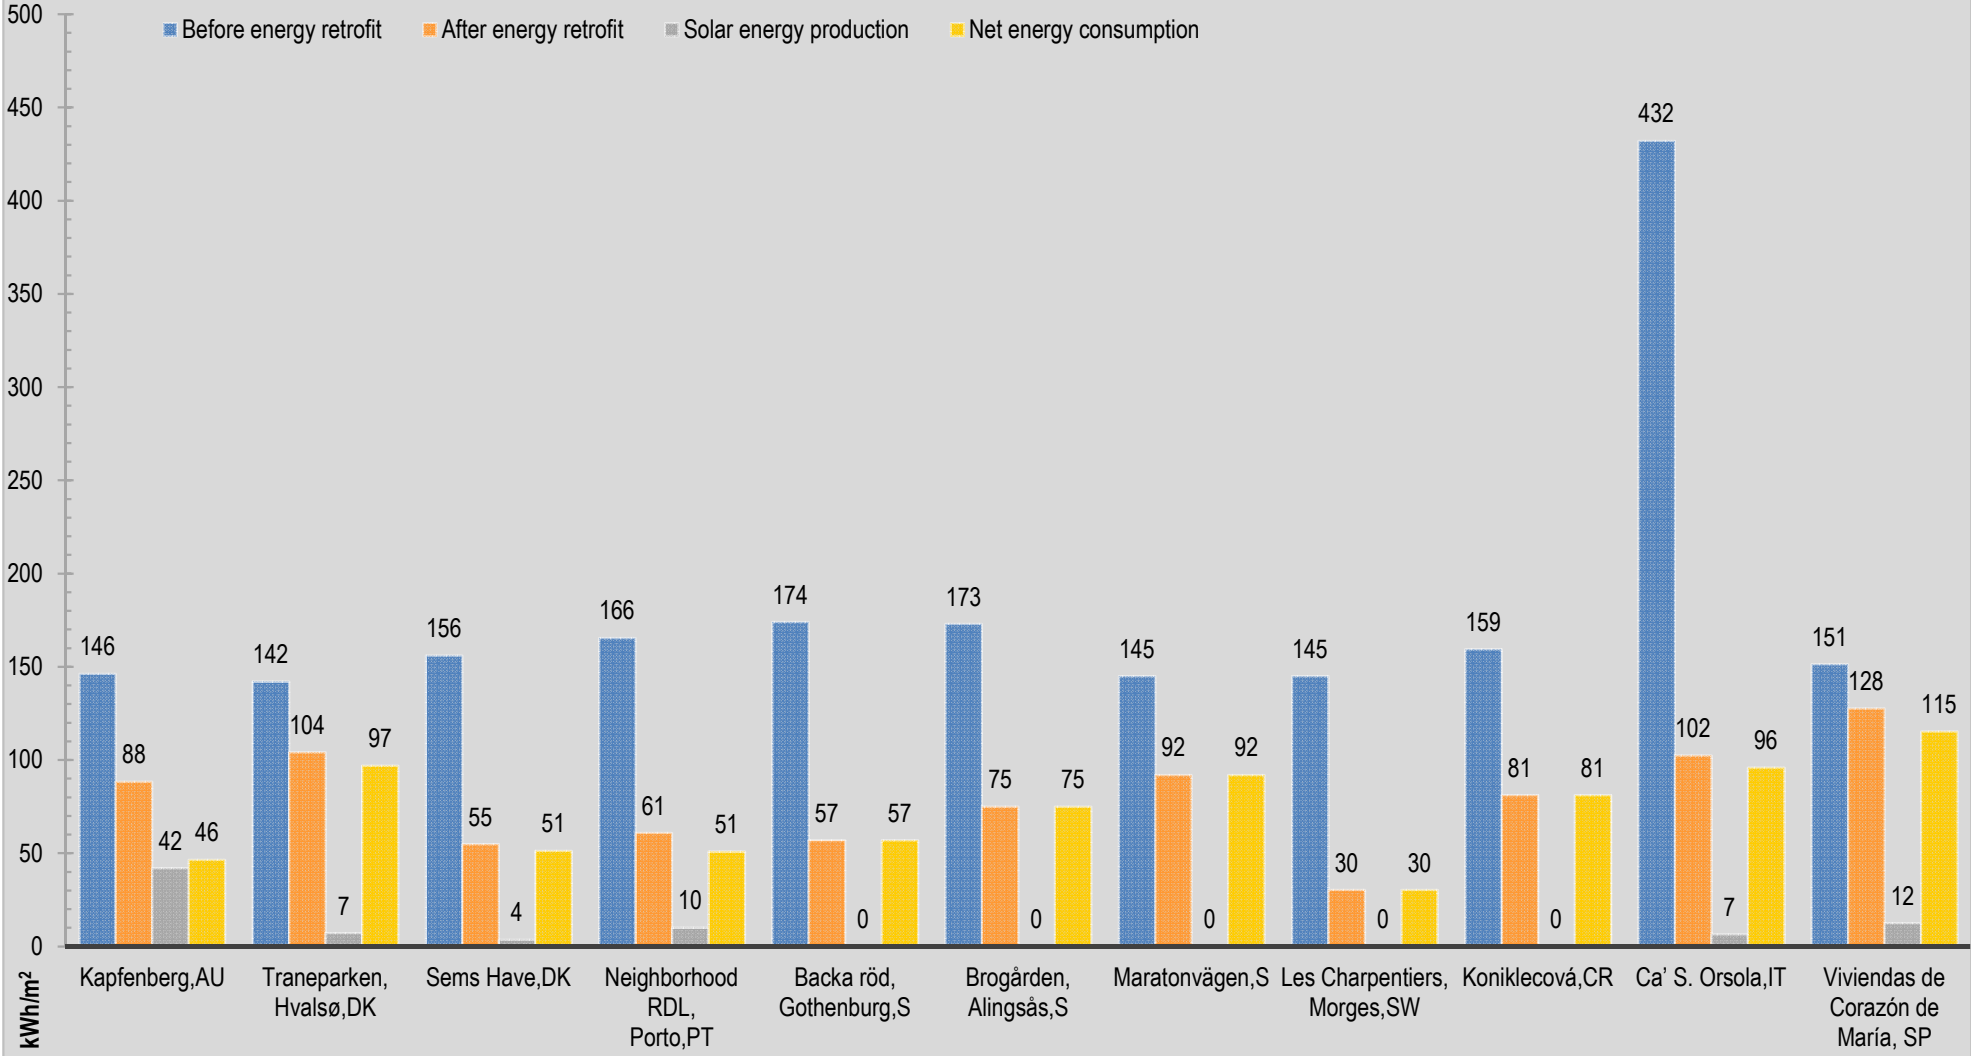
**Energy consumption of multifamily buildings**

Overview of the Energy consumption before and after energy retrofit of multifamily buildings.

The highest percentage of solar energy contribution, both Solar thermal and PV electrical, is found in Kapfenberg, Austria, reducing 48% the total energy consumption after energy renovation by RUE.
