Experimental Investigation on the Long-term Durability of Bond Between FRP and Masonry Substrates

B. Ghiassi¹, D.V. Oliveira², P.B. Lourenço³

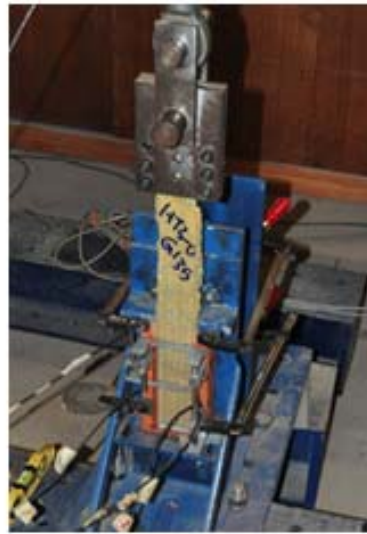
Single-lap shear bond tests were performed using a mechanical testing machine with maximum load capacity of 50 kN. A steel frame was used to support the specimens appropriately and avoid misalignments in load application. The specimens were placed on the steel frame and firmly clamped to it as shown in Figure 6. Tests were driven under displacement control conditions with reference to the LVDT sensor placed at the loaded end of the FRP composite. The specimens were pulled monotonically with a speed rate of 5µm/sec. The resulting load was measured by means of a load cell. The relative slip between the GFRP and the masonry substrate was measured with the LVDTs glued along the bonded length.

Figure 6: Single-lap shear bond test setup.
