# Structural repair of decayed old timber end beams

**ABSTRACT:** Timber end-beams represent portions with high risk of degradation due to biotic agents like rot fungi and insect attacks. Different repair techniques are available, with distinctive level of intrusion, but the substitution of the damaged part with a solid wood prosthesis is a methodology well accepted. The connection of the prosthesis to the original member can use screws, binding strips, stirrups and glued-in rods. Despite it is possible to find different case studies in literature, no study is known for the case of maritime pine beams and prosthesis connected with glued-in steel rods. This work intends to fill this gap by presenting an experimental campaign aimed to evaluate a technique to repair timber end beams through the use of wood prosthesis connected to the original element by glued-in steel rods. For comparison purposes, the addition of new timber elements connected by screws is also evaluated as it represents a current practice in Portugal.

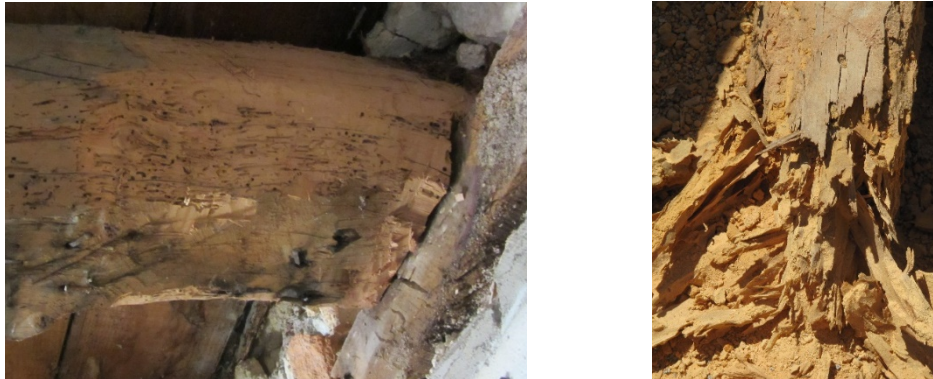
Figure 1. Examples of decayed old timber end beams.

In the specific case of wooden elements, it is well known that end-beams represent portions with high risk of degradation due to biotic agents (rot fungi and insect attacks). In fact, when a high level of humidity is present in masonry (e.g., due to infiltration for disconnections in roofing) and the adsorbed moisture cannot be evaporated because of lacking in ventilation, the suitable

conditions for biotic attacks are established, and therefore degradation of end-beams can be expected (see Figure 1). This fact is well known among structural restorers and engineers familiar with timber. The first considerations about the effects of moisture content onto the end-beams were due to Vitruvio (Barbaro, 1997), whereas the suggestion of preparing aerated supports for hosting beam heads were firstly attributable to Leon Battista Alberti (Portuguese et al., 1966).

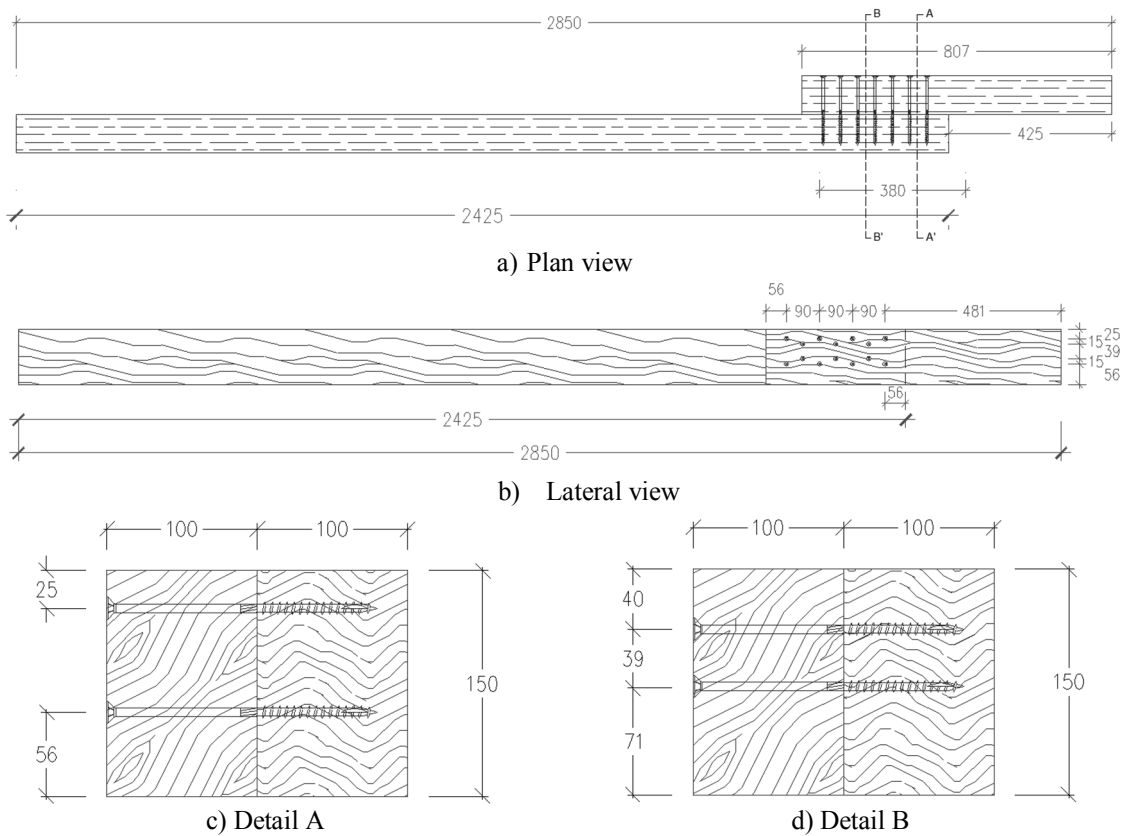
Figure 4. Specimens representing the repair technique based on one new timber element (dimensions in millimeters).

In the case of the repair technique based on the use of new timber elements, the effective cross-section was reestablish by one new element of 100x150mm<sup>2</sup> (Figure 4) or two new elements of 50x150mm<sup>2</sup> (Figure 5), in the case of specimens O and T, respectively.

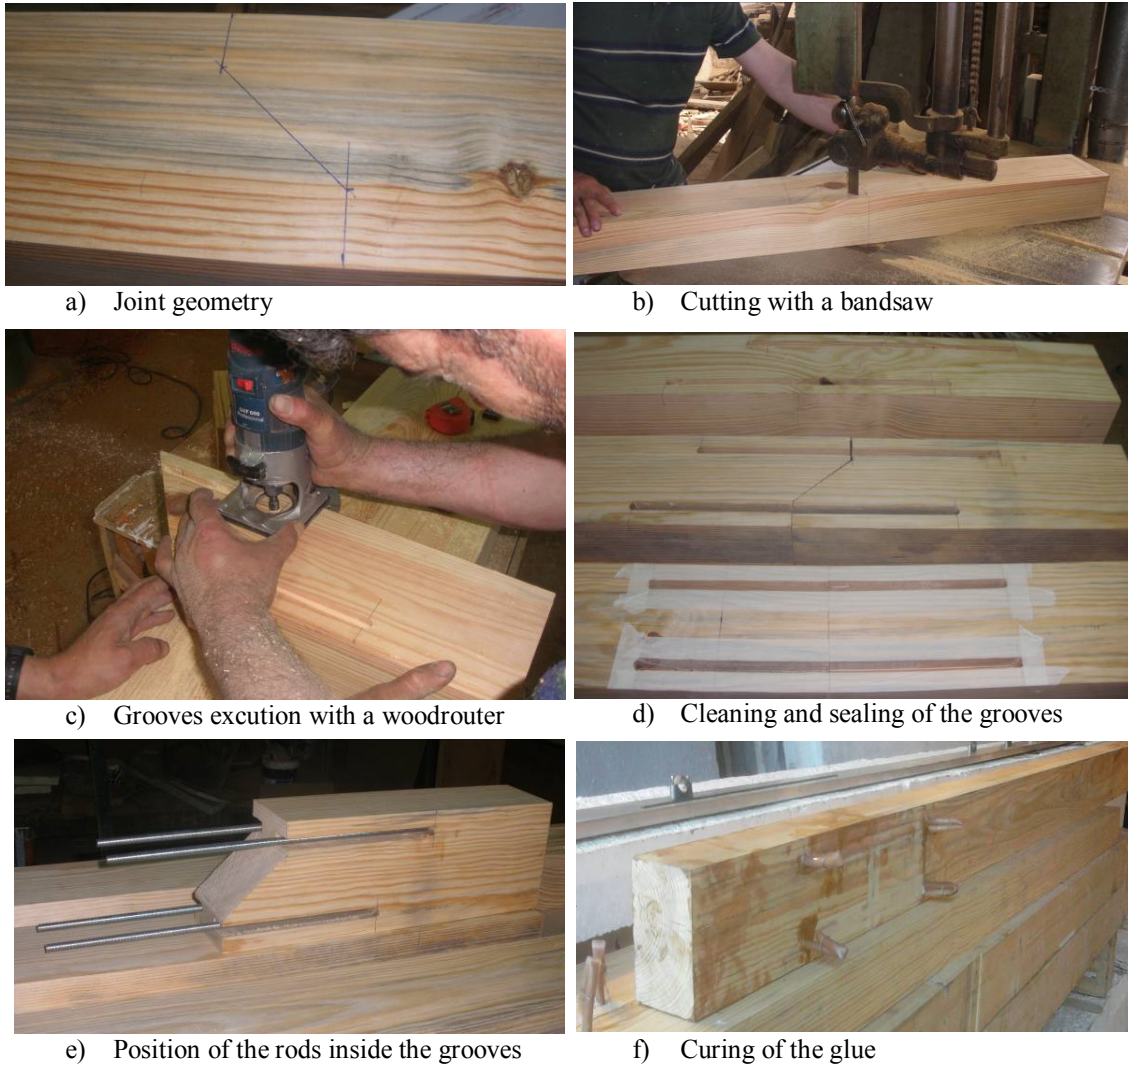
Figure 6. Main steps in the specimens repaired with timber prosthesis.

All specimens have been built by AOF – Augusto de Oliveira Ferreira & CA, Lda, in their own carpentry in Braga, applying the best practices developed more than 50 years of extensive field activity of intervention on existing timber structures. Specimens have been produced and after 10 days they have been transported to the Structural Laboratory of University of Minho in Guimarães. As example, Figure 6 shows the main steps in the production of the specimens used to evaluate the series GM.
