THE 19TH AND 20TH CENTURY INTERVENTIONS ON THE DORMITORY WING OF THE JERÓNIMOS MONASTERY IN LISBON: AN ACCOUNT WITH A FOCUS ON THE CONSTRUCTIVE ASPECTS

Vincens, Baptiste*¹, Vasconcelos, Graça**², Hughes, Moriah*, Gourd, Constantin*,
Joudeh, Safa*, Sepulveda Cruz, Saray*, Mendes, Nuno**

Keywords: Jerónimos, manueline, historical, masonry, museum

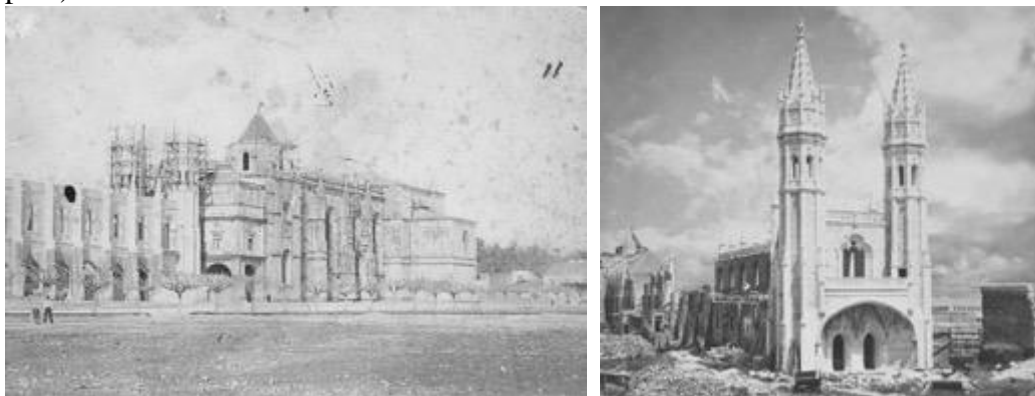
Figure 4: left: Photograph of the eastern extremity, ant. 1868, unknown author and possession; right: Photograph of the western extremity of the dormitory wing during the substitution of the first floor, Carlos Relvas, 1869, frSFP_0351im_EP_0005 © SFP.

As described by Regina Anacleto [5], Almeida was in complete control of the interventions and appointed a succession of architects at the head of the works himself. The first wave of interventions was supervised by Valentim José Correia, between 1863 and 1865, who proceeded to destroy the first floor, conserving only the gallery, to reconstruct a new one that adopts the same rhythm of buttresses and pierced with neomanuelin windows of his design. The right photograph in Figure 4 shows in the background a portion of the building where the first floor was already replaced. In the foreground, the first floor is being demolished. This new first floor is taller than the former and composed of a unique room in its width (see the left photograph of Figure 4). The addition of turrets (see Figure 4) at the extremities of the wing are attributed to J. Samuel Bennet, an English architect. Between 1867 and 1878, José Cinatti and Aquiles Rambois, italian scenographers at the San Carlos theatre who had previous experiences as architects were appointed. They completed the lateral turrets and demolished the Hall of the Kings which had the effect of separating the wing from the rest of the complex. They undertook the construction of a central tower, an eclectic composition of Manueline, gothic and oriental origins that replaced the three central spans (Figure 5). This tower was flanked by two smaller bodies at the back (letter A in the current plan in Figure 6) and another body containing the staircase was constructed at the east extremity (letter B in the plan).

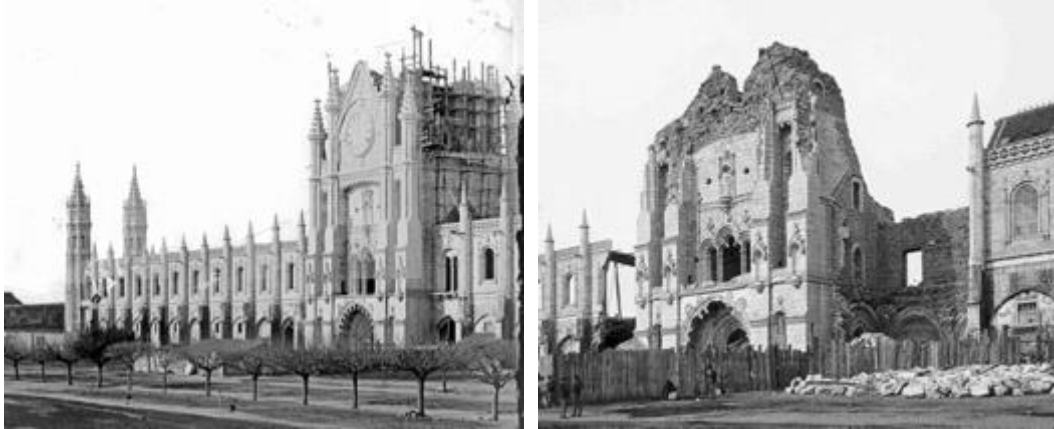
Figure 5: left: Photograph captured during the construction of the central tower, unknown author, 1877, © Arquivo Municipal de Lisboa; right: Photograph captured after the collapse of the central tower, Henrique Nunes, 1878, © Arquivo Municipal de Lisboa.

The tower collapsed mid-construction on 18 December 1878 at 9 am. Luciano Cordeiro [3] invoked as reasons that the vaults were too depressed and the masonry of poor quality. Several photographs that document the collapse exist; one is presented in Figure 5, the others in the Appendix. The spans immediately next to the tower were partially destroyed. However, the outer walls of the two smaller bodies flanking the tower at the back remained.

Figure 10 shows a comparison between the authentic structure of the gallery and the structure of the new galleries erected at the beginning of the 20th century. The constitution of the walls is revealed by the photographs of the collapse (see Figure 5 and the other photographs in the Appendix). The walls of the ground floor are constituted of a typical gothic “three-leaf” system of ashlar facing stones filled with a mixture of gravels and mortar. The photograph reveals that the walls of the collapsed tower and reconstructed first floor are made of an irregular masonry of small stones, a sort of *opus caementicium* that is concealed on the façade by a thin veneer of ashlar (probably attached by metallic clamps to the masonry) and left visible inside (the walls were initially covered with wood panelling). Close inspection of the stonework indicates that the surfaces of the new buttresses are made of ashlar masonry. This shows a certain pragmatism in the design of the structure: the buttresses are made of a good quality and heavy masonry because they need to ensure the lateral resistance of the building and produce the weight necessary to retain the vaults; the walls have little role in the carrying of the loads and therefore are made of a less noble and lighter material that however intends to emulate the authentic construction technique by the use of covering.

One photograph (left Figure 9) captured during the reconstruction of the original gallery vaults close to the central body provides information on its constitution (see also the right photograph of Figure 5). The use of multiple crossed ribs that create many key stones and the curious pointed basket-handle arches are visible in many of the Manueline constructions (including in the church of Santa Maria de Belém) [6]. Their particularity

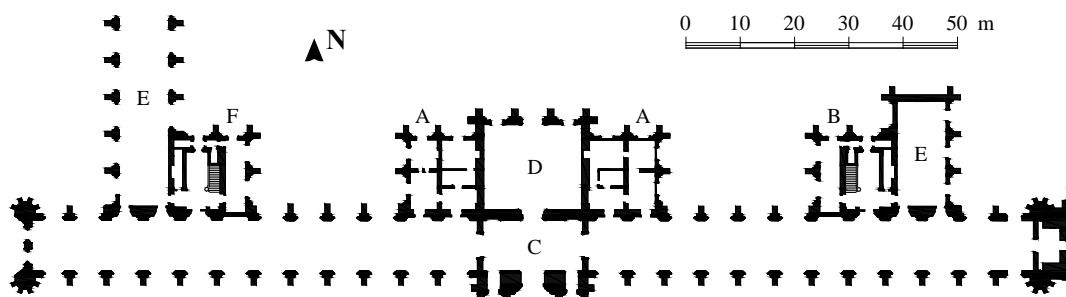
Figure 6: Current ground floor plan of the building.

Around 1903, the project was undertaken (see the completed project in the left photograph of Figure 7): a lower central body was constructed in the gap. It contains a vaulted entrance hall at the front and a large room at the back (respectively C and D in

Figure 6) with the same disposition repeated on the first floor. This body is lined with the two smaller bodies that survived the collapse that contain administrative spaces. Parente da Silva also added of two wings at the extremities of the building (E in Figure 6) that link it to another wing at the back built by Casa Pia in the mid-19th century. These wings copy the façade and disposition of internal spaces of the main building. They are respectively partially finished on the right of the aerial view of Figure 7 and unfinished on the left side. These works probably came to a stop because of a lack of funds. The construction of the new wings was temporarily abandoned and the room at the back of the central body was left unfinished to this day. The right photograph of Figure 7 shows the east wing left mid-construction.

removal of some of the ornamentation of the central body. The aborted east wing started in the 1903 works was closed with a facade (mid-construction in the left photograph of Figure 8). The prepared piers and arches of the right photograph of Figure 7 were demolished. The west wing was later completed in the 1960s and given along with the north building to the Navy Museum inaugurated in 1962 (see the right photograph of Figure 8). A staircase body mirroring the one constructed before the collapse of the tower was added in 1961 (F in the plan of Figure 6; see the left photograph of Figure 8).

The floors of the administrative spaces (A, B and F in the plan of Figure 6) are in all probability a system of metallic I-shape beams connected by thin brick vaults covered with a layer of cementitious material. Metal detection tests reveal the presence of these beams and indicate of spacing of 60 cm. Additionally, the observation of some ceilings (see photograph in Appendix) indicates the characteristic curved intrados of the brick vaults and lower flange of the metallic beams. This flooring system was a very economical alternative for the covering of medium spans in this period before the advent of reinforced concrete floors.

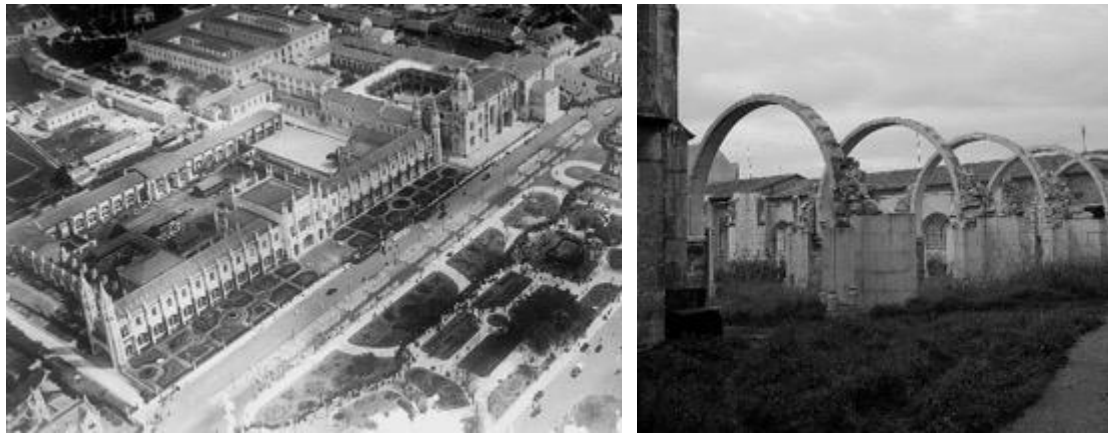
Figure 7: left: Aerial photograph of the monastery, c. 1929, Foto 00503579, © IHRU/SIPA; right: Eastern wing mid-construction, c. 1929, Foto 00504224, © IHRU/SIPA.

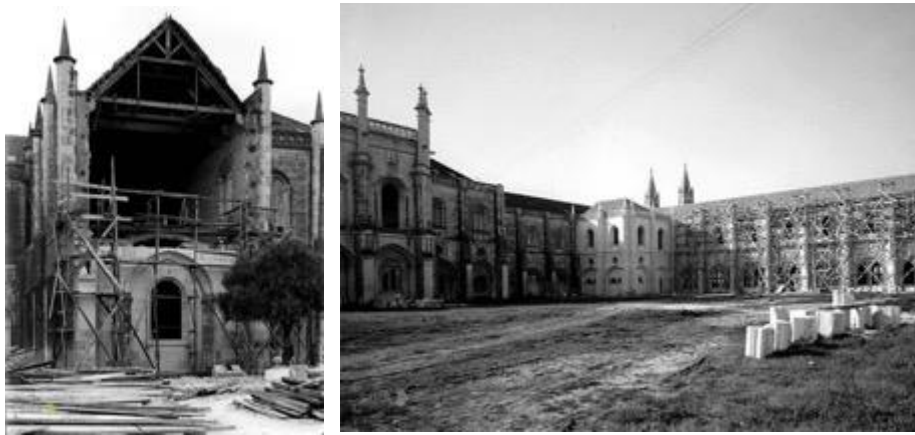
Figure 8: left: Photograph of the construction of the facade at the end of the aborted east wing, c. 1939, Foto 00503331, © IHRU/SIPA; right: West wing mid-construction and new staircase outbuilding, 1961, Foto 00503653, © IHRU/SIPA.

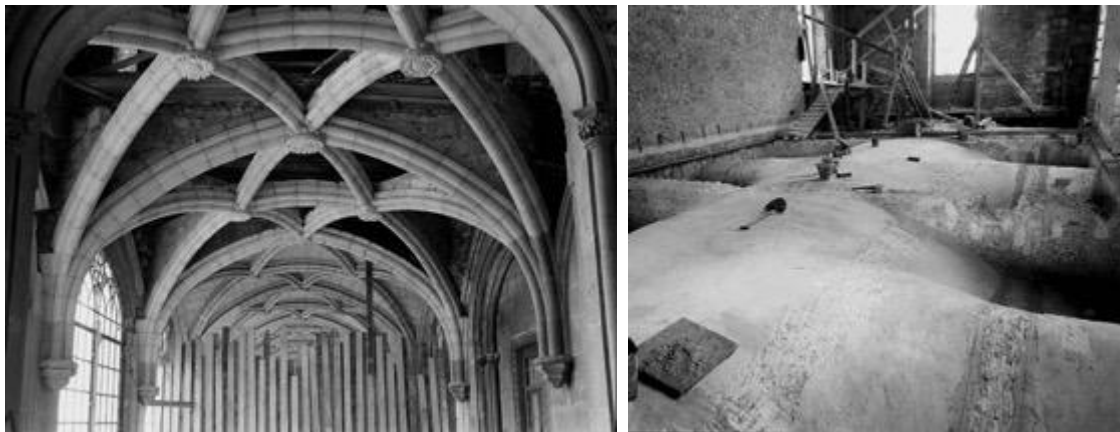
Figure 9: left: photograph of the gallery vaults under reconstruction next to the central body, c. 1939, Foto 00502933, © IHRU/SIPA; right: photograph of the extrados of the east wing vault, c. 1939, Foto 00503336, © IHRU/SIPA.

is that the triangular surfaces produced by the ribs, which are filled with the webbing, are rather small and therefore the main load-bearing role is ensured by the rib skeleton. As visible in the photograph, the ribs connected to the walls are reinforced with spandrels. This disposition is not typical in the original French gothic constructions but was observed and interpreted as a gothic anti-seismic apparatus by Pepa Cassinello in Spanish cathedrals that were built in zones of high seismicity [7]. When the ribs are loaded laterally, these spandrel walls can enter into compression by pushing against the buttresses which prevents the opening of cracks on the ribs that typically lead to the failure of a vault. As visible in Figure 10, the extrados is completely filled with earth to create a flat surface on which a timber floor was placed, later replaced by a floor of thin masonry arches as attested by photographs (see Appendix).

on the intrados. The intrados is visible in the right photograph of Figure 9 and reveals the presence of spandrels above the arches. The extrados is not filled with earth but walls are mounted directly on it, acting also as ribs to the vault, and hold the floor structure that is composed of a light system of masonry vaulting covered with a cementitious material. Here the arch is nothing else than a *doubleau* without great structural role. It is mostly a device used to mark the passage of the thrust forces to the wall and that expresses the stiffening spandrel wall placed above. Here again the pragmatism of the construction is made clear by the choice of a vault of simple geometry constructed using light materials and fitted with a floor structure that is very efficient. The construction of the walls is similar to the one used fourty years before for the reconstruction of the first floor of the main building.

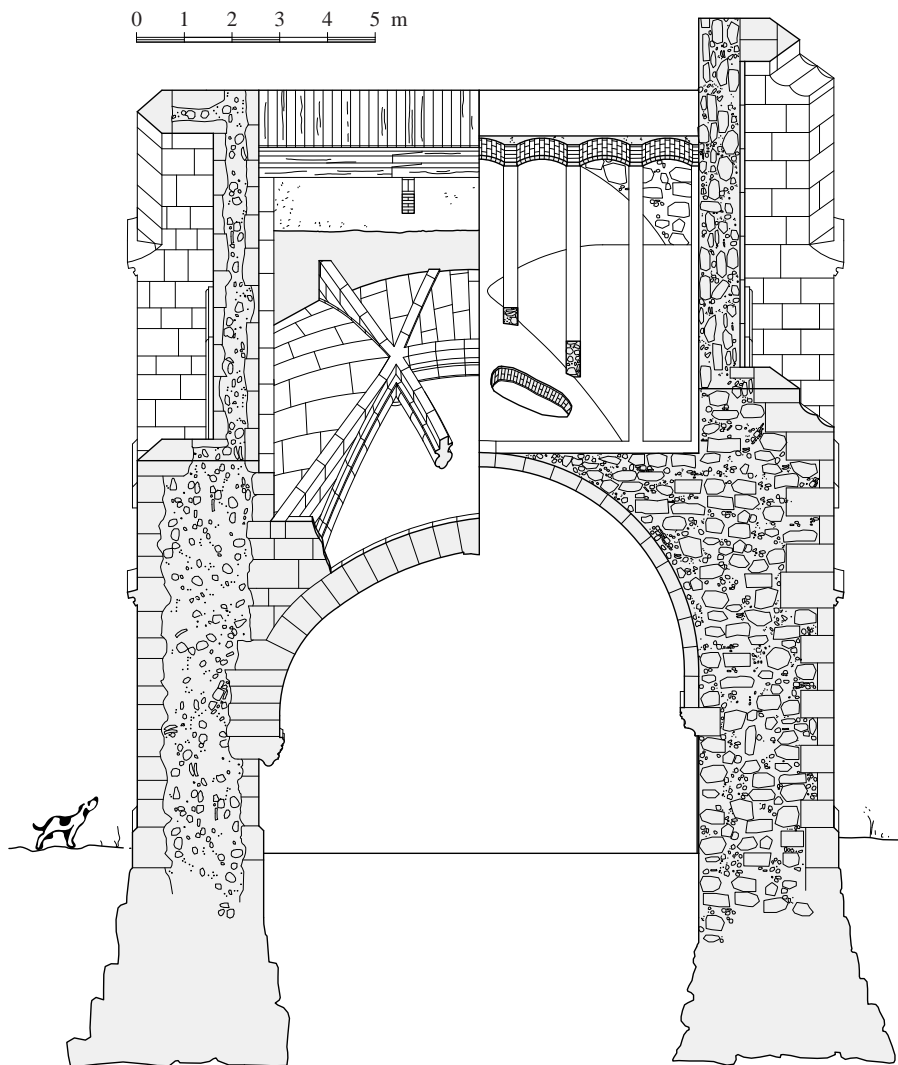
Figure 10: Constructive axonometric view of the galleries. left: 16th century; right: 20th century extension.

The new wings copy the rhythm of buttresses and façade of the original part but adopt a different vaulting system. A circular arch is positioned at each buttress and the void between two consecutive arches filled with groin vaults made of brick masonry plastered

The drawing of Figure 10 is based on the photographs shown previously and described in this section. Some additional photographs were used but their importance being inferior, they were gathered in the Appendix. The constitution of the walls is based, apart from the photographs, on a careful examination of the stone joints and completed with informations from Viollet-le-Duc's *Dictionnaire raisonné de l'architecture française du XIe au XVIe siècle* [9]. The drawing of the foundations is hypothetical.

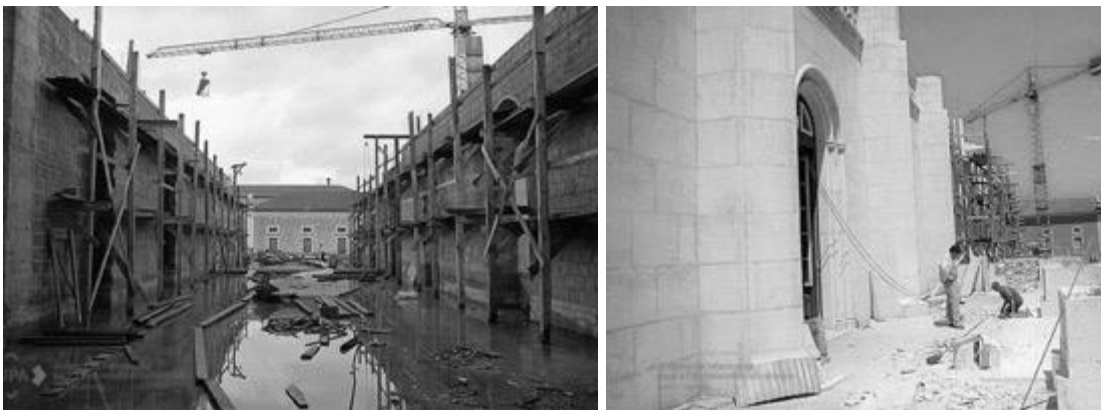
Figure 11: left: photograph of the first floor of the North wing mid-construction, c. 1984, Foto 504317, © IHRU/SIPA; right: photograph of the façade of the North wing mid-construction, c. 1984, Foto 00504325, © IHRU/SIPA.

The interventions come to an end in the 1980s, the North wing is fitted with a first floor, for use of the Marine Museum, which again emulates the rest of the constructions. This time the use of stone is abandoned to make way to brick and reinforced concrete veneered with stone (see Figure 11). This attitude of the “pastiche”, which in the case of this complex, seems to have adopted because of the political importance of the building, has already been identified as problematic in some cases by historians (see [10] for example). Here we see that it led to the sterility of the architecture. The choice of a set external envelope is made at the cost of the quality and suitability of the internal spaces. The use of contemporary and economical construction techniques that have little to do with the ones used in the 16th century conflict with the envelope and naturally engender the use of devices to create the illusion of authenticity.
