Moisture effects on the bond strength of FRP-masonry elements

Abstract

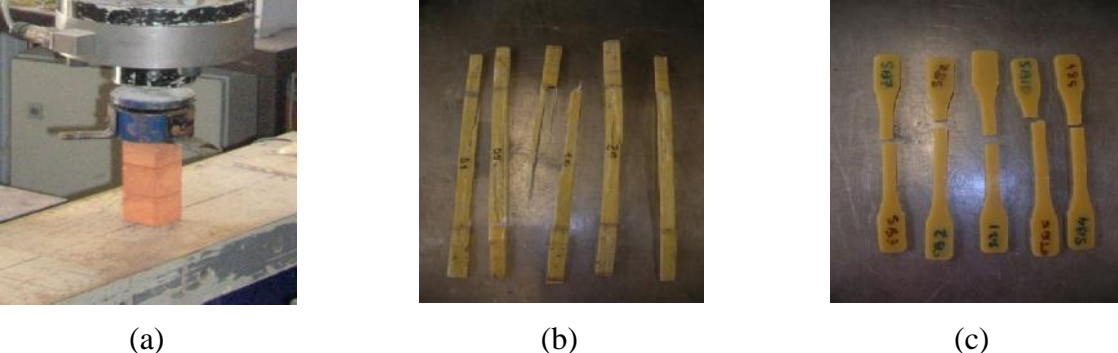
Figure 1. Material characterization tests; (a) Brick specimens; (b) GFRP coupons; (c) Epoxy resin specimens.

The mechanical properties of masonry bricks were obtained according to the test standards UNI EN 771-1[11] and UNI EN 8942-3[12] in terms of compressive strength, f_{cb} , tensile strength, f_{tb} , and elastic modulus, E_b .

Regarding the composite materials, the mechanical properties of GFRP coupons were obtained according to ISO 527-1[13] in terms of tensile strength, f_{tf} , and elastic modulus, E_f .

Mechanical and thermal properties of the epoxy resin were investigated on samples previously cured for 15 days at room temperature. The basic tensile properties were obtained following the standard tensile tests, ISO 527-1[13]. The glass transition temperature (T_g) of the epoxy resin was obtained by means of the DSC (Differential Scanning Calorimetry) method. The epoxy samples were cured at room temperature 15 days before performing the tests. The thermal scans were carried out between 5°C and 200°C with a heating rate of 10°C/min. The T_g was calculated as the mean value of four tests.

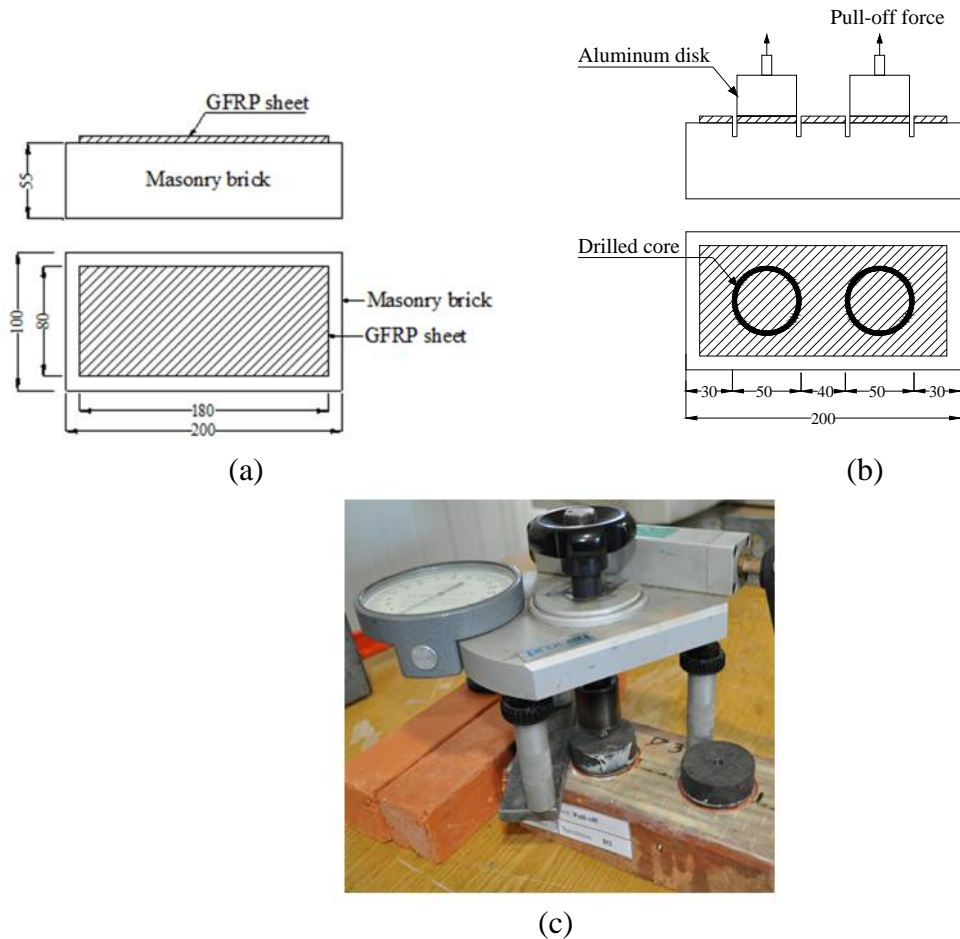
Figure 2. (a) Test specimen; (b) schematic of the pull-off test; (c) test setup.

The pull-off tests were performed based on a partial coring technique. In this method the tensile load is applied to the partial core through an aluminum disk bonded to the overlay with

a structural adhesive, see Figure 2. A loading device with a reaction frame applies the tensile force at a constant rate to the aluminum disk.

In this study, 50 mm cores with an approximate depth of 10 mm were drilled on the brick surfaces by means of a rotary core cutting drill with diamond bits. To avoid damage in the bricks, special care has been devoted to ensure uniform pressure when the core is being drilled. Afterwards, the aluminum disks were glued on the core surfaces by means of a structural adhesive.

The loading were applied with a DYNA Z15 instrument at a rate of $0.05 \pm 0.01 \text{ N/mm}^2\text{S}^{-1}$. This equipment has a capacity of 16 KN and an accuracy of 2%.

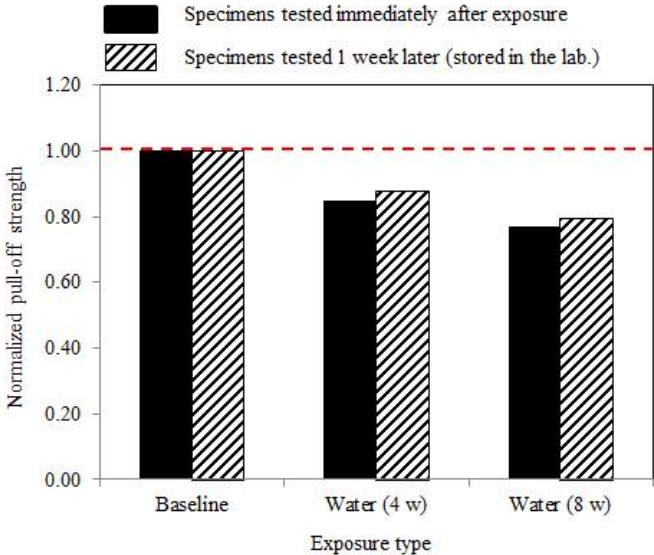
Figure 3. Average pull-off bond strength of specimens exposed to different moisture conditions.

Average bond strengths obtained from 10 pull-off tests for each conditioning type are normalized by the baseline specimens in Figure 3. It can be seen that a relatively large reduction is found in the bond strength after four and eight weeks. On the other hand, the bond strength was not recovered significantly after one week laboratory storage, which can be due to the irreversibility of the observed degradation in the bond strength.

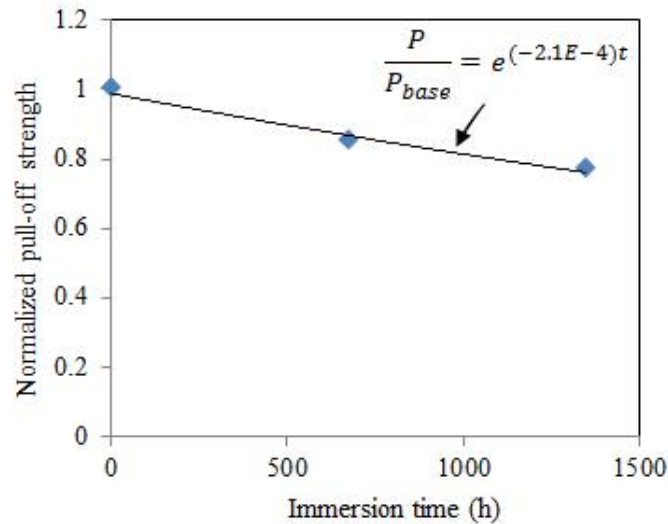
Figure 4. Bond strength decay with water immersion time.

As it can be observed in Figure 4, the reduction in the bond strength during the investigated period can be expressed with a linear formula. However, since the reduction rate has been reduced with time increment using an exponential decay curve with respect to the immersion time seems more reasonable, Eq. (1). Although, performing experimental tests with longer immersion times is necessary for a better understanding of the decay trend.

$$\frac{P}{P_{base}} = e^{-(2.1E-4)t} \tag{1}$$

where P is the bond strength after t hours of immersion in water and P_{base} is the baseline bond strength.

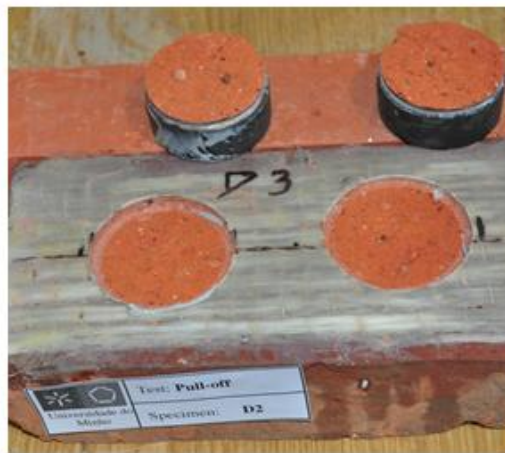
Figure 5. Typical failure mode in the specimens.

A typical failure mode of fracture in the upper layer of the bricks was observed in all the dry specimens, see Figure 5. However, the failure was mainly observed in primer-brick interface in the moisture conditioned specimens.
