Application of Braided Fibre Reinforced Composite Rods in Concrete Reinforcement

Abstract. This paper describes the work that is being done at the University of Minho concerning the development of braided rods for concrete reinforcement. A preliminary research study has been conducted to understand the mechanical behaviour of braided fabrics. Various samples have been produced varying the type of fiber (glass, polyester and aramid), the type of braided fabric (simple, hybrid and core reinforced) and in the latter case, the number of core reinforcing yarns. The tensile properties of these samples have been evaluated and the results presented. The influence of each factor on the tensile properties of braided fabrics has also been analysed and discussed. In order to produce braided reinforced composite rods to use as a concrete reinforcement, a special technique has been developed using a standard vertical braiding machine. The braided reinforced composite materials have been produced in rib structure to improve adhesion between them and the concrete. Special samples have been prepared and tested to evaluate the adherence between both materials involved. The tensile and bending prope

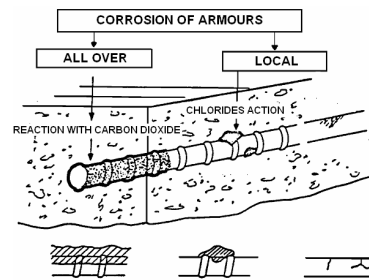
Figure 1 – Corrosion of steel armours

In building construction, concrete structures are subjected to repeated loading and to aggressive agents which may lead to poor mechanical performance of the structures with time. One of the most serious problems affecting concrete is corrosion of the steel armours. As shown in Fig.1 this corrosion may occur due to its reaction with carbon dioxide or to the action of chlorides. In the first case, the reaction with the carbon dioxide existing in the atmosphere leads to a gradual decrease in concrete alkalinity. When the concrete covering the armours loses its alkalinity, the oxide layer protecting the steel may be destroyed, thus leading to the development of the “stack effect”, i. e., the formation of electric currents which are responsible for the corrosion of the steel. The action of chlorides resulting from deteriorated construction materials or from their migration to the interior of the structure, increases significantly the potential for steel corrosion. This fact is particularly hazardous in marine or polluted environments [1].

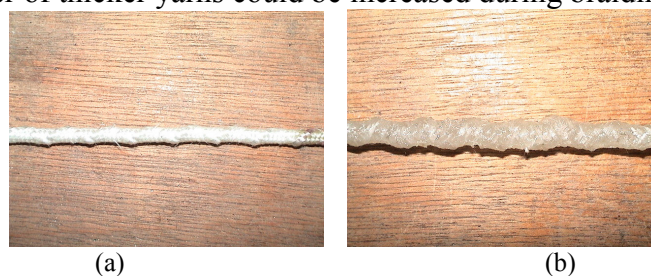
(a) braided fabric (b) braided reinforced composite rod

Figure 2 – Rib structure

Production. The samples have been produced on a conventional braiding machine specially adapted to impregnate simultaneously the braided fabrics. In order to increase roughness of the braided reinforced composite material rods, and then its adhesion to the concrete, braided fabrics have been produced as a rib structure, as shown in Figure 2. This rib structure is provided by thicker yarns that are used in the braiding machine in a rate of 7 normal to 1 thicker. For a stronger effect on roughness the number of thicker yarns could be increased during braiding process.

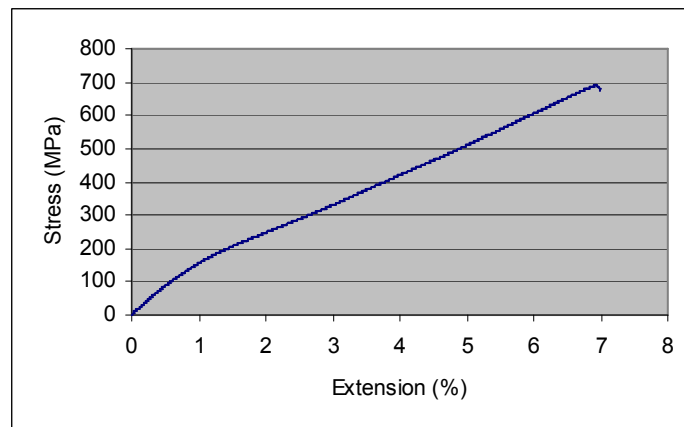
Figure 3 – Typical stress-strain curve for braided reinforced composite rods

Mechanical Properties. The evaluation of tensile properties of the braided reinforced composite rods previously produced, experimental work has been undertaken using a HOUNSFIELD universal tensile tester, according to the ASTM D638 standard, at a speed of 1 mm/min. The results obtained are shown in Table 2 while Figure 3 shows the typical load-extension curve.

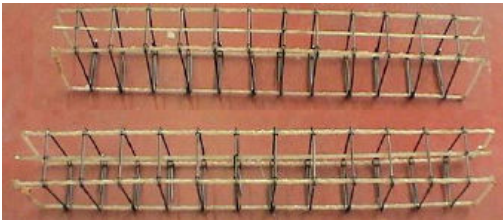
Figure 4 - Armour of braided composite rods

Samples Preparation. Three concrete beams reinforced by an armour of braided composite rods (Figure 4) have been prepared, jointly with three concrete beams reinforced by steel. The dimensions of the beams are presented in Figure 5.

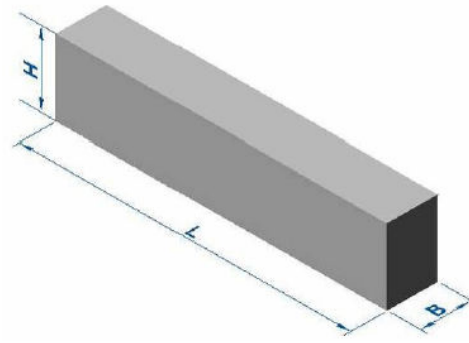
Figure 5 - Beam dimensions
(B=10 cm H=15 cm L=65 cm)

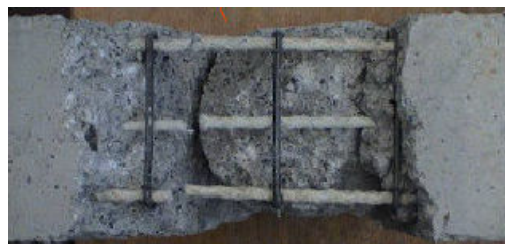
Figure 7 – Beam produced with braided reinforced composite rods after testing

Figure 7 presents a beam after testing, where are visible the braided reinforced composite rods broken.

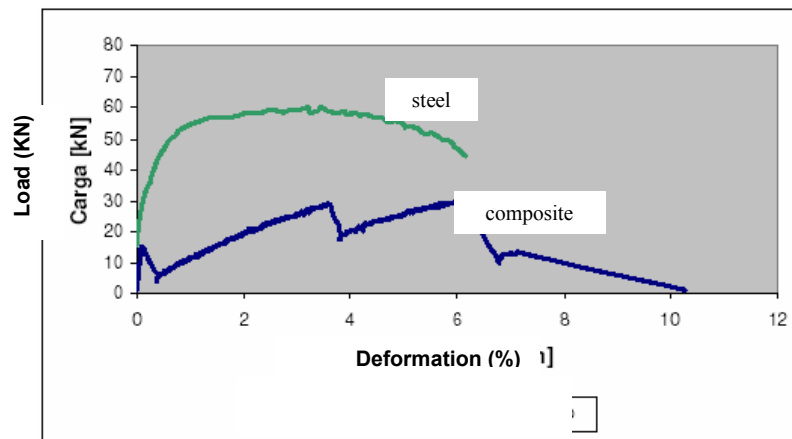
Figure 8 – Load-extension curve for concrete beams reinforced by braided fibre reinforced composite rods

Figure 8 presents the load-extension curves for each type of beam tested.

Analysing the results obtained and the correspondent load-extension curves it is possible to detect different performances between both types of beams tested. The steel reinforced beams are bearing the double of the load supported by the composite reinforced ones. Moreover, the extension values of the steel reinforced beams are lower than those obtained for the composite reinforced ones. In the load-extension curves obtained for the composite reinforced beams, several peaks are visible corresponding to the breakage of each braided composite rod used in the armour. These peaks are showing that the material (concrete+composite) is not working as a whole material. Besides, analysing the first peak, it is possible to conclude that the composite rod is not taking the load immediately after the concrete reinforcement. This behaviour could be explained by the non-uniform tension of the composite rods in the concrete and by their lower modulus when compared with the steel rods used.
