THE COMBINATION OF GEOMATIC APPROACHES AND OPERATIONAL
MODAL ANALYSIS TO IMPROVE CALIBRATION OF FINITE ELEMENT
MODELS: A CASE OF STUDY IN SAINT TORCATO CHURCH (GUIMARÃES,
PORTUGAL).

This case study seeks to validate said methodologies, using as an example the case of Saint Torcato Church, located in Guimarães, Portugal.

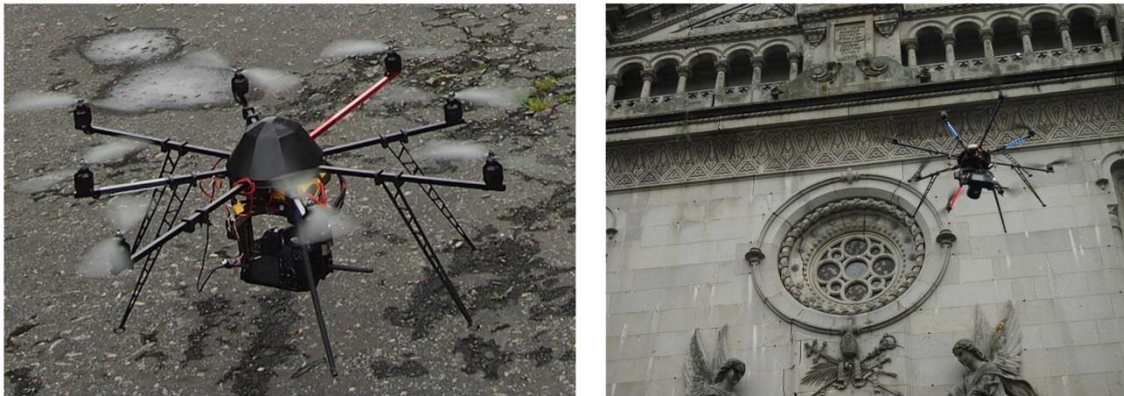
Fig.1. Image of the UAV platform and the digital camera (Left). Image taken during the data collection of the point cloud SfM (Right).

The chosen photogrammetric platform was designed by Roca et al [16]. It is made of aluminum and carbon fiber, and comprises a total of eight MK-3638 SLOWFLY APC propeller motors controlled by a central 12x3.8 Brushless Control V2.0 that can manage separately the rotational speed of each of the motors. All of this provides the system with great stability and robustness against failure in flight.

In addition to this platform, a low-cost sensor, a Canon EOS 450D digital camera that had been previously geometrically calibrated (Table 2), and a Canon EF 20mm wide-angle lens were assembled. The wide-angle lens is meant to minimize the amount of images taken.

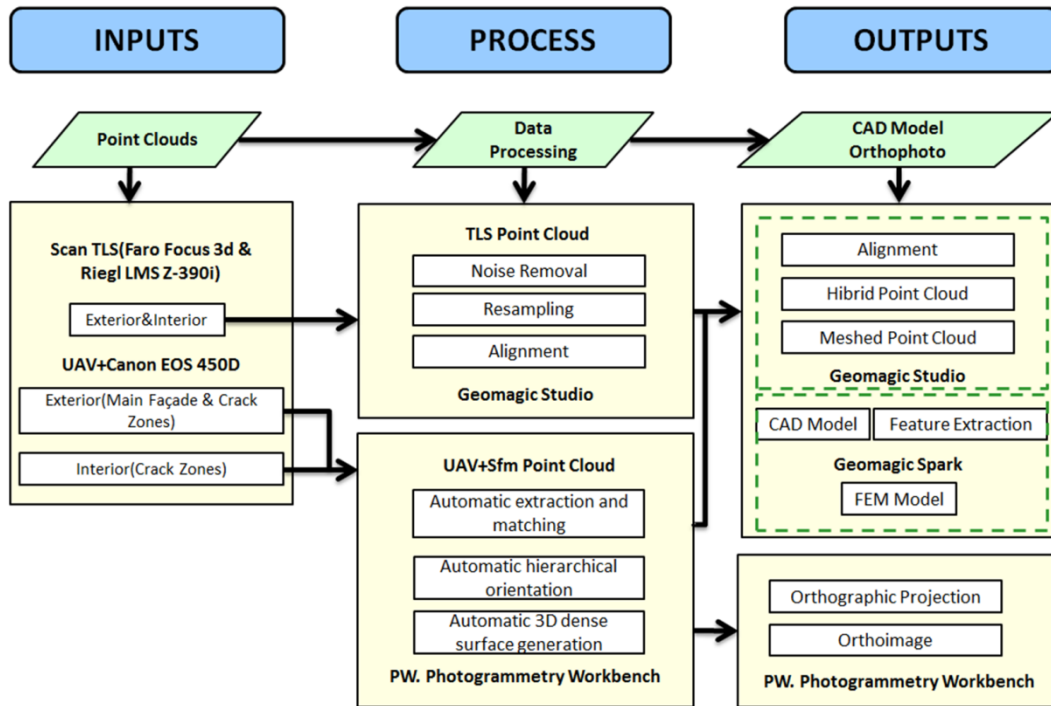
Fig. 2 Workflow for the proposed methodology.

This methodology requires a multi-phase post-processing that involves three main steps: (i) Data fusion at the same coordinate system through registration algorithms; (ii) Point cloud resampling and (iii) Point cloud simplification (removing certain architectural details without relevance) and parameterization for CAD model conversion.

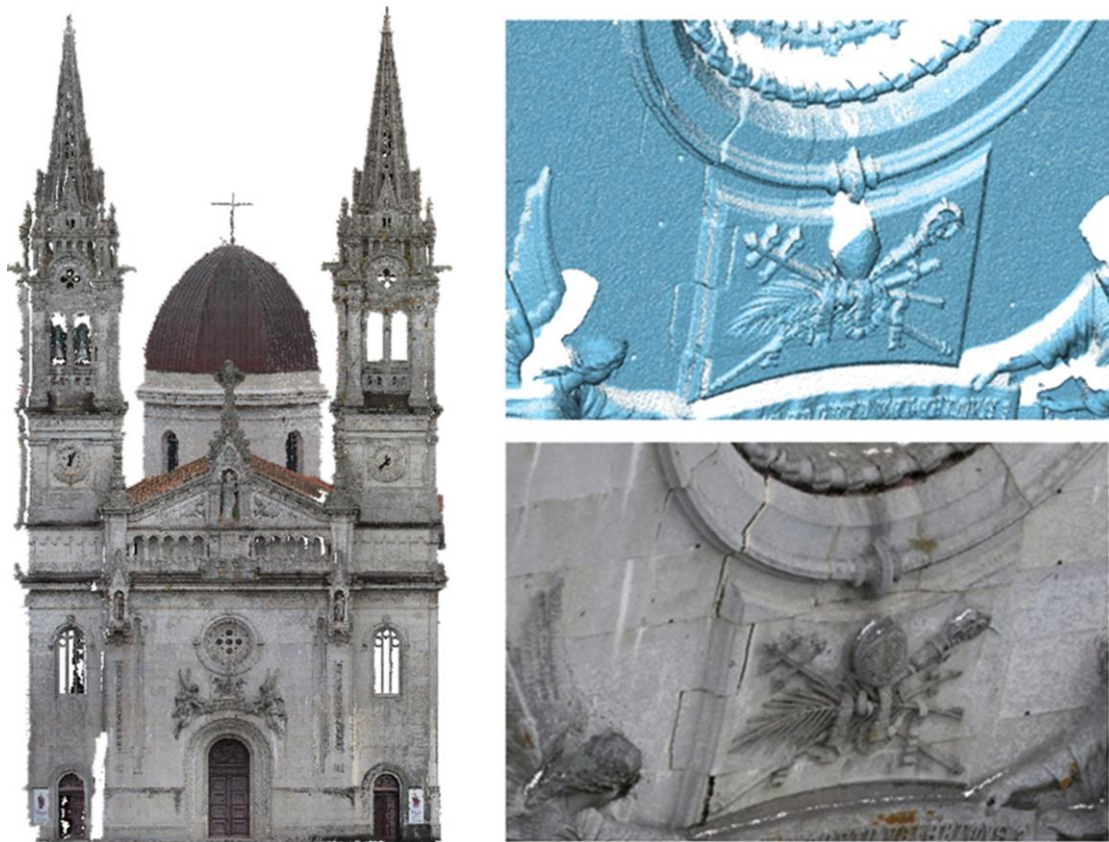
Fig. 7. Front elevation of the point cloud obtained through SfM technique and PW software (Left). Detailed comparison between the laser scanner point cloud and the one obtained in PW software (Right).

models. These models profit from the features obtained from the hybrid point-cloud, such as cracks (Fig. 7).

This model, generated through the describend technique, is comprised of a total of 398 photographs taken by UAV platform: (i) 273 photos of the main façade dividen in 3 vertical strips (1 for each tower and one for the main façade) and (ii) 125 photos of the cracks on chapels, also divided in 3 vertical strips. Alongside these photographs, 117 aditional shots were taken without UAV platform (terrestrial photogrammetry): (i) 85 photos of the arches of the chapels of the main nave and (ii) 32 photos at the level of the Church choir.
