GUIDELINES FOR THE ON-SITE ASSESSMENT OF HISTORIC TIMBER STRUCTURES

Short title: **Guidelines for the assessment of timber structures**

This paper provides information on the criteria to be used in the assessment of load bearing timber structures in heritage buildings. It covers the preliminary assessment (desk survey, preliminary visual survey, measured survey, structural analysis and preliminary report), as well as the detailed survey of timbers (with a special emphasis on visual strength grading on site) and carpentry joints. The subsequent diagnostic report and the detailed design of repairs are outside its scope.

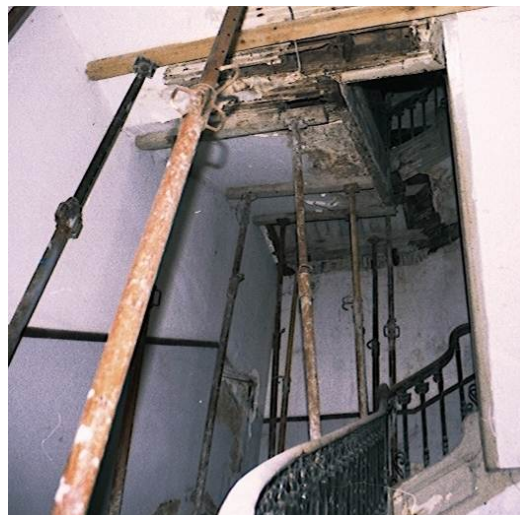
Figure 2 - Need for propping

A preliminary visual inspection is required to identify any obvious damage and susceptible zones of the structure, to determine the assessment strategy, and to identify the possible need for any immediate propping or stabilizing measures, and/or restriction of access (Figure 2). This work should be done by a specialist who understands timber structures.

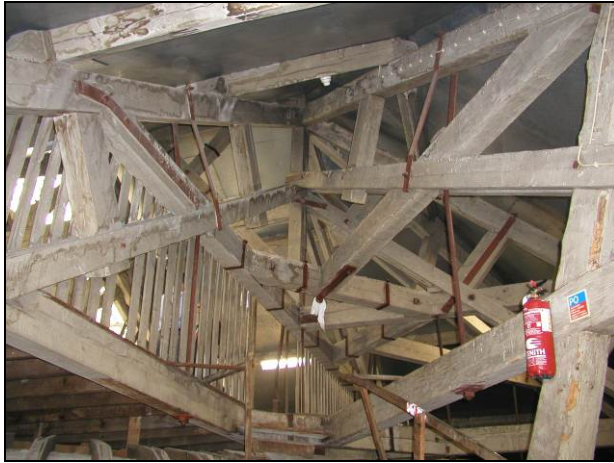
Figure 5 - Spatial structure of high complexity

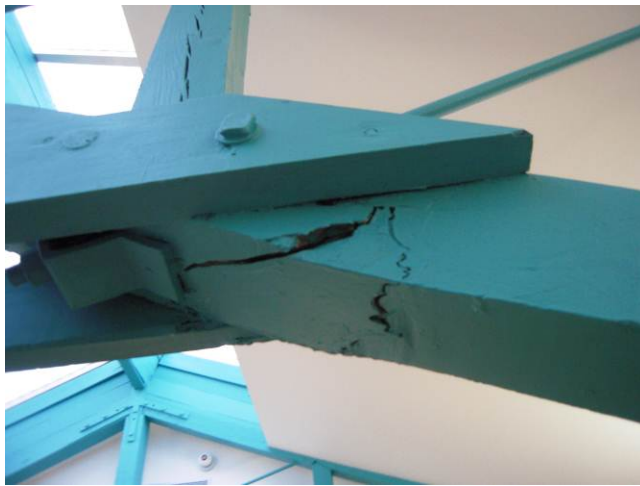
Figure 6 - Timber failure in the vicinity of the joint

any areas of mechanical damage or structural distress in the timbers, such as timber cracks (due to overloading), structural failure of members and joints or excessive deflections (Figure 6);

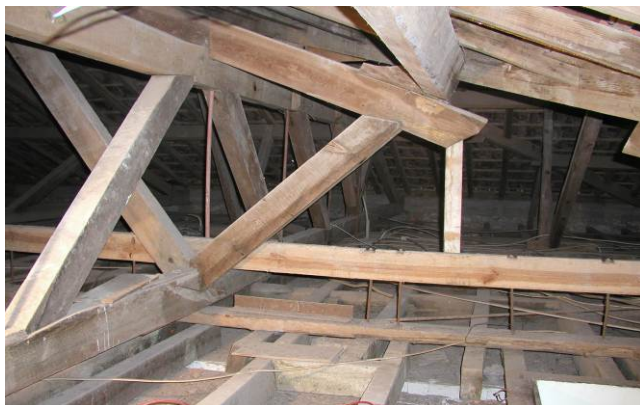
Figure 7 - Missing part of the structure due to previous interventions

a note of any indications of changes made to the structure during its life (Figure 7). These might have been made to accommodate changes in the plan or external form of the building or previous repairs. These often result in changes to the load paths and, consequently, in changed loading at members and connections. When known, these changes must be reported;

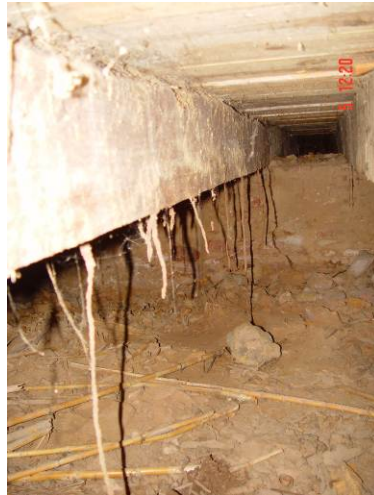
Figure 9 - Subterranean termites attack

One shall recognize, specify and characterize biological damage (Figures 9 and 10).

In the case of subterranean termites, the timbers may exhibit no external signs of attack, even if the element may have important internal degradation. The volume of destructed material must be carefully estimated (e.g. by drilling or other non-destructive methods) in order to judge the corresponding strength loss and needed intervention.

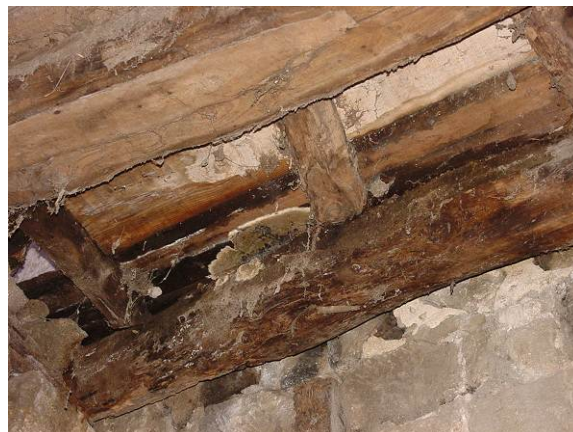
Figure 10 - Fungal attack

In the presence of fungal attack, the estimation of an effective cross section, which may vary along the length of the element, is normally difficult. Non-destructive techniques (e.g drilling methods) may be used to help establish the mass loss or density loss caused by fungal attack and the effective reduction of timber mechanical properties. The method used must be recorded.

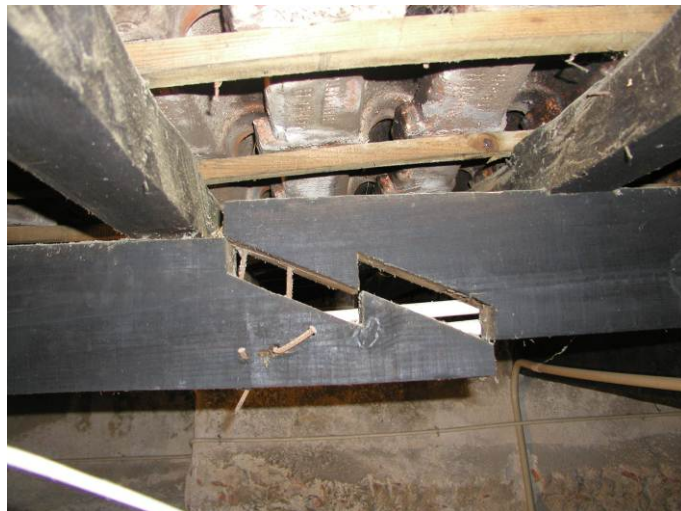
Figure 12 - Lack of contact and failure of the joint

- corrosion of metal fasteners, straps and plates
- shrinkage of timbers and associated fissures
- biological attack
- fire attack
- intentional modifications (human interventions)
- failures, movements (Figure 12), deformations as a result of excessive loading
- crushing of timbers
- buckling of metal fasteners
