OUT-OF-PLANE BEHAVIOR OF MASONRY INFILL WALLS

Keywords: Masonry, Infill, Out-of-Plane, Airbag

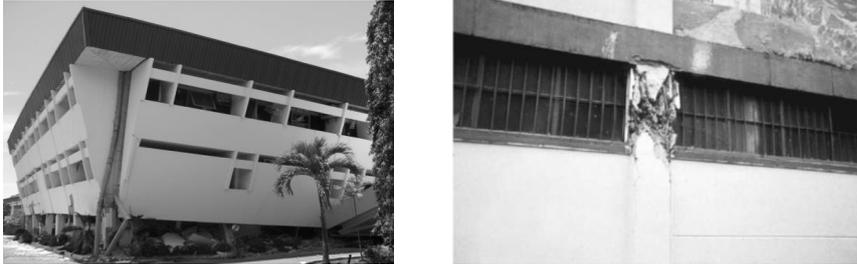
Figure 1 Negative effects of infill within structure; soft storey mechanism, (Kusumastuti 2010)(left), short column mechanism (Guevara and García)(right)

the structure or when the masonry infills leave a short portion of the column clear, leading to the shear collapse of the columns, see Figure 1.

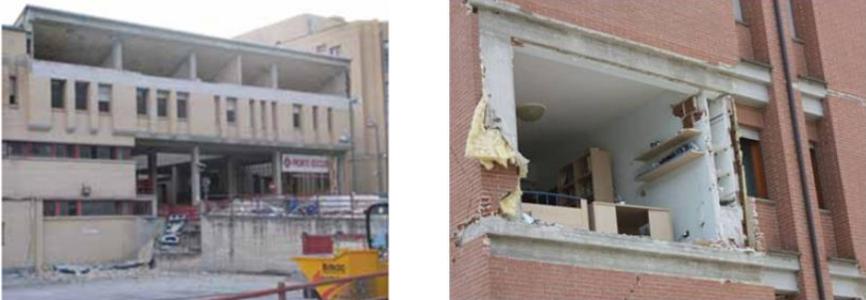
Figure 2 Damage in non-structural elements (Braga, Manfredi et al. 2011)

Out-of-plane collapse of masonry infills within concrete frames has been observed in most of the earthquakes. Although the infill panels are assumed as non-structural elements, their damage or collapse is not desirable, given the consequences in terms of human life losses and repair or reconstruction costs. In addition, this type of damage can limit the immediate occupancy after the earthquake event. The earthquakes such as Mexico City earthquake on 19th of September 1985 (Miranda and Bertero 1989), Bhuj earthquake on 26th of January 2001 (Jain, Lettis et al. 2002) and L’Aquila earthquake on 6th April 2009 (Braga, Manfredi et al. 2011), highlights the damages developed in the infill walls in relation to the minor cracks observed in the structure. In these cases, it was observed that no immediate occupancy was possible due to the generalized damage in the masonry infills. As it is observed in the Figure 2 the ground motion was not strong enough to cause structural damage but due to improper anchorage and interaction of the infill walls and surrounding frame, the exterior walls tore away and the concrete beam and columns were exposed.

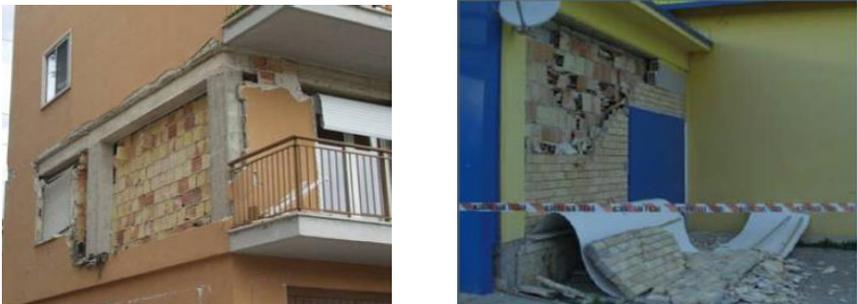
Figure 3 Detachment of the leaves in multi leaf walls (Braga, Manfredi et al. 2011)

Out-of-plane failure of the infills can be observed in dividing walls and also in multi-leaf walls when there is no proper transversal connection between the leaves as it is shown in Figure 3.
