XVIII International Colloquium on Mechanical Fatigue of Metals (ICMFM XVIII)

Design S-N curves for old Portuguese and French riveted bridges connection based on statistical analyses

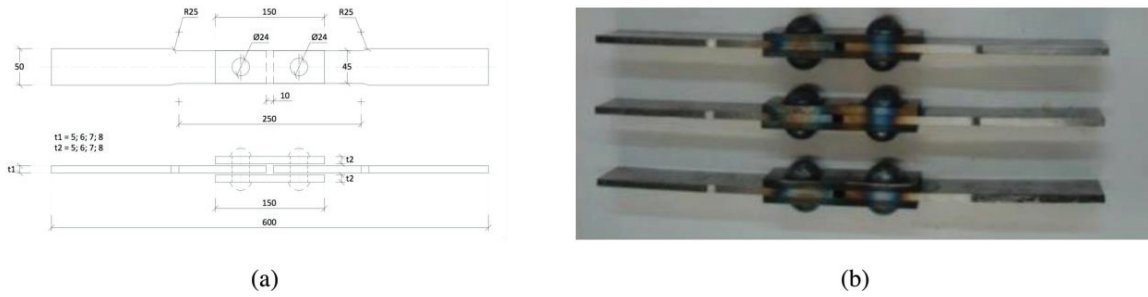
Fig. 4. Riveted specimens fabricated from puddled iron pieces from the Fão Bridge (Portugal) [10-13]; (a) layout of the specimens; (b) some examples of the fabricated specimens (plate surfaces were machined and holes drilled).

In order to compare riveted assemblies in similar loading configuration (double shear in our case), the following geometrical configurations were studied: single riveted double lap joints (see figure 3, also characterized under monotonic loads in [18], single riveted double butt joints (see figure 4) and double riveted double butt joints (see figure 5).

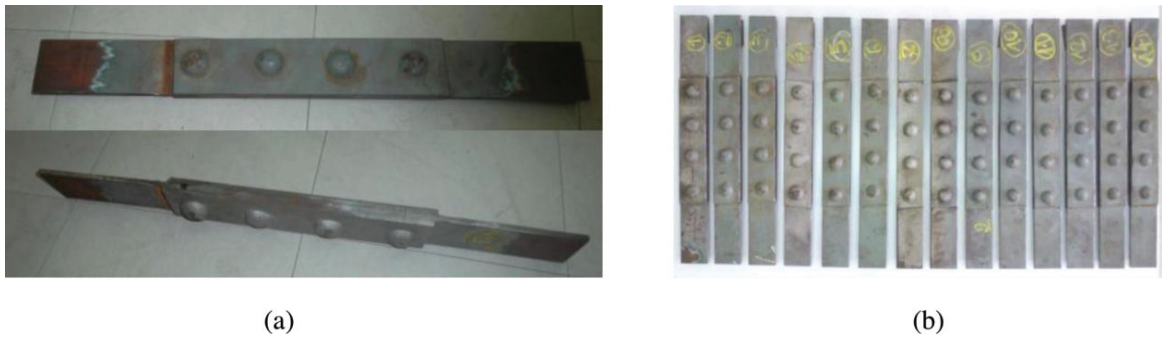
Fig. 5. Riveted specimens from the Eiffel Bridge (Portugal) (original joints sliced from girders web) [10-13].

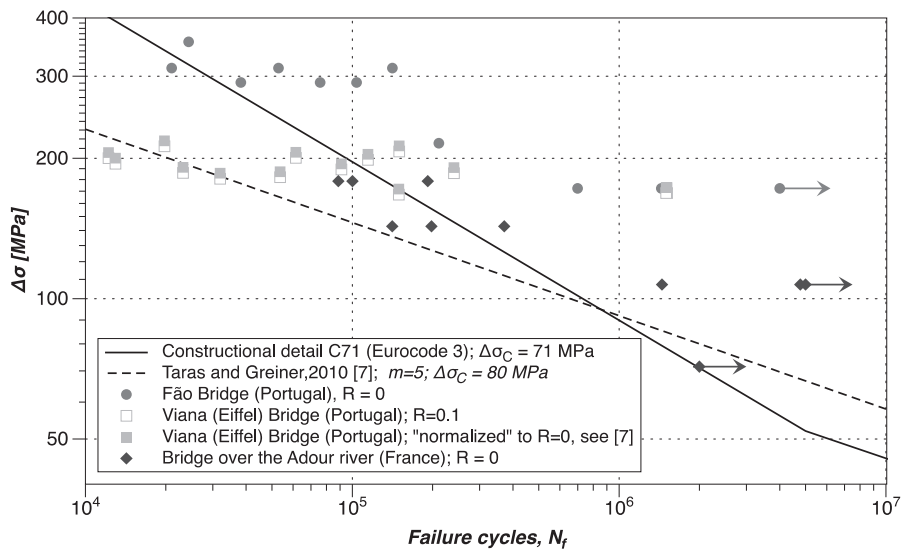
The following figure shows the data obtained from classical fatigue testing for the assemblies shown in the previous section.

Fig. 6. Fatigue tests performed for double shear specimens fabricated from Portuguese and French ancient metallic bridges.

Several conclusions can be proposed from the figure 6:

- C71 constructional detail does not represent a conservative lower boundary for range stresses over 150 MPa.
- The fatigue curve proposed by Taras and Greiner ($\Delta\sigma_c=80$ MPa, $m=5$) seems to be more suitable, however it still under-estimates high cycle fatigue resistance.
- There is no unique fatigue behavior for the tested specimens.
- The re-manufactured specimens showed less scatter behavior than the original riveted assemblies. However, stress ranges are significantly different.

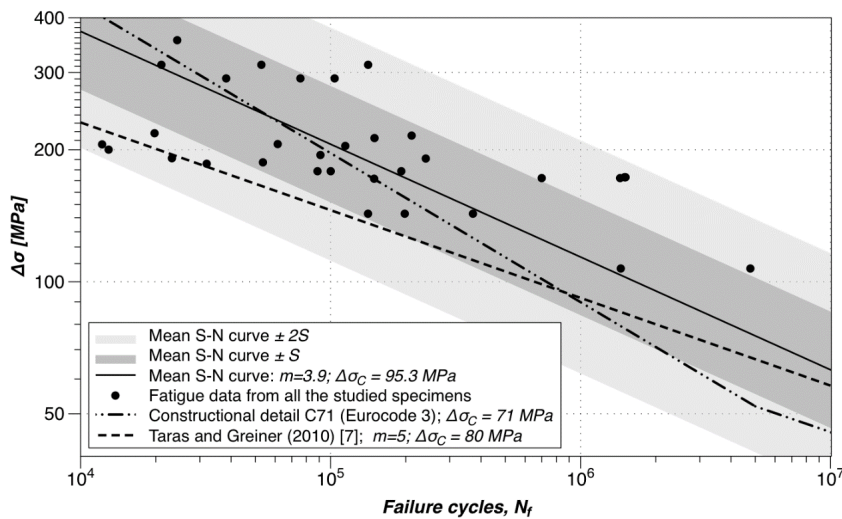
Figure 7 shows the mean S-N curve and the rectilinear confidence bands for fatigue tests performed for double shear specimens from Portuguese and French bridges. Based on statistical analysis, a design S-N (mean S-N curve $\pm 2S$) is obtained ($m = 3.9$ and $\Delta\sigma_c = 51.7 \text{ MPa}$). In comparison with Taras and Greiner proposal [7], $\Delta\sigma_c$ value is somewhat higher while the parameter m (linked to the slope of the curve) is lower.

Fig. 7. Statistical analysis for fatigue tests performed for double shear riveted specimens from Portuguese and French bridges.

Through a statistical analysis performed on the combined group of experimental tests (all of them double shear riveted specimens), a mean fatigue curve defined by $m = 3.9$ and $\Delta\sigma_c = 95.3 \text{ MPa}$ was obtained. Confidence bands of $\pm S$ (68%) and $\pm 2S$ (95%) were also calculated. For the 95% confidence band, the lower boundary is given by a fatigue curve defined by $m = 3.9$ and $\Delta\sigma_c = 51.7 \text{ MPa}$. The upper limit is given by $\Delta\sigma_c = 175.6 \text{ MPa}$.
