Concrete Reinforced by Braided Fibre Composite Rods

Abstract — This paper describes the work that is being done at the University of Minho concerning the development of braided rods for concrete reinforcement.

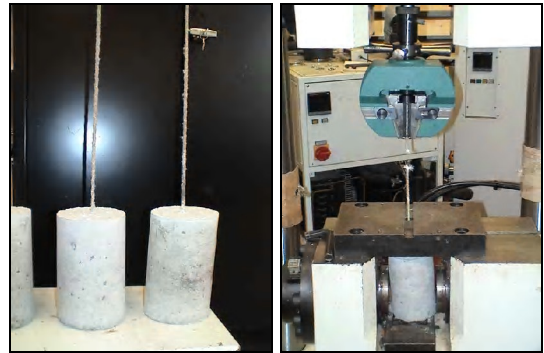
In order to evaluate the adherence between the braided composite rods and the concrete, 8 samples have been prepared, as shown in Figure 4. The samples have been tested (Figure 5) on a universal tensile tester, at a cross-head speed of 0.1 mm/s, according to standard NP EN 10002-1 usually used for steel. The braided composite rods have completely adhered to the concrete up to the breaking point

Fig. 4. Samples for adherence test
