On the Analysis of Masonry Structures without box behavior

Paulo B. Lourenço, Nuno Mendes, Luís F. Ramos, Daniel V. Oliveira

Short Title: Analysis of Masonry structures without box behavior

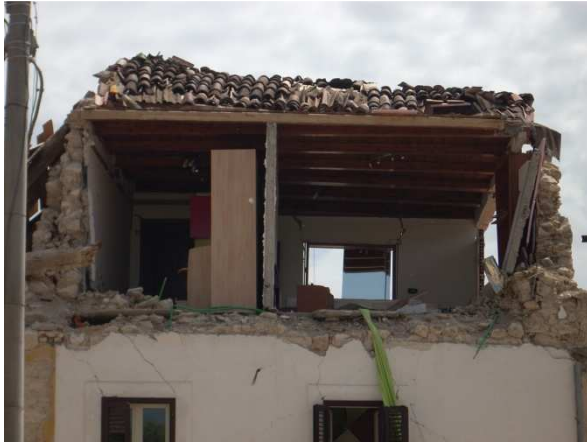
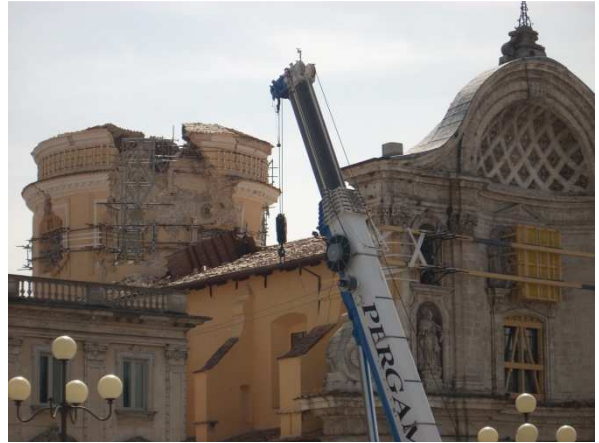
Figure 1: Examples of the URM buildings damage, Italy 2009: (a) residential building in Onna; (b) collapse of the dome of St. Massimo in L'Aquila.

This communication presents three cases studies of unreinforced masonry structures (S. Torcato church, Qutb Minar and “Gaioleiros” buildings). These structures have very different characteristics, namely in terms of mass and stiffness distribution. However, they present a common aspect of the historical buildings. In general, the historical buildings not present stiff floors able to provide diaphragmatic action, the so-called “box behavior”. This type of structures have shown poor performance in many past earthquakes, see Figure 1.

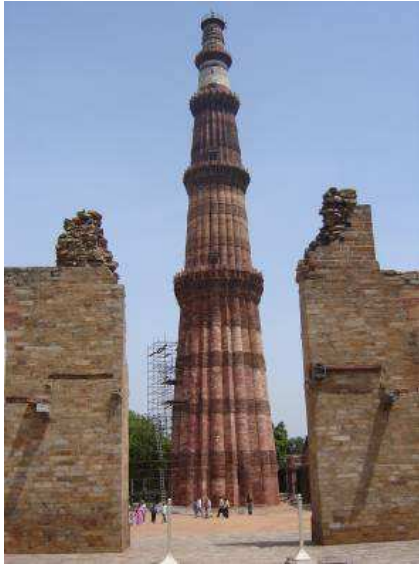
Figure 4: Qutb Minar: (a) general view; (b) dimensions (in meters).

The Qutb Minar (Figure 4a) is the highest monument of India and one of the tallest stone masonry towers in the world, dating from the 13th century. The cross-section is circular/polilobed, being the base diameter equal to 14.07 m and tapering off to 3.13 m at the top, over a height of 72.45 m (Figure 5b). The tower is composed by an external shell corresponding to a three leaf masonry wall and a cylindrical central core (Chandran, 2005). The core and the external shell of the tower are connected by a helicoidal staircase and by 27 “bracings” stone lintels. The staircase is spiral, disposed around the central masonry shaft, and it is made of Delhi quartzite stone. Each storey has a balcony and the uppermost storey finishes with a platform.

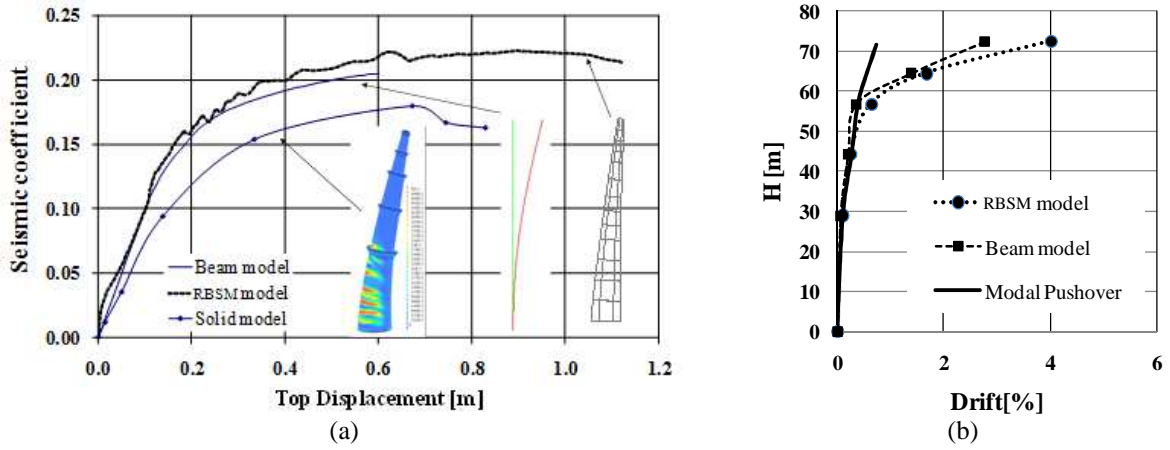
Figure 6: Results of the pushover analyses: (a) capacity curves of the pushover analyses proportional to the mass; (b) comparison between the drifts obtained through modal pushover analysis and trough dynamic analyses of the Beam and RBSM Models.

Pushover analyses were carried out considering a uniform acceleration distribution. The load was applied with increasing acceleration in the horizontal direction and a control point at the top of the tower was considered. Figure 6a shows the capacity curves (lateral displacement – seismic coefficient at the base level). Similar behavior was found with the different models. It can be observed that the average seismic factor is 0.20 and the minaret collapses by overturning at the base.

In order to study the influence of the distribution of the lateral load in the pushover analysis, additional non-linear static analyses were performed. Four different configurations of lateral loads were considered: (a) linear distribution of the displacement along the height; (b) loads proportional to the first modal shape; (c) adaptive pushover analysis, changing the load distribution according to the changes in the first modal shape during the analysis; (d) modal pushover analysis (Chintanapakdee and Chopra, 2003). The results of the pushover analyses do not change qualitatively from what is shown in Figure 6a and the failure mode and displacements' distribution along the height are not in agreement with the non-linear dynamic analysis. Even model pushover analysis, in which the responses of the first seven modes were

combined, is not able to simulate the amplification of the response at higher levels (Figure 6b).

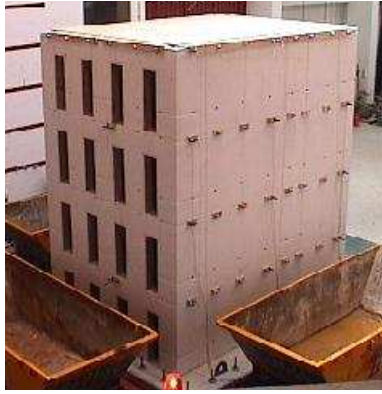
Figure 8: General view of the mock-up.

In order to assess the seismic vulnerability of the “gaioleiro” buildings, shaking table tests were carried out at the 3D shaking table of National Laboratory of Civil Engineering (LNEC), Lisbon (Candeias et al., 2004). A prototype of an isolated building was defined, constituted by four storeys with an interstory height of 3.60 m, and two opposite façades with a percentage of openings equal to 28.6% of the façade area, two opposite gable walls (with no openings) and timber floors. Due to the size and payload of the shaking table, the mock-ups (Figure 8) were built using a 1:3 reduced scale, taking in account Cauchy’s law of similitude (Carvalho, 1998). In plant, the mock-up has 3.15 x 4.15 m² and interstory height is equal to 1.2 m. The walls, originally built in poor quality rubble masonry with lime mortar, were replaced by a self compacting bentonite-lime concrete. The thickness of the walls is equal to 0.15 m. In the construction of the timber floors, medium-density fiberboard (MDF) panels connected to a set of timber joists, oriented in the direction of the shortest span, were used. The panels were cut in rectangles stapled to the joists, keeping a joint for separating the panels.

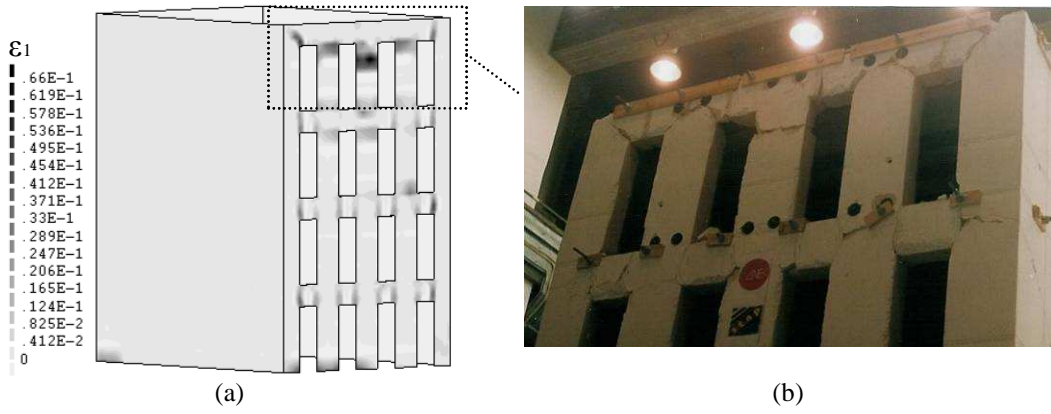
Figure 9: Damage the model: (a) numerical; (b) experimental (Model 1).

(ϵ_l is the principal tensile strain, which is an indicator of crack width)

The capacity curves of the pushover analysis proportional to the 1st mode (in the applied direction) show that the maximum load capacity approach the dynamic analysis. As expected, the crack patterns only provide in plane damage (Figure 13), which is not in agreement with the out-of-plane mechanism found in the time integration analysis and shaking table test (Figure 9 and 10).

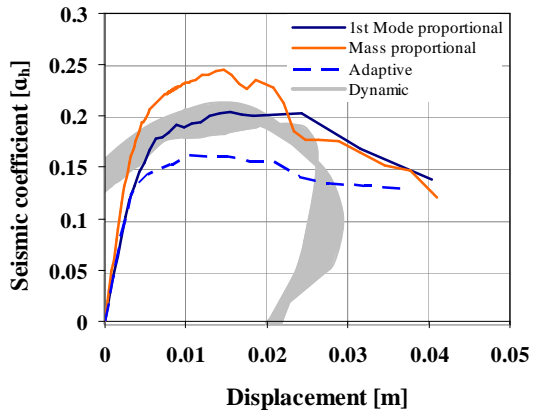
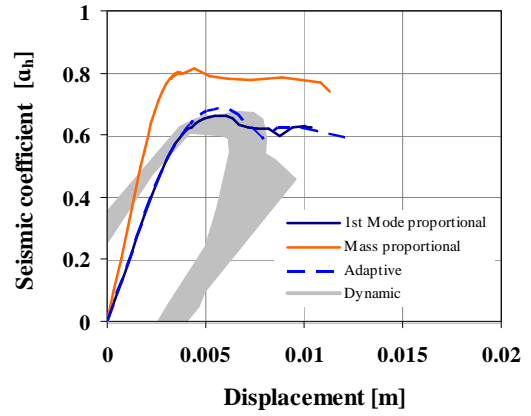
Figure 12: Capacity curves of the pushover analyses: (a) transversal direction; (b) longitudinal direction.

(The silver pattern represents the envelope of the three dynamic analyses).

In the capacity curves of the pushover analyses proportional to the mass (Figure 12), the maximum seismic coefficients are higher than the dynamic analysis (about 24%) and the damage concentration only appears at the lower zone of the structure. It is noted that in the dynamic analysis the damage concentrates at the 4th floor (façades) and at the base. Thus, this

In an attempt to explore the pushover analyses, two adaptive analyses were performed (Figure 12). In the first adaptive pushover analysis, the lateral loads, proportional to the 1st mode shape in were applied independently by direction and were updated as a function of the existing damage. The aim was to understand how the update of the external load vector can influence the structure response. However, this analysis did not provide any improvement in terms of load-displacement diagrams or failure mechanisms (Mendes and Lourenço, 2010). Finally, in the second adaptive pushover analysis the lateral loads, proportional to the 1st mode shape in the applied direction, were applied simultaneously in the transversal and longitudinal direction in the relation 30% and 100%, respectively. Here, the aim was to obtain the in-plane and the out-of-plane damage together in the same analysis. However, the combined effect of the loads applied simultaneously in the two directions cause the damage concentration on lintels, not simulating correctly the performance of structure under seismic load (Mendes and Lourenço, 2008). Thus, the usually adopted pushover analyses did not simulate correctly behavior of the “gaioleiro” buildings under seismic load, namely the out-of-plane behavior.

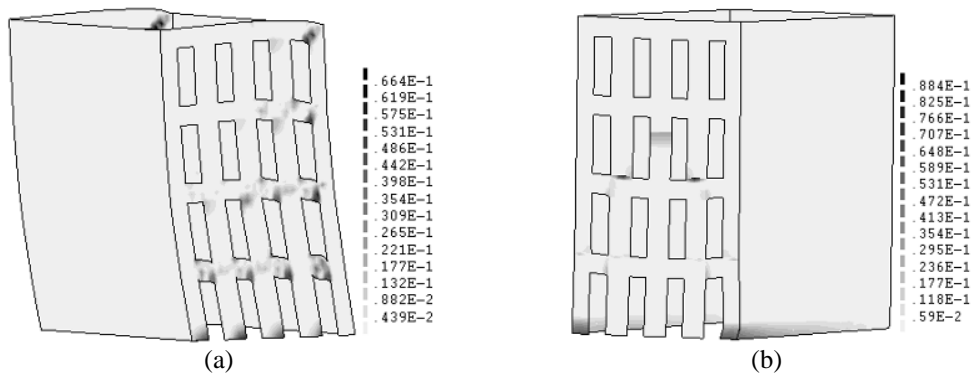
Figure 13: Tensile principal strains of the pushover analysis proportional to the 1st mode in the: (a) transversal direction; (b) longitudinal direction.
