## INFLUENCE OF INFILL ON THE CYCLIC BEHAVIOUR OF TRADITIONAL HALF-TIMBERED WALLS

Elisa Poletti, Graça Vasconcelos and Daniel Oliveira

ISISE, Department of Civil Engineering, University of Minho, Guimarães, Portugal

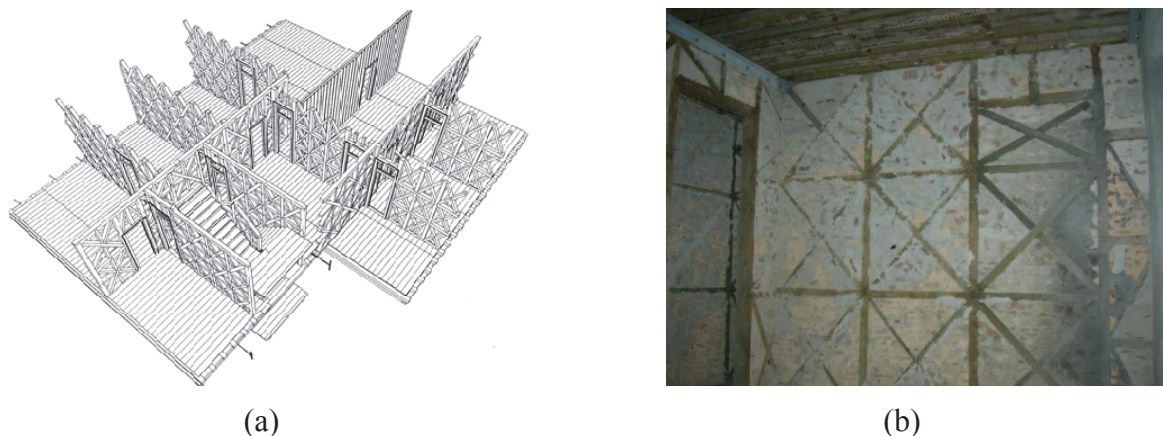
Figure 1: Examples of *gaiola pombalina*: (a) general floor plan (C3oias, 2007); (b) detail of half-timbered wall (<http://eventos.fct.unl.pt/cirea2012/>)

The example that is of most interest in this study is that of the reconstruction of Downtown Lisbon after the 1755 earthquake, which destroyed that part of the city. The new regulations for the reconstruction of the city introduced by Marques de Pombal included a building of usually five storeys with a stone masonry ground floor and an internal timber frame structure (named *gaiola* in Portuguese, which means cage) for the upper floors (Figure 1a). The *gaiola* was linked to the external masonry walls through the timber floor beams, to which it was connected. A minimal timber skeleton was present also in the external masonry walls. The framing of the *gaiola* was characterized by the typical St. Andrew's crosses (Figure 1b), which provided a bracing effect to the structure. The walls were filled with rubble or brick masonry. The internal half-timbered walls originally did not participate in the bearing of the vertical loads of the structure, the load bearing walls were the external masonry ones, but subsequent alterations or changes in use of the structure could have altered this condition.

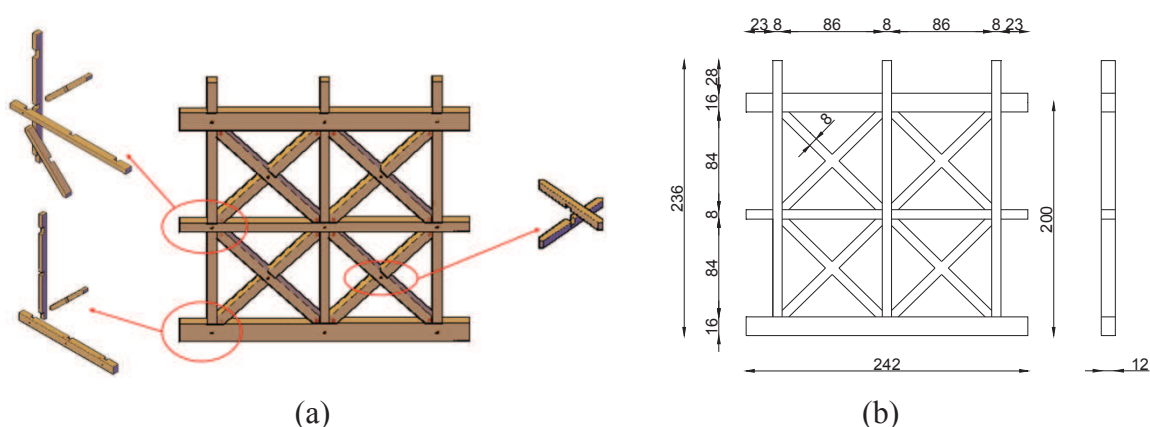
Figure 2: Wall specimens: (a) connections used; (b) dimensions of elements (in cm)

Half-timbered wall specimens were prepared according to dimensions found in existing buildings in Lisbon. All the connections between the vertical posts and the beams are overlapped ones, as well as the connections between the two diagonals of the St. Andrew’s crosses, whilst the connections between the diagonal and the main frame are simple contact ones (see Figure 2a). The walls were built in real scale, with realistic cross sections for all the elements (see Figure 2b).

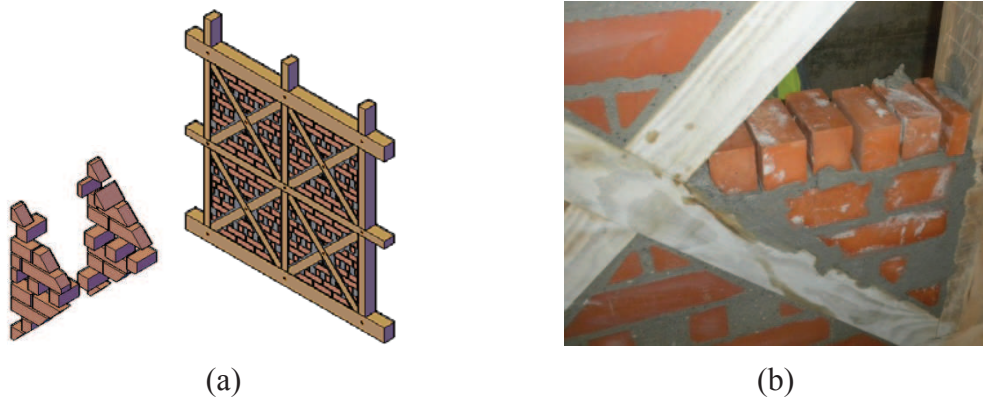
Figure 3: Half-timbered walls: (a) masonry pattern of infill walls; (b) detail of wall construction

having large portions of the masonry infill with only mortar due to the dimension of the brick. In fact, in historical buildings, bricks were usually smaller and moreover, rubble masonry could be used, thus having a more uniform distribution of the two components even in the corners. The masonry pattern chosen consists of double leaf masonry with transversal series of bricks every two rows of horizontal double leaf masonry (Figure 3).

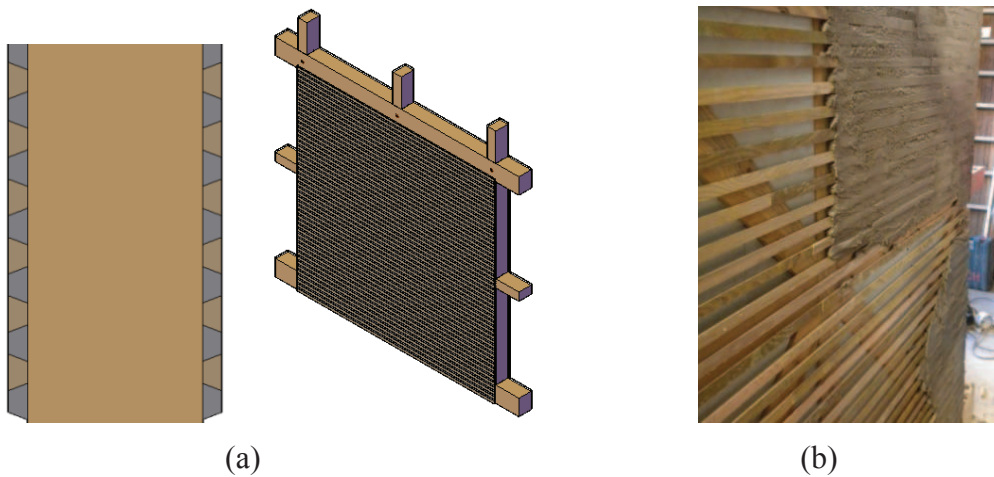
Figure 4: Fatchwork wall: (a) geometry of the wall; (b) detail of construction

The second kind of infill chosen for the walls consists of wood strips nailed with a nail gun to the timber frame. This kind of walls is known as fatchwork. The wood strips, which had a trapezoidal section (Figure 4) spaced of 2 cm, were not always continuous, but of varying length, and were nailed to each timber element they encountered with at least 3 nails.

Mortar was inserted between the strips (with the same ratio as that used for the masonry infill walls) and inside the timber frame for a thickness of 1.5 cm on each side of the wall. To prevent a higher mortar thickness, isolating panels were inserted in the wall to reduce the free space inside, but without providing any additional stiffness or weight to the wall.

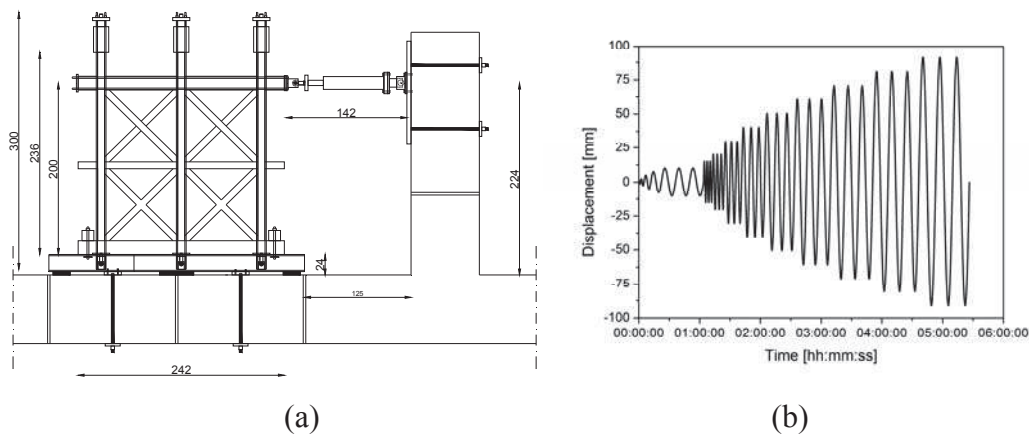
Figure 5: (a) Test setup used in the experimental campaign; (b) test procedure

Cyclic tests were performed on half-timbered walls using a reaction wall to which a hydraulic actuator was attached, which applied the horizontal displacement to the walls (Figure 5a). The actuator was connected to the reaction wall and to the top beam through two-dimensional hinges that allowed vertical displacement and rotation of the top border of the wall. Three hydraulic jacks applied the constant vertical pre-compression on the posts and could follow the horizontal movement of the walls by means of rods attached to the top of the jacks and connected to hinges fixed at the bottom steel beam. The walls were restrained at the bottom using steel angles and plates that fixed the bottom beam of the walls to a steel beam which was connected to the reaction floor. Out-of-plane movements were prevented by means of steel rollers attached to an external frame securing the top beam of the walls.

A cyclic test procedure was adopted following standard ISO DIS 21581 (2009), adding more steps in the procedure in order to better capture the highly non-linear behaviour of the walls. Due to limitations of the test equipment, the cycles were introduced with a sinusoidal law (Figure 5b), but no significant alterations were found in the tests when compared to others performed previously with linear cycles. Two different test speeds were adopted: for displacements up to 10% of the maximum one an average speed of 0.05mm/s was used; for higher displacements, a speed of 0.35mm/s was adopted.

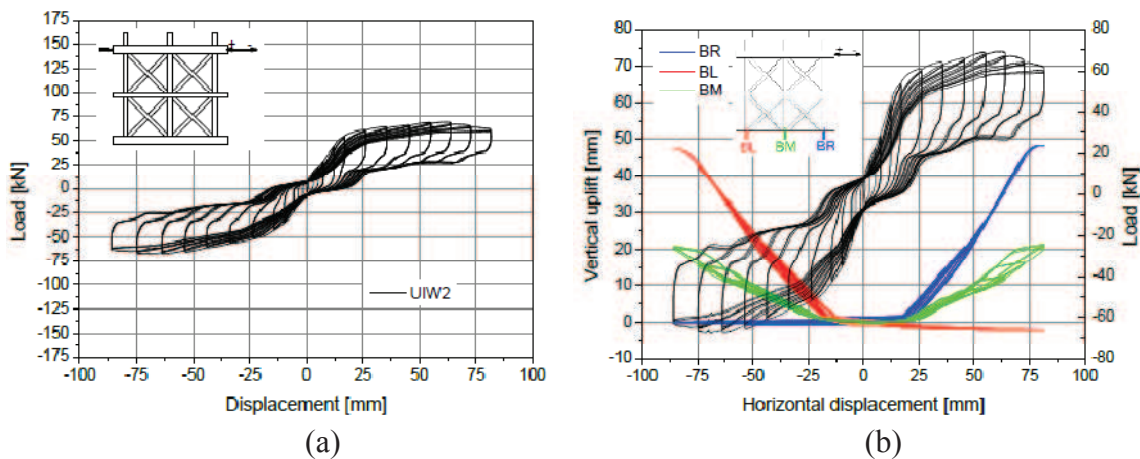
Figure 6: Hysteretic behaviour of half-timbered walls: (a) hysteretic loops; (b) vertical uplift corresponding to steps in loops.

All unreinforced half-timbered walls subjected to the lower vertical pre-compression level (UIW25) present a similar behaviour. The behaviour is highly non-linear since low values of displacement. The walls have a highly rocking behaviour, characterized by the S-shape of the curve (see Figure 6a), with a significant vertical uplift of the vertical posts (see Figure 6b). The lateral posts were uplifting as much as 50 mm, pointing out the important rotation experienced by the walls. This behaviour is due to the particular geometry of the wall, which presents in all connections overlapped connections. Since the bottom connections do not present the same continuity of the vertical element as the other connections in the post, the connection is a lot weaker, being simply a notched connection secured only by a nail, whereas in the other connections the continuity of the two timber elements prevents the early separation of the connection, which happens only if one element ruptures. Once the connections were completely open, the walls exhibited a low decrease in terms of strength. This behaviour is typical of the rocking mechanism, for which high displacements can be reached with little reduction of strength.

The hysteretic loops present a peculiar form which is not present, for example, in similar tests conducted on modern timber walls (Lam *et al.*, 1997) or masonry walls (Vasconcelos and Lourenço, 2009). If we compare the form of the hysteretic loops with the uplift of the vertical posts for the same horizontal displacement, one can notice how first: the change in stiffness in the loading branch starts when the lateral posts start uplifting; second: the small steps in the unloading branch of each cycle occur when the bottom connections start closing.

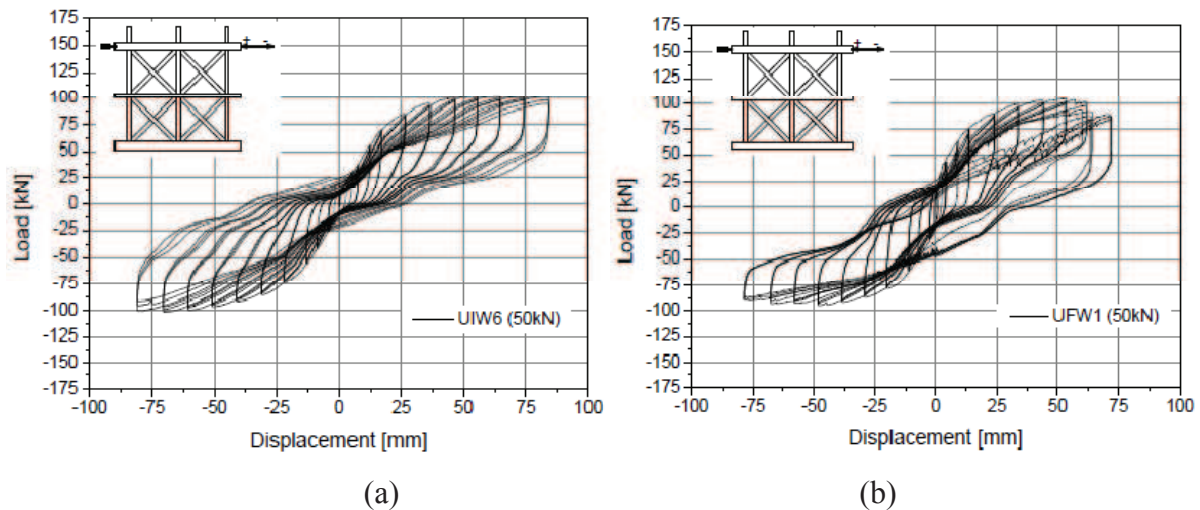
Figure 7: Hysteretic behaviour for higher vertical load level: (a) masonry infill; (b) fatchwork

The walls tested under the higher vertical load level (UIW50) presented a noticeably different behaviour. The behaviour of the walls went from being flexural to being mainly a shear one (see Figure 7a), though a flexural component is still present. The walls exhibit a progressive loss of stiffness, even though the ultimate load does not differ greatly from the maximum one. The typical damage for this wall was the crushing of the central overlapped connections of the wall, which failed in shear. Pinching is still present, but it is not as noticeable as it was for the walls tested with the lower vertical pre-compression level.

The walls still exhibited uplift in the bottom connections, though significantly lower than that observed for the walls tested for the lower pre-compression. The posts uplifted up to 50% less than what observed in the previous tests. Still, the same shape of the unloading branch can be observed when the posts close, with a noticeable step. The typical shape of the walls in this case is more oval, having the behaviour of the walls a shear component which solicited more the posts in bending.

The results on fatchwork walls for both vertical load levels were very similar to those observed for the masonry infill walls. The wall tested under the lower vertical load level (UFW25), exhibited a clear flexural behaviour, characterized by the S-shaped curve, while the wall tested with the higher vertical load level (UFW50) (Figure 7b), showed a dual flexural and shear behaviour, similarly to what observed for the walls tested with masonry infill.

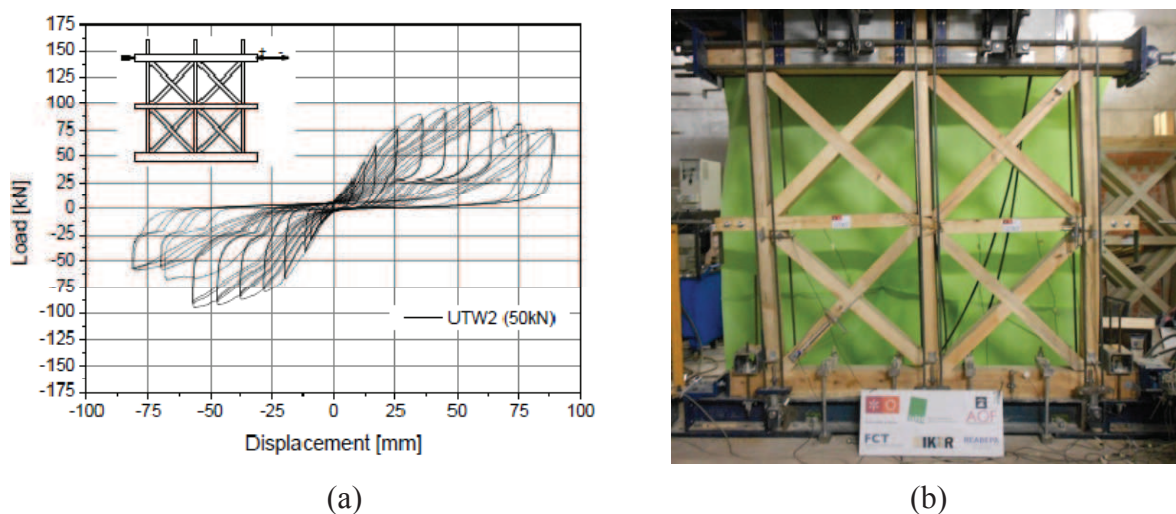
Figure 8: Behaviour of timber frame walls: (a) hysteretic behaviour for UTW50; (b) deformed shape of UTW50.

Timber frame walls exhibited a different behaviour from that of the infill walls. The behaviour was a predominant shear one, again with a minor flexural component. But, as it can be noticed from the hysteretic curves (Figure 8a), the walls experienced severe pinching. Moreover, the unloading branch of the various loops is more regular, even if the “step” characterizing the post uplifting is still present. For the two vertical load levels, the vertical uplift of the posts was similar and minimal, if compared to that of the infill walls (13.8 mm for UTW25 and 17.51 mm for UTW50). Contrary to what happened in the infill walls, the uplift was higher for the wall tested with the higher vertical load level (UTW50), but this was due to the fact that the wall failed for higher levels of horizontal displacement and the posts were stressed more.

The timber frame walls encountered heavy damage for both vertical load levels. Contrary to what happened in the infill walls, the damages in the timber frame walls were concentrated in the central beam (Figure 8b), due to the higher shear behaviour of the wall which stresses more the beams in tension.

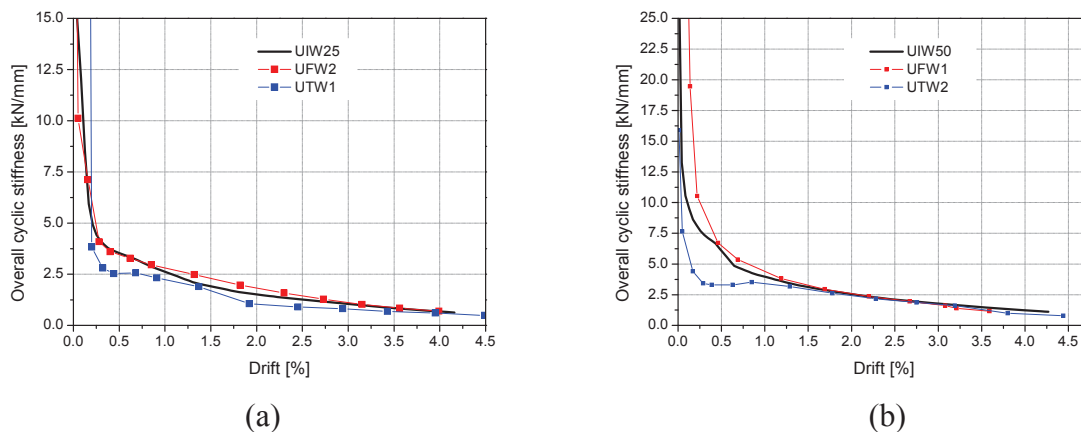
Figure 9: Overall cyclic stiffness: (a) lower vertical load level; (b) higher vertical load level

In terms of cyclic stiffness (Figure 9), timber walls exhibit the lowest stiffness, but for higher values of drift the results of the three wall types are comparable, after 1.5% for the higher vertical load level and only after 3.5% for the lower vertical load level. UTW25 walls reached an almost constant value of cyclic stiffness after a value of drift of 1.85%, while walls UIW25 and UFW25 continued to lose stiffness for increasing values of drift. UTW50 instead, degraded its stiffness in a way more similar to what happened for the infill walls.

For values of drift less than 3.5%, stiffness was always higher for the walls tested with the higher vertical load. For drifts up to 2.5%, the cyclic stiffness was almost the double for the highly loaded walls. After this value, stiffness starts to be comparable for the two load levels.

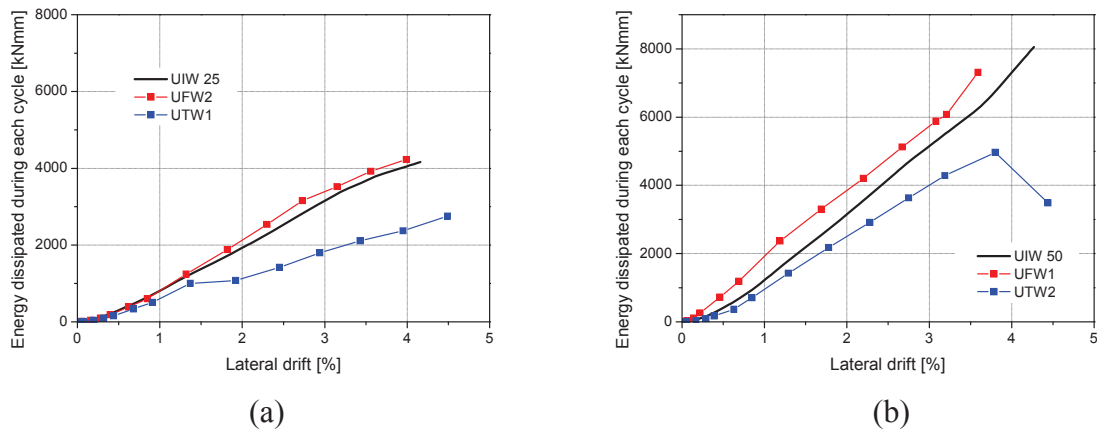
Figure 10: Dissipated energy: (a) lower vertical load level; (b) higher vertical load level

A confirmation that infill helps in improving the seismic characteristics of the walls comes from the comparison of the trends in terms of energy dissipation (Figure 10). For both load cases, infill walls were able to dissipate a higher amount of energy for the same drift value. It should also be pointed out, that for the same amount of lateral drift, the energy dissipated by the walls tested with the higher vertical load level is almost the double of that dissipated by the walls tested with the lower load.
