SEM ANALYSIS OF BOND EPOXY BASED LAYER BETWEEN HARDENED CONCRETE AND SFRC REPAIRING

E. Bonaldo^a, J.P. Castro-Gomes^b, J. A. O. Barros^c, P. B. Lourenço^d

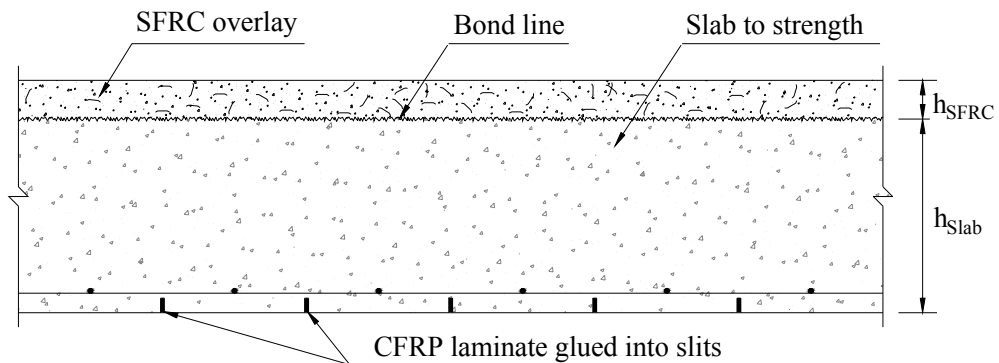
Figure 1: The hybrid strengthening technique for concrete slabs: CFRP laminate in tension zone and bonded SFRC overlay in compression zone.

The present work deals with aspects related to the microstructural analysis of the bond between concrete of distinct characteristics, and is a part of a more comprehensive research project involving carbon fibre reinforced polymer (CFRP) and discrete steel fibres for flexural strengthening and rehabilitation of concrete slabs. In the hybrid strengthening (see Figure 1) strategy, to overcome the limitation (concrete crushing in the compression region) resulted from the CFRP strengthening, a thin layer of steel fibre reinforced concrete (SFRC) can be bonded to the existing concrete at the compression surface, using an adhesive compound (Barros & Sena-Cruz, 2001). The development and maintenance of a sound bond between the overlay and the existing concrete substrate is an utmost requirement for the performance of the

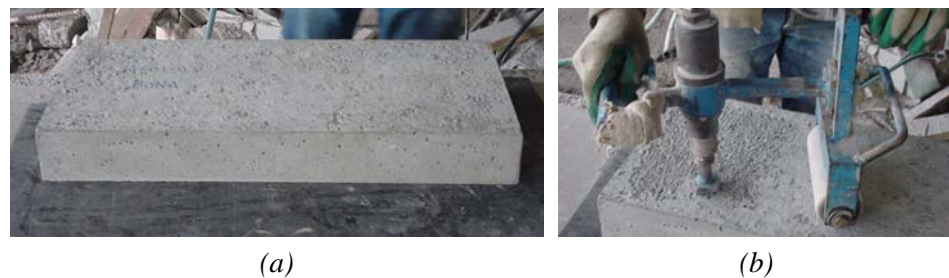
Figure 2: The specimen surface before roughening (a) and the roughening machine (b).

A specimen before surface treatment and the equipment used to roughen the surface is shown in Figure 2.

The process of roughening the top surface of the concrete substrate had the purpose of removing a very thin layer of the surface, in order to remove grease, oils, free particles, laitance or dirt, as well as producing an irregular surface. Figure 3

In the previous micrographs, microcracks are observed in the concrete substrate. The microcracking phenomenon extends to about 1 mm into the concrete substrate and is associated to the surface treatment used (see Figure 2).

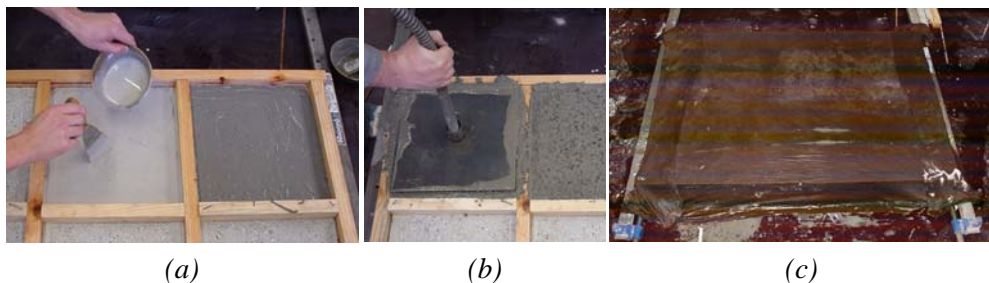
Figure 3: Main steps of the bonding process of the SFRC overlay: (a) placing the bond product, (b) consolidating of the SFRC and (c) curing with wet burlap.

shows the main bond steps. When the concrete overlay attained an age of about 28 days, the partial core was drilled and the pull-off tests were carried out.

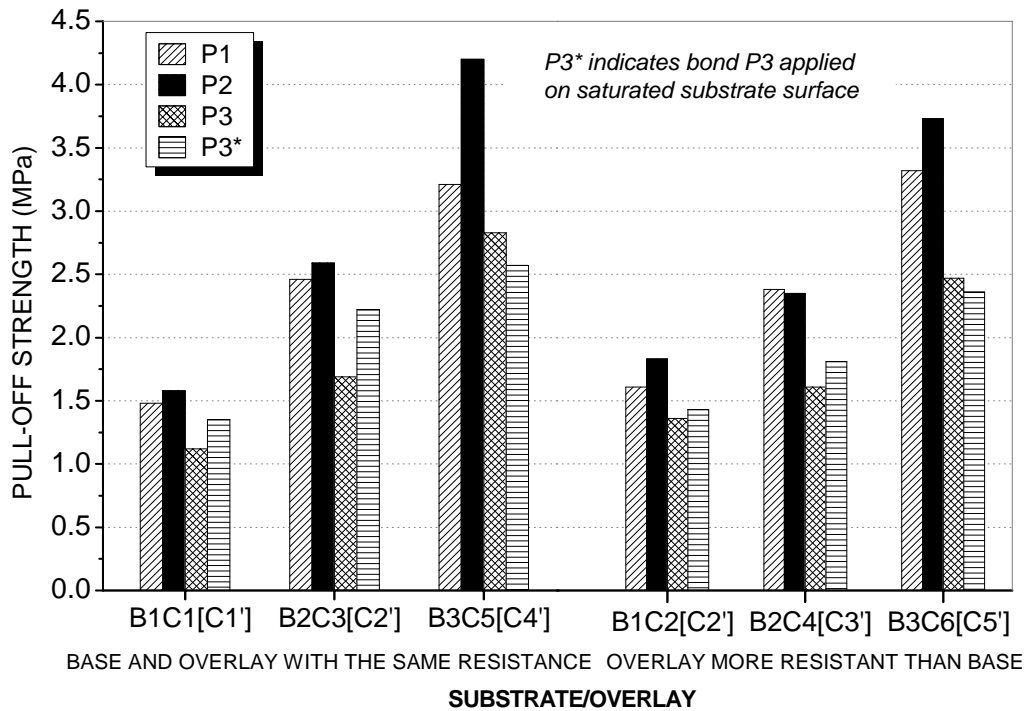
Figure 4: Pull-off average strength for each substrate and overlay type. Here $B_n C_m [C_m']$ indicates: B_n - ordinary concrete substrate, C_m - SFRC overlay bonded with P1, P2 and P3, and $[C_m']$ - SFRC overlay bonded with P3, on saturated substrate surface ($P3^*$).

The mechanical bond behaviour was assessed from pull-off tests on non reinforced substrate concrete slabs overlaid with SFRC. The series of tests were composed according to the concrete strength given in Table 2. The influence of the strength class of concrete substrate and repairing SFRC, and also the adhesive agent used to bond the two concretes was analysed (Bonaldo et al., 2004). The mechanical resistance - pull-off strength, is summarized in Figure 4. For a more comprehensive review refer to Bonaldo et al. (2004, 2005).

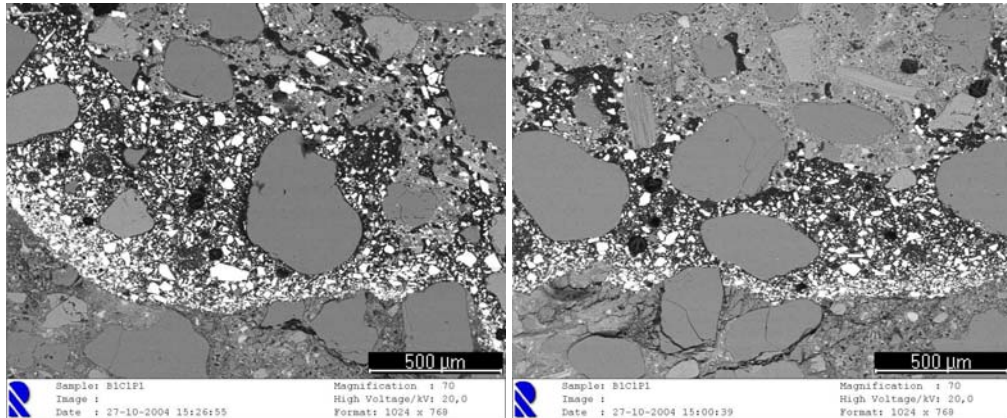
(a) Bond Layer P1 (70x mag.)

(b) Bond Layer P1 (70x mag.)

Figure 5: Micrographs of sample bond system B1-P1-C1.

Micrographs of sample bond system B1-P1-C1 and B3-P1-C5 are presented in Figures 5 and 6, respectively. These images show a well defined boundary line corresponding to base concrete, connected to the epoxy layer. The top layer corresponding to SFRC does not have a well defined boundary line. On the contrary, SFRC sand particles and hydrate cement paste are intercalated in the epoxy resin layer. The sand particles are of size between 0.3 and 0.5 mm approximately, and hydrate cement paste varies from very small individual particles to clusters of about 300 μm diameter.

The epoxy layer bond in Figure 5 has about 1 mm mean value thickness, and also contains a large amount of a mineral admixture (white entities). Thus giving this

layer different characteristics from bottom to top which may be considered as three distinct sub-layers as follows: close to boundary substrate bottom line there is high concentration of mineral admixture blended in epoxy, in the middle portion the resin layer has sand particles and hydrate cement clusters and, in the top sub-layer, fragments of epoxy resin are mixed together with hardened SFRC.

Porosity is also visible in the bond layer, resulting from air voids with sizes ranging from about 5 to about 20 μm .

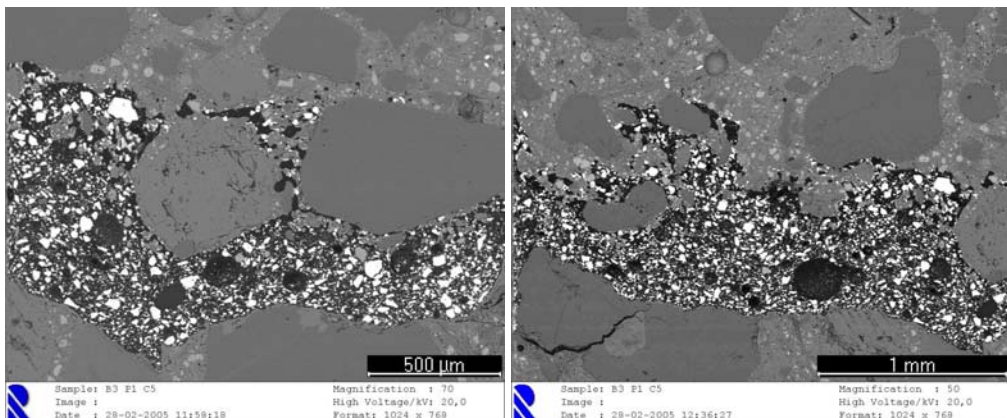
(a) Bond Layer P1 (70x mag.)

(b) Bond Layer P1 (50x mag.)

Figure 6: Micrographs of sample bond system B3-P1-C5.

Micrographs of bond system B3-P1-C5, presented in Figure 6, exhibit very small differences from those of B1-P1-C1 system. However, in this case it seems that the mineral admixtures of epoxy resin are more evenly distributed. The epoxy bond layer is well defined and also contains sand particles and hydrated cement clusters embedded with it.

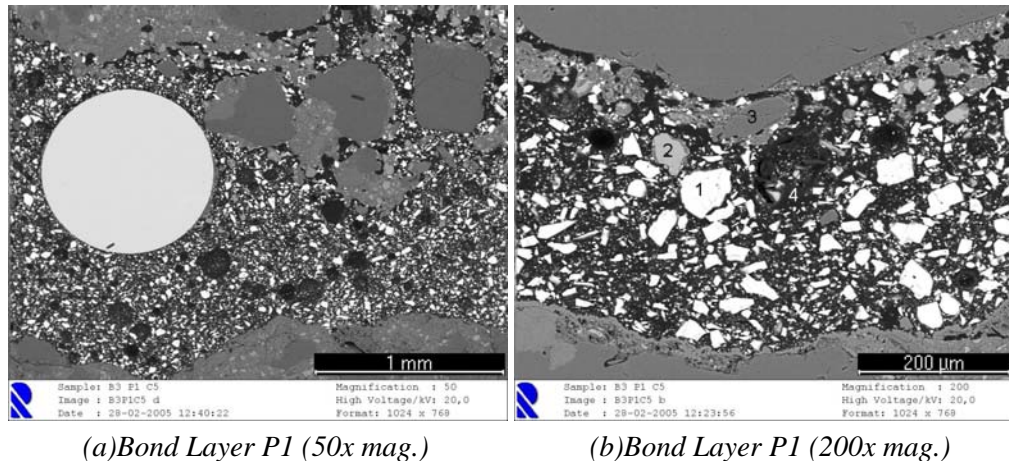
Figure 7: Micrographs of sample bond system B3-P1-C5.

In Figure 7 (a) a steel fiber completely embedded in resin bond layer is shown.

Figure 7 (b) presents the resin epoxy bond layer at 200x magnification. EDX analysis was done in points 1, 2, 3 and 4 identified in this figure. Point 2 corresponds to a cement particle partially hydrated, as commonly found in hardened cement pastes (Castro-Gomes et al., 1998), and point 3 corresponds to a small sand particle.

The points 1 and 4 of Figure 7 (b) correspond to the bright clusters and dark areas, respectively, which constitute the resin bond layer. The bright clusters correspond to the mineral admixture while the dark areas are the epoxy resin itself. This was confirmed with the EDX analysis in points 1 and 4.

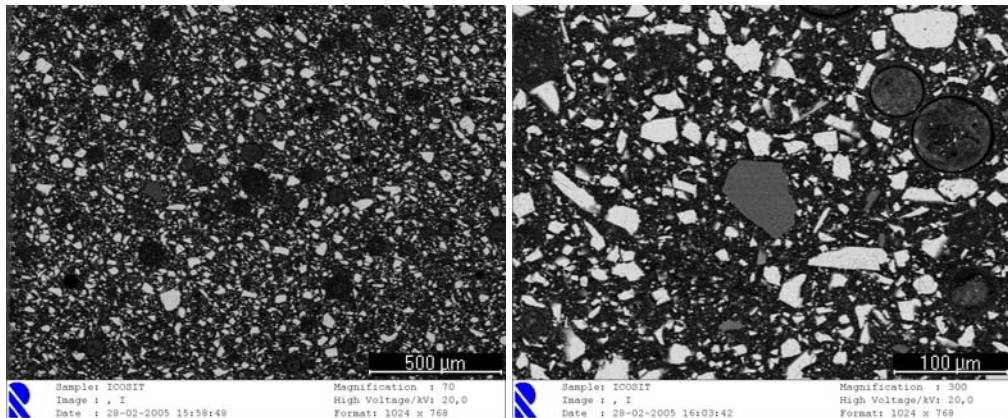
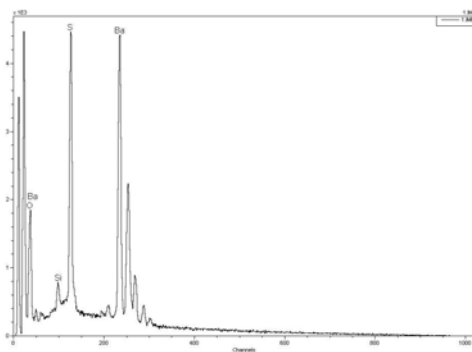
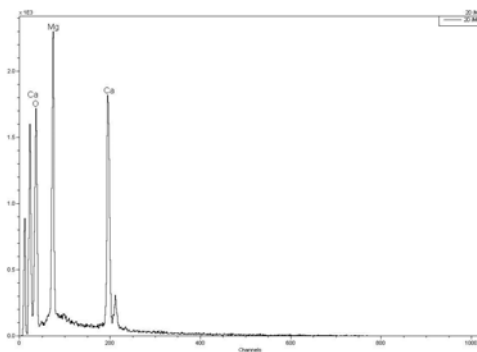
(a) Epoxy Resin P1 (70x mag.)

(b) Epoxy Resin P1 (300x mag.)

(c) EDX of point 1 (Figure 7(a))

(d) EDX of grey cluster (Figure 8 (b))

Figure 8: Micrographs and EDX graphs of epoxy resin P1.

The EDX analysis of point 1 is presented in Figure 8 (c). It shows that the mineral admixture is most probably crushed fragments of barite (BaSO_4), although this information was not supplied by the producer. The morphology of these particles is sharply angular and exhibit conchoidal fracture, as expected in crushed fragments of barite. Some particles are elongated, some are prismatic, and other particles are thin and thick tabular.

Figures 8 (a) and (b) shows micrographs of epoxy resin P1 at two different magnifications. These micrographs also show that resin P1 contains another mineral admixture appearing light grey, which is not barite that appears bright white.

The EDX of Figure 8 (d) corresponds to this other mineral, particularly the light grey cluster visible in the micrograph of Figure 8 (b). The EDX gives presence of Mg and Ca elements which indicates that it might correspond to a magnesium clay,

such as magnesium dolomite (Mg, Ca) CO₃. According to the supplier it corresponds to a variety of montmorillonite clay. It is known that modified clays are very fine materials commonly used blended with epoxy resins to modify its thixotropic properties. Other fine materials like cristobalite, fine quartz, fumed silica or fine barite particles can also be used with the same purpose. These colloidal fine materials are thixotropic agents. They increase resin viscosity when it is in contact with absorbing materials, for example, such us concrete, thus preventing resin to be absorbed in concrete pores.

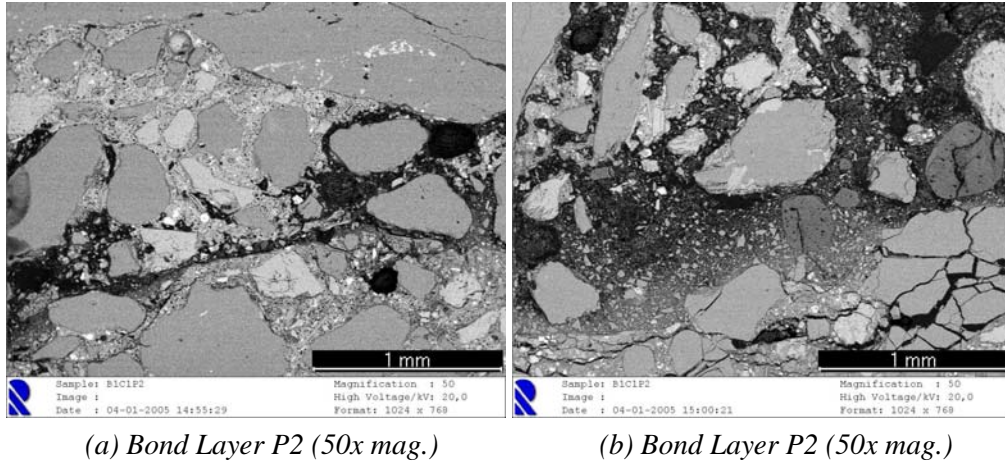
Figure 9: Micrographs of sample bond system B1-P2-C1.

Figures 9 and 10, present sample bond system B1-P2-C1 and B3-P2-C5, respectively. The first micrograph of Figure 9 (a) shows epoxy layer thickness varying from 0.5 mm to 1 mm. Figure 9 (b) shows a bond layer with thickness up to 2.5 mm. The top concrete layer is somewhat intercalated with the resin layer, as in the case systems of low strength concrete with epoxy P1. However, in case of P2 resin, it seems that larger cement paste clusters of those found in systems with epoxy P1 were involved with the resin. This apparently results from the fact that the epoxy compound P2 is denser than P1, as was found during the application in the laboratory.

Some sand particles of the overlay are also found embedded in the epoxy resin layer. According to the producer, resin P2 contains 25 - 50% quartz filler (SiO_2), clearly visible and relatively well distributed, although with some concentration in the low portion of the bond layer in system B1-P2-C1. Some porosity resulting from air voids of 50 to about 100 μm is also visible.

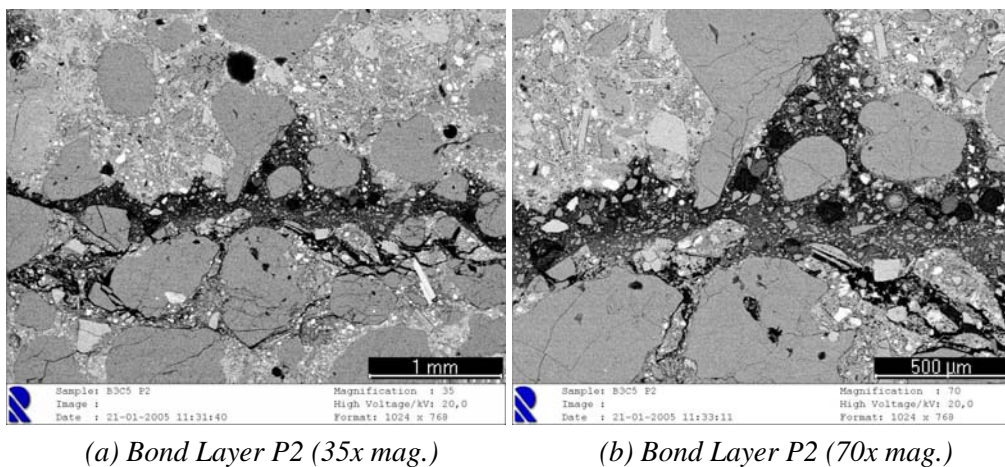
Figure 10: Micrographs of sample bond system B3-P2-C5.

Micrographs of Figure 10 show similar features of epoxy region bond system B3-P2-C5. In this case the epoxy bond layer contour appears better defined than in system B1-P2-C1. Similar well defined epoxy layer contour was found in system B3-P1-C5. Concrete top and bottom layers of B3-P2-C5 system show reasonable amount of anhydrous cement and partially hydrated cement particles. It is well known that in cases of low water cement ratios significant amounts of partially hydrated and anhydrous cement can still be found in hardened concrete, even after one year age (Castro-Gomes et al. 1998).

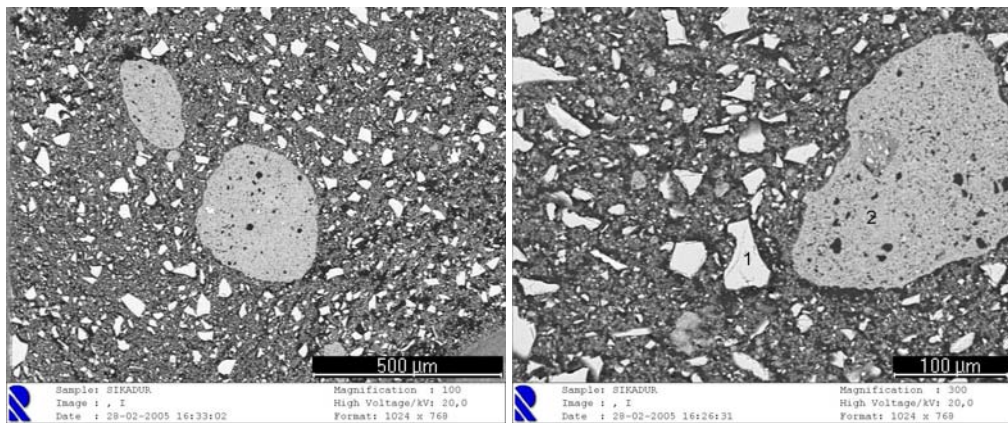
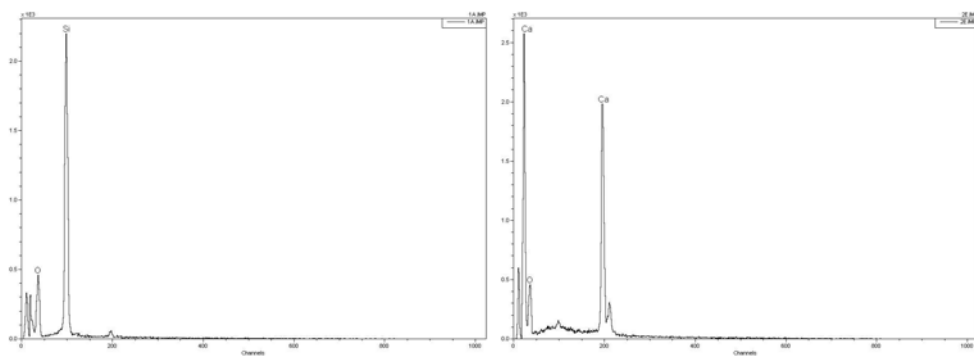
(a) Epoxy Resin P2 (100x mag.)

(b) Epoxy Resin P2 (300x mag.)

(c) EDX of white particles (Figure 11(a))

(d) EDX of grey cluster (Figure 11 (b))

Figure 11: Micrographs and EDX graphs of epoxy resin P2.

Figures 11 (a) and (b) presents resin epoxy P2 at two different magnifications. EDX analysis was done in points 1 and 2 identified in Figure 11 (b). EDX graphs of points 1 and 2 are presented in Figures 11 (c) and (d), respectively. According to EDX analysis, white particles were identified as quartz (SiO_2). This is in accordance with producer information given. The morphology of quartz is identical to the morphology of barite, found in resin P1. However, the percentage of quartz particles found in P2 resin is smaller than barite particles percentage blended in P1 resin. This is evident when comparing micrographs of Figures 8 (b) and 11 (b). It is also evident that both quartz and barite particles are of very fine or colloidal degree and are smaller than approximately $80 \mu\text{m}$.

EDX in point 2 (the large light grey particle) gives mainly calcium. This indicates that the other mineral admixture is calcite CaCO_3 , as was confirmed by the manufacturer. However this regular shaped fragments could correspond to dolomite..

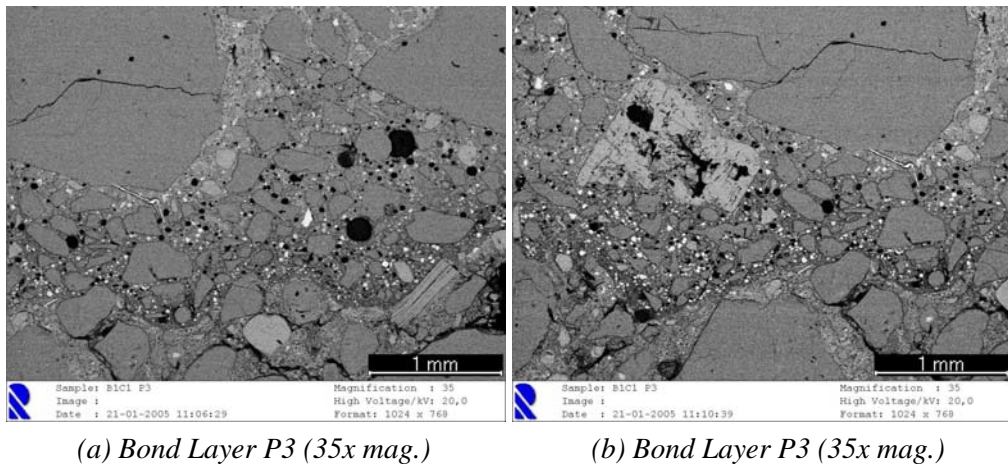
Figure 12: Micrographs of sample bond system: B1-P3-C1.

Micrographs of sample bond system B1-P3-C1 are presented in Figure 12. This image shows the epoxy layer of about 2 mm thickness (from 1 mm up to 3 mm). The boundaries are not easily identified as in P1 and P2 previous micrographs. Sand particles and mortar of the top layer are uniformly blended with the epoxy cement layer and apparently there are no separately clusters as in P1 and P2 bonds. Finer porosity, 2 or 3 μm as well as void pores of 20 to 30 μm are visible. A significant amount of anhydrous cement and partially hydrated cement in the bond layer is also clearly noticeable.

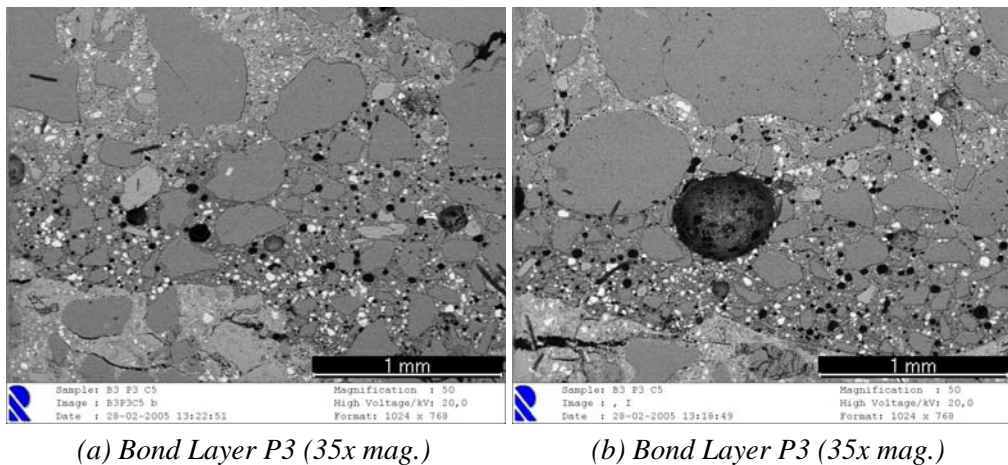
Figure 13: Micrographs of sample bond system: B3-P3-C5.

Micrographs of sample bond system B3-P3-C5 are given in Figure 13 and show similar features of those found in Figure 12.

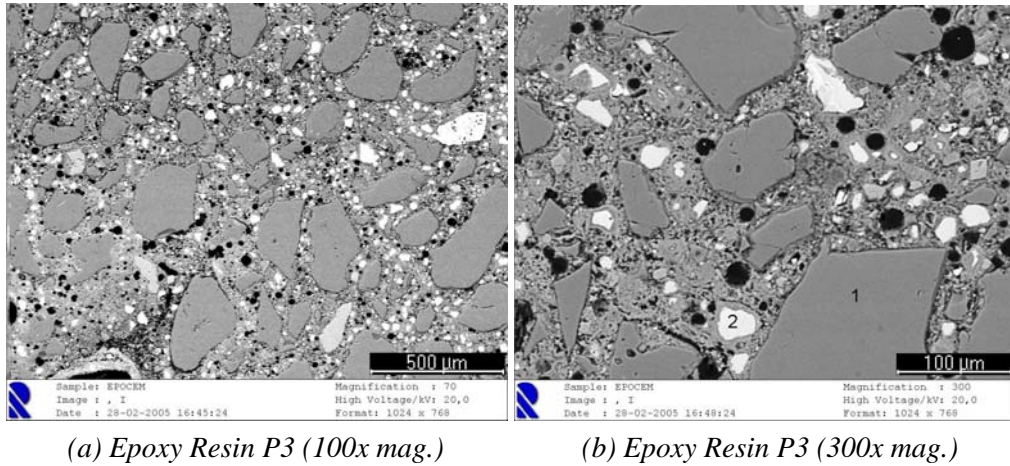
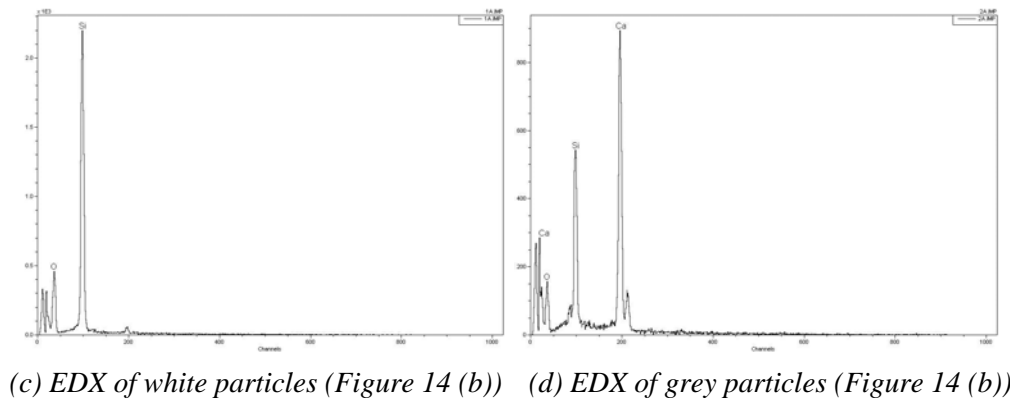
Figure 14: Micrographs and EDX graphs of epoxy resin P3.

EDX analysis and micrographs of resin P3 are presented in Figure 14. According to EDX spectrum in point 1, grey particles were identified as fine sand quartz (SiO_2) while grey particles corresponding to point 2 are identified as partially hydrated cement. This is as expected according with resin producer information.

Quartz sand particles size varies from 0.1 to 0.5 mm.
