## **Seismic Vulnerability Overview of Historical Masonry Churches in Europe**

### **Abstract**

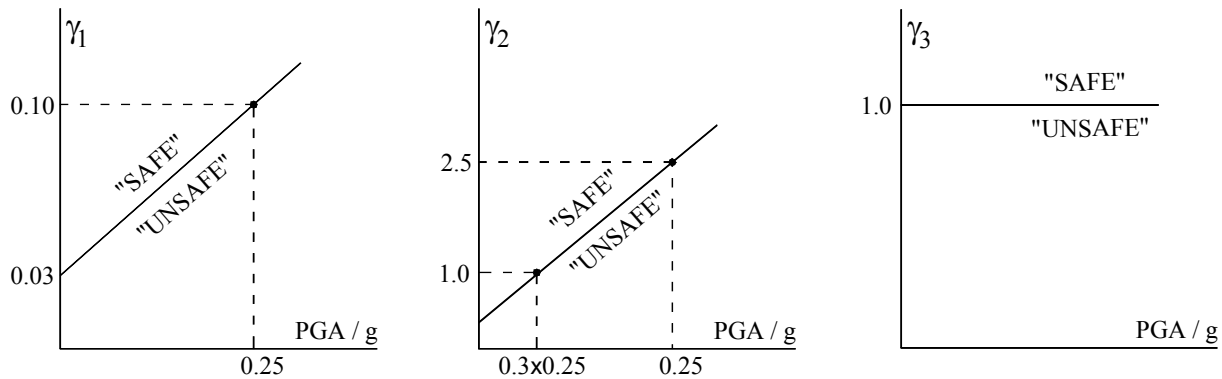
**Figure 1 - Assumed thresholds for indexes 1, 2 and 3 as a function of PGA/g**

buildings must have identical safety, these indexes should be larger with increasing seismicity. For indexes 1 and 2, the seismicity is taken into account by considering that the threshold value, defined above, is valid for a PGA/g value of 0.25 and assuming its linear variation with PGA/g, as illustrated in Figure 1, see also Eurocode 8<sup>9</sup>. On the other hand, index 3 should be constant in different seismic zones, as it considers the effect of seismicity. This index format is close to the traditional safety approach adopted for structural design, being the threshold value equals 1, see Figure 1.

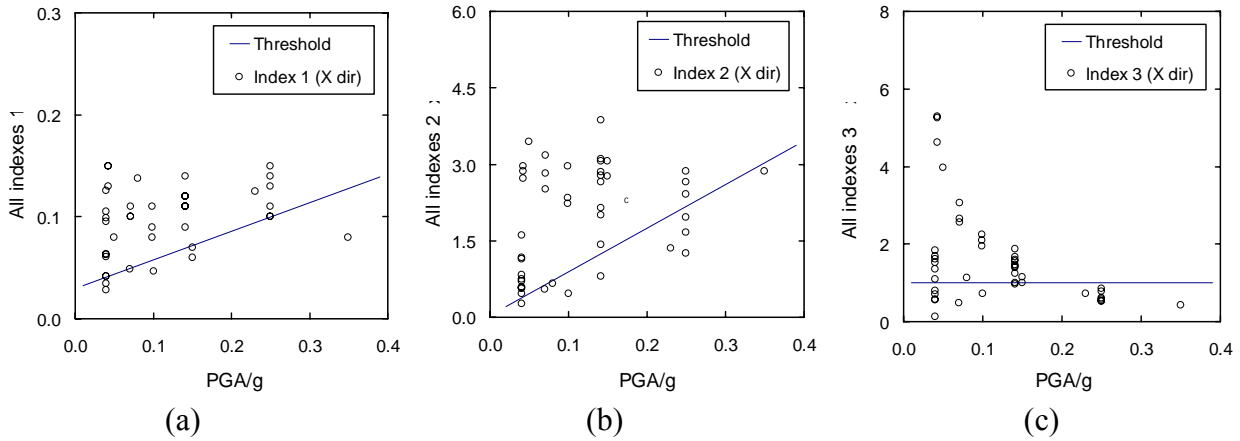
**Figure 2 - Relationship between in-plane indexes (direction x) and PGA/g, for the entire sample: (a) index 1, (b) index 2, (c) index 3**

For the application of the simplified analysis methods, it was assumed that all the masonry materials were similar, the volumetric weight of masonry was  $20 \text{ kN/m}^3$  and the weight of roofs was equal to  $2.0 \text{ kN/m}^2$ . The values computed for the three in-plane indexes, which can be found elsewhere<sup>12</sup>, are graphically represented in Figure 2 and Figure 3, for the entire sample and for each direction, as a function of the local parameter PGA/g.

In terms of average values, index  $\gamma_1$  presents lower values in the transversal direction (x) of the church nave, which is expected due to churches' geometry, although Italian indexes are quite similar in both directions. Index  $\gamma_1$  does not show a clear variation with seismicity, but Figure 2a and Figure 3a indicate that this index tends to grow roughly with increasing seismicity. When a comparison is made using the proposed threshold, 25% of the churches violate it in the x direction and 9.1% in the y direction, as expected, since the same criterion is used in both directions. This means that the cases that might require further investigation are due to a deficient earthquake resistance mainly along the transversal direction of the church nave.

Index  $\gamma_2$ , although being inversely proportional to the height of the buildings, presents a situation similar to index 1. Again, the calculated values don't show a visible trend with respect to seismicity, however a slightly tendency associates the increase of  $\gamma_2$  with PGA increase, see Figure 2b and Figure 3b. On average terms, also index  $\gamma_2$  presents lower values in the x direction, which can be justified again by churches' geometry. As a result, this index is violated by 38.6% and 29.5% of the monuments in x and y directions, respectively. This index is mainly violated by Spanish churches.

Index  $\gamma_3$  shows an unexpected and alarming decreasing variation with the PGA parameter, see Figure 2c and Figure 3c. For moderate and high seismicity areas (PGA greater than 0.15g), index  $\gamma_3$  is violated by all churches, in both directions. In spite of that, also for low seismicity areas, index  $\gamma_3$  is not entirely fulfilled. As happened with both previous indexes, index  $\gamma_3$  presents lower values in the x direction. Individually, 40.9% and 31.8% of the churches in x and y directions violate it, respectively, which denotes a deficient earthquake resistance along both the transversal and longitudinal directions. Unexpectedly, this index assumes minimum values slightly lower than 0.15, in both directions, which is most likely associated to high vulnerable structures, probably unable to face properly an earthquake. This index is mainly violated by Italian churches.

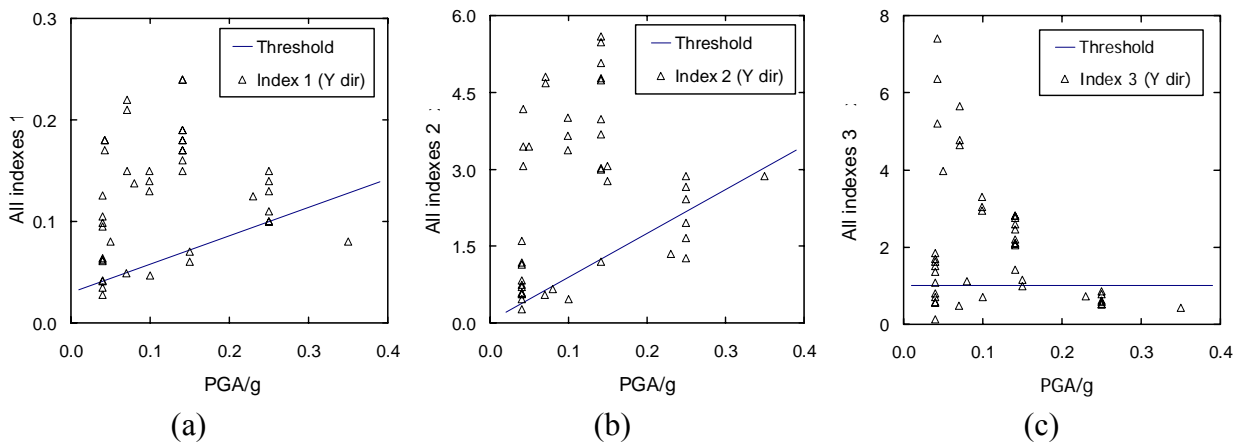
**Figure 3 - Relationship between in-plane indexes (direction y) and PGA/g, for the entire sample: (a) index 1; (b) index 2; (c) index 3**

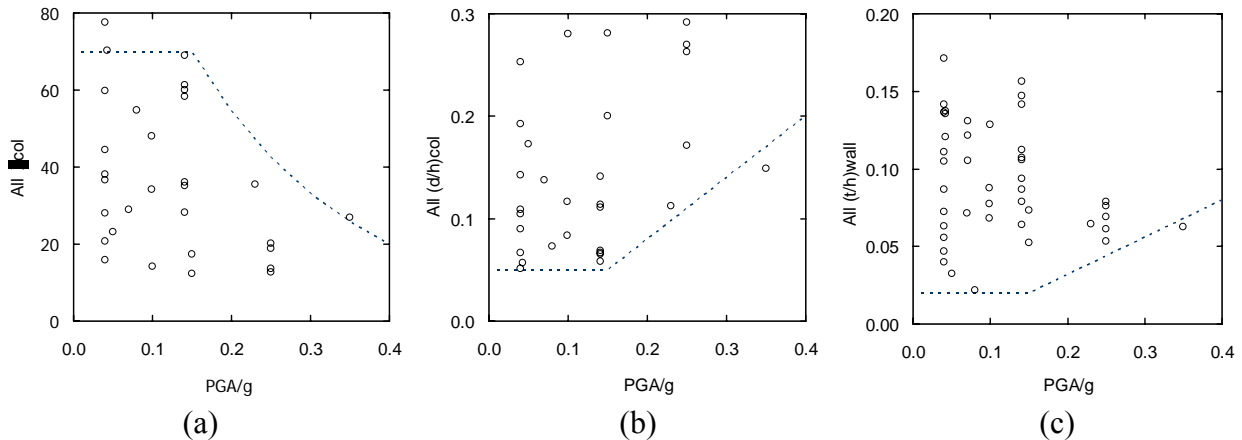
**Figure 4 - Relationship between out-of-plane indexes and PGA/g, for the entire sample: (a) index 4; (b) index 5; (c) index 6.**

The values obtained for the three out-of-plane indexes, are graphically represented in Figure 4, for the entire sample, as a function of the local seismicity.

Similar to use of the in-plane indexes, the out-of-plane indexes do not show any clear relationship with seismicity, see Figure 4. However, a deeper analysis allows distinguishing a slightly common variation of the three indexes with seismicity. In fact, for low and moderate seismicity areas (PGA up to 0.10g – 0.15g), the indexes do not exhibit a dependency on seismicity, assuming a large range of values instead. However, for a PGA greater than 0.15g, a possible trend may be established. From Figure 4 it can be observed that index 4 (column's slenderness) tends to decrease with increasing seismicity and that both index 5 and index 6 seem to increase continuously with seismicity. These trends are depicted in Figure 4 by dashed lines. Their general evolution with increasing seismicity was expected since for a same safety level, index 4 should decrease and both indices 5 and 6 should increase. Therefore, the dashed lines can be seen as possible threshold proposals, to be comprehensively calibrated, that these indexes should observe.
